DTC	B0136/74	Open in P/T Squib (LH) Circuit
------------	-----------------	---------------------------------------

CIRCUIT DESCRIPTION

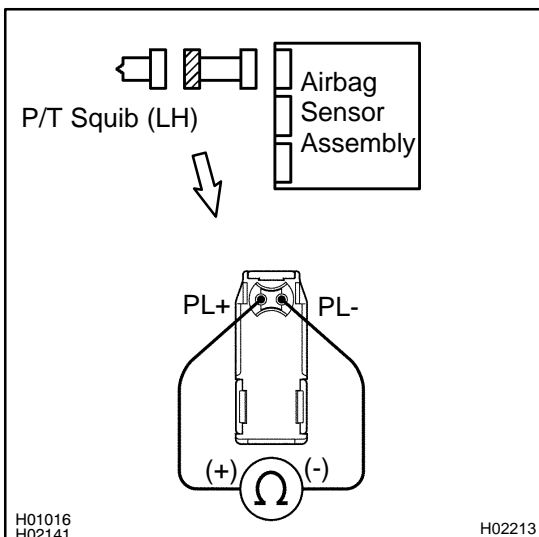
2	Check P/T squib (LH) circuit.
----------	--------------------------------------

CHECK:
For the connector (on the seat belt pretensioner side) between the seat belt pretensioner (LH) and the airbag sensor assembly, measure the resistance between PL+ and PL-.

OK:
Resistance: Below 1 Ω

NG → **Repair or replace harness or connector between seat belt pretensioner (LH) and airbag sensor assembly.**

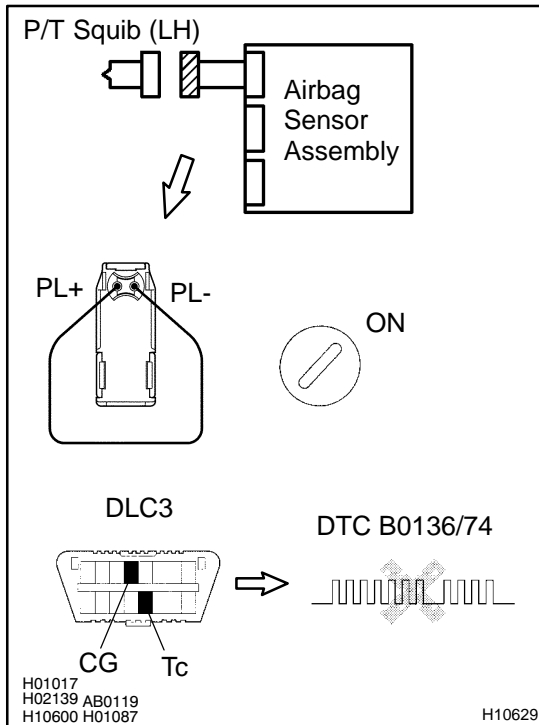
3 Check airbag sensor assembly.

- Connect the connector to the airbag sensor assembly.
- Using a service wire, connect PL+ and PL- of the connector (on the seat belt pretensioner side) between the seat belt pretensioner (LH) and the airbag sensor assembly.
- Connect negative (-) terminal cable to the battery, and wait at least for 2 seconds.

- Turn the ignition switch to ON and wait at least for 20 seconds.
- Clear DTC stored in memory. (See page [DI-239](#))
- Turn the ignition switch to LOCK, and wait at least for 20 seconds.
- Turn the ignition switch to ON, and wait at least for 20 seconds.
- Check DTC. (See page [DI-239](#))

DTC B0136/74 is not output.

Replace airbag sensor assembly.

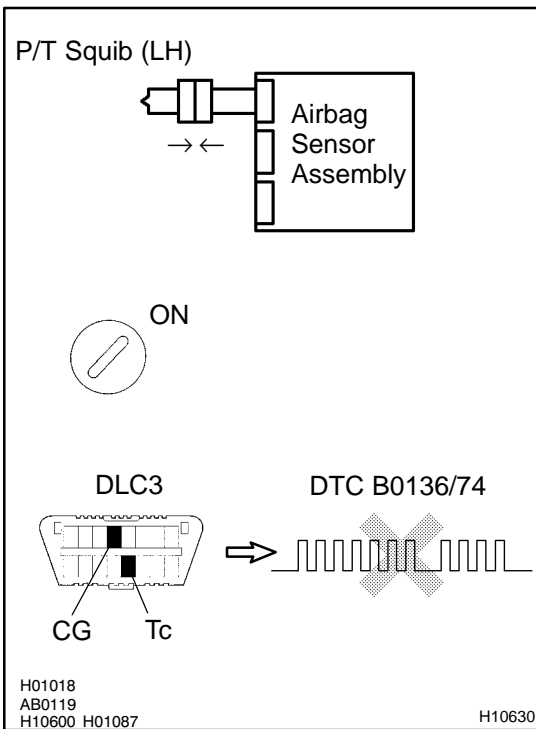
4 Check P/T squib (LH).

- Turn the ignition switch to LOCK.
- Disconnect negative (-) terminal cable from the battery, and wait at least for 90 seconds.
- Connect the seat belt pretensioner (LH) connector.
- Connect negative (-) terminal cable to the battery, and wait at least for 2 seconds.

- Turn the ignition switch to ON, and wait at least for 20 seconds.
- Clear DTC stored in memory. (See page [DI-239](#))
- Turn the ignition switch to LOCK, and wait at least for 20 seconds.
- Turn the ignition switch to ON, and wait at least for 20 seconds.
- Check DTC. (See page [DI-239](#))

DTC B0136/74 is not output.

Replace seat belt pretensioner (LH).
