# Position of Parts in Instrument Panel (LHD)

- \* 18: Before Aug. 2017 Production
- \* 19: From Aug. 2017 Production
- \* 24: w/ PTC Heater
- \* 25: w/o PTC Heater

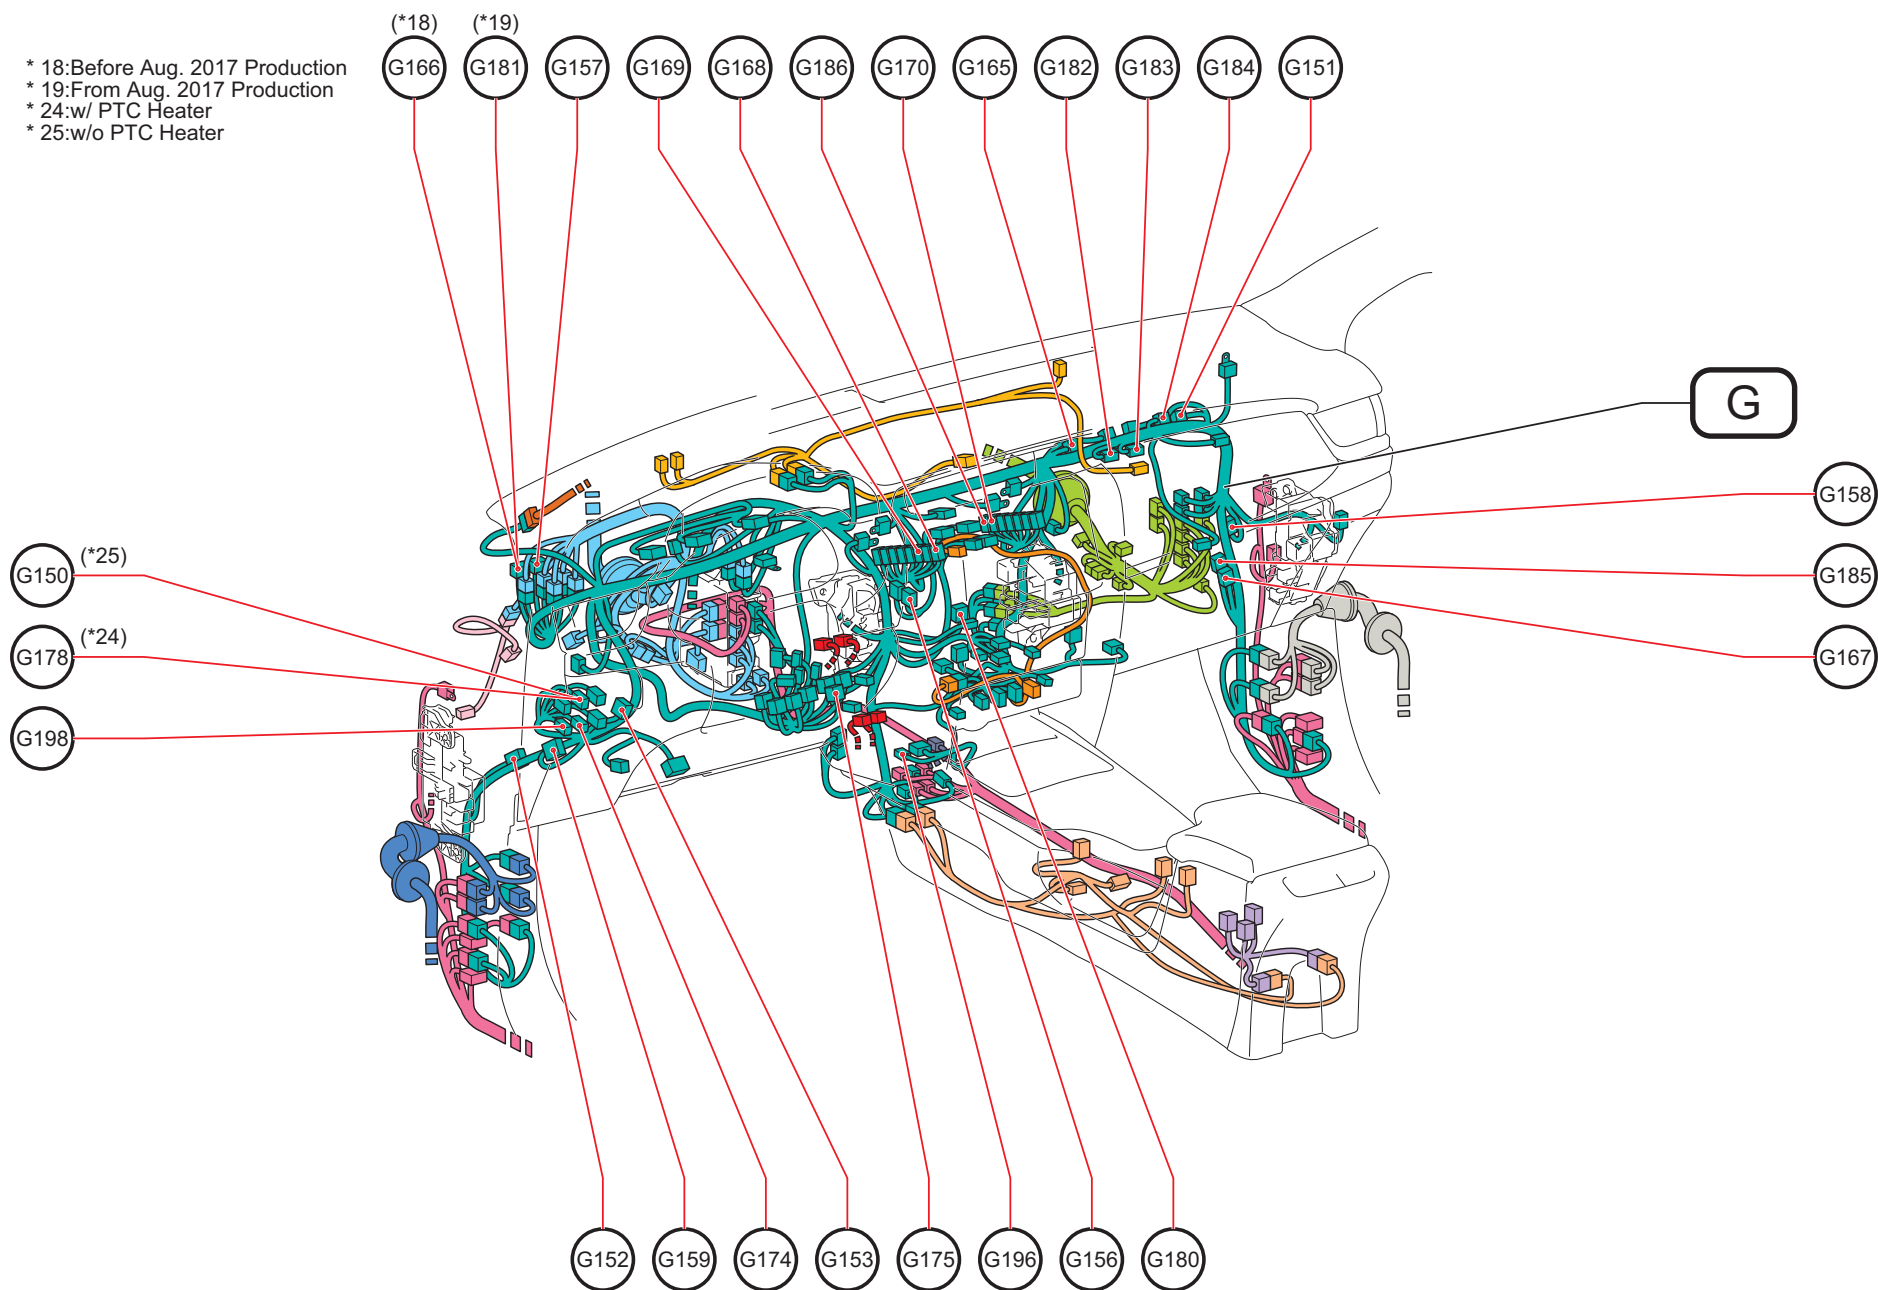
G150 Tire Pressure Warning Reset Switch (Tire Pressure Warning Switch)

G151 No. 32 Junction Connector

G168 No. 1 CAN Junction Connector

G174 Door Control Switch Assembly

G175 Spiral Cable Sub-Assembly

G178 Heater Switch Assembly

G180 Telephone Transceiver Assembly

G196 A/C Amplifier Assembly

G198 Diesel Particulate Reduction Switch Assembly

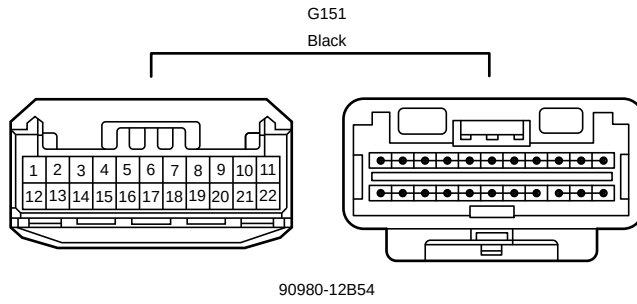
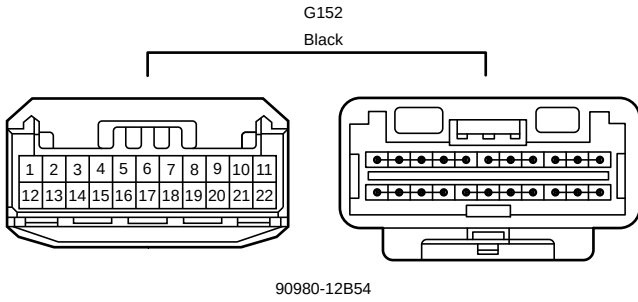
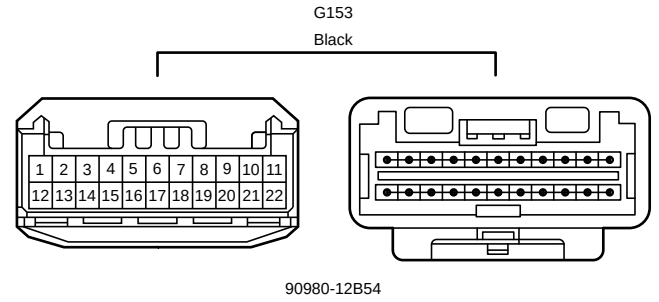
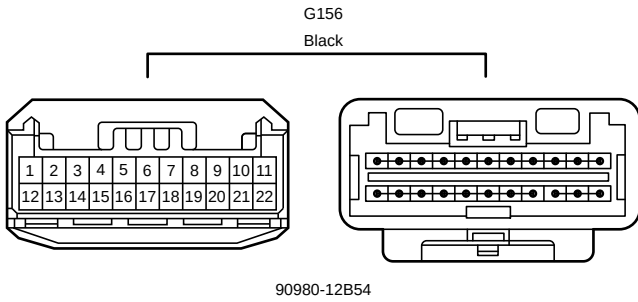
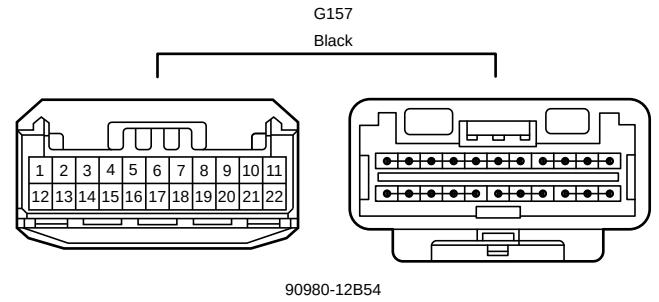
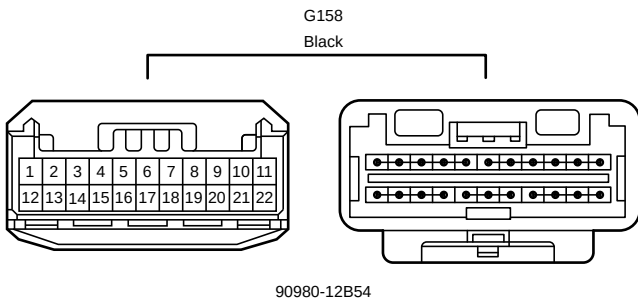
## Position of Parts in Instrument Panel (LHD)

G152 No. 33 Junction Connector

G153 No. 34 Junction Connector

G156 No. 35 Junction Connector

G157 No. 36 Junction Connector

G158 No. 37 Junction Connector

G159 No. 38 Junction Connector

G165 No. 39 Junction Connector

G166 No. 40 Junction Connector

G167 No. 41 Junction Connector

G169 No. 1 CAN Junction Connector

G170 No. 2 CAN Junction Connector

G181 No. 43 Junction Connector

G182 No. 44 Junction Connector

G183 No. 45 Junction Connector

G184 No. 46 Junction Connector

G185 No. 47 Junction Connector

G186 No. 2 CAN Junction Connector
