Position of Parts in Instrument Panel <LHD>

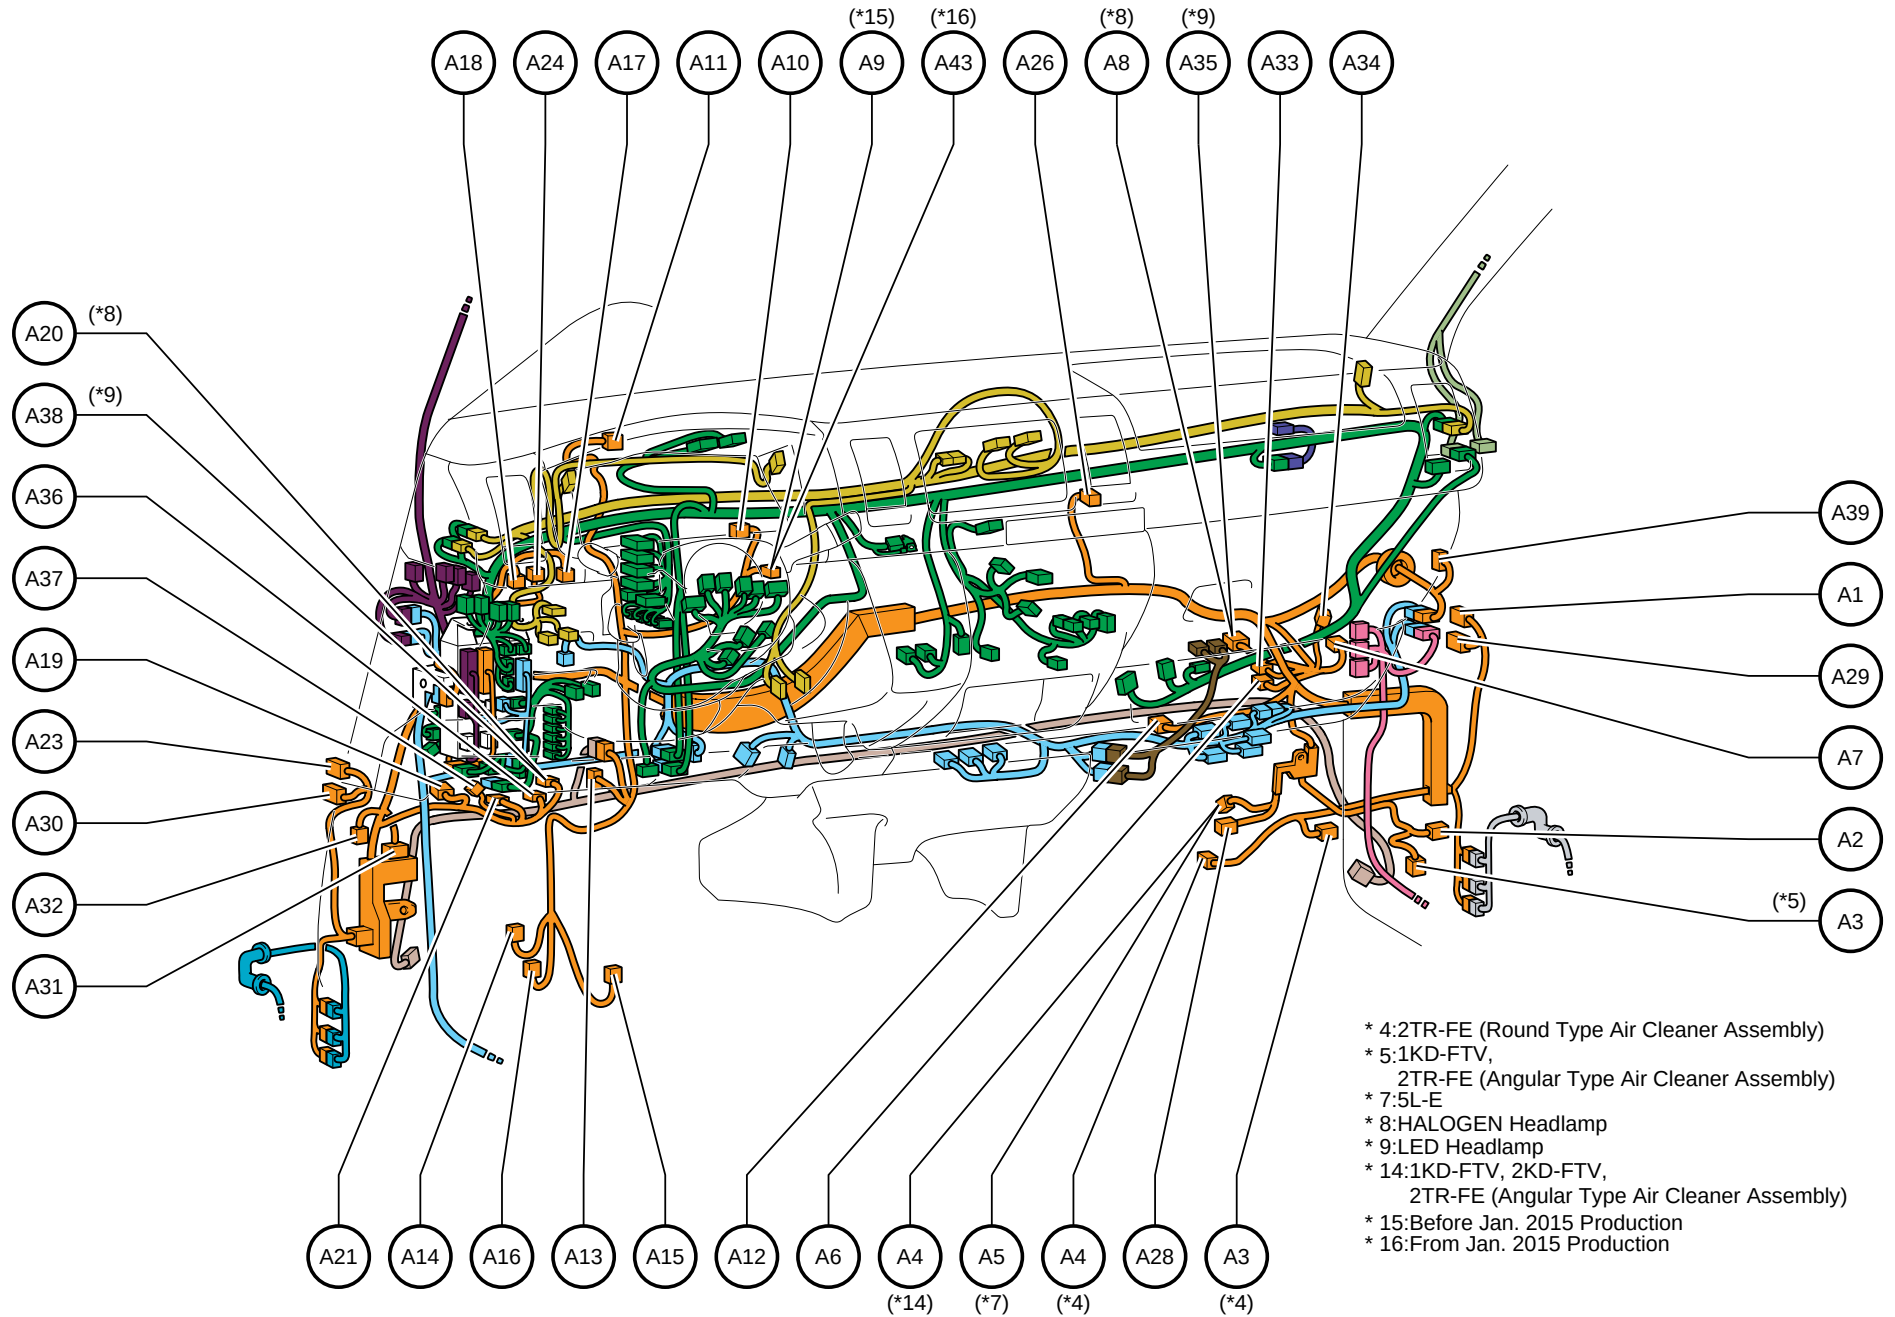
- A 1 Turn Signal Lamp (Front RH)
- A 2 Inlet Air Temp. Sensor (Air Cleaner)
- A 3 Air Flow Meter
- A 4 A/C Pressure Sensor No.1
- A 5 Pressure SW
- A 6 Clearance Lamp (Front RH)

- A 7 Headlamp (RH)
- A 8 Headlamp Leveling Motor (RH)
- A 9 Brake Vacuum Warning SW
- A 10 Brake Fluid Level Warning SW
- A 11 Windshield Wiper Motor
- A 12 Airbag Sensor (Front RH)

- A 13 Airbag Sensor (Front LH)
- A 14 Ambient Temp. Sensor
- A 15 Horn (Low)
- A 16 Horn (High)
- A 17 Windshield Washer Motor
- A 18 Rear Washer Motor
- A 19 Headlamp (LH)

- A 20 Headlamp Leveling Motor (LH)
- A 21 Clearance Lamp (Front LH)
- A 23 Turn Signal Lamp (Front LH)
- A 24 Short Pin (Vacuum)
- A 26 A/C Pressure Sensor No.2

- A 28 Magnet Valve
- A 29 Daytime Running Light (Headlamp Assembly RH)
- A 30 Daytime Running Light (Headlamp Assembly LH)
- A 31 Junction Connector
- A 32 Option Connector (Car Finder Out)

- A 33 Headlamp Assembly RH
- A 34 Headlamp Assembly RH
- A 35 Headlamp Leveling Motor (RH)
- A 36 Headlamp Assembly LH
- A 37 Headlamp Assembly LH
- A 38 Headlamp Leveling Motor (LH)

- A 39 Headlamp Leveling Computer Assembly
- A 43 Brake Vacuum Warning SW
