## Power Source

Audio System, Navigation System and  
Parking Assist (Rear View Monitor)

33 HILUX (Cont' d)

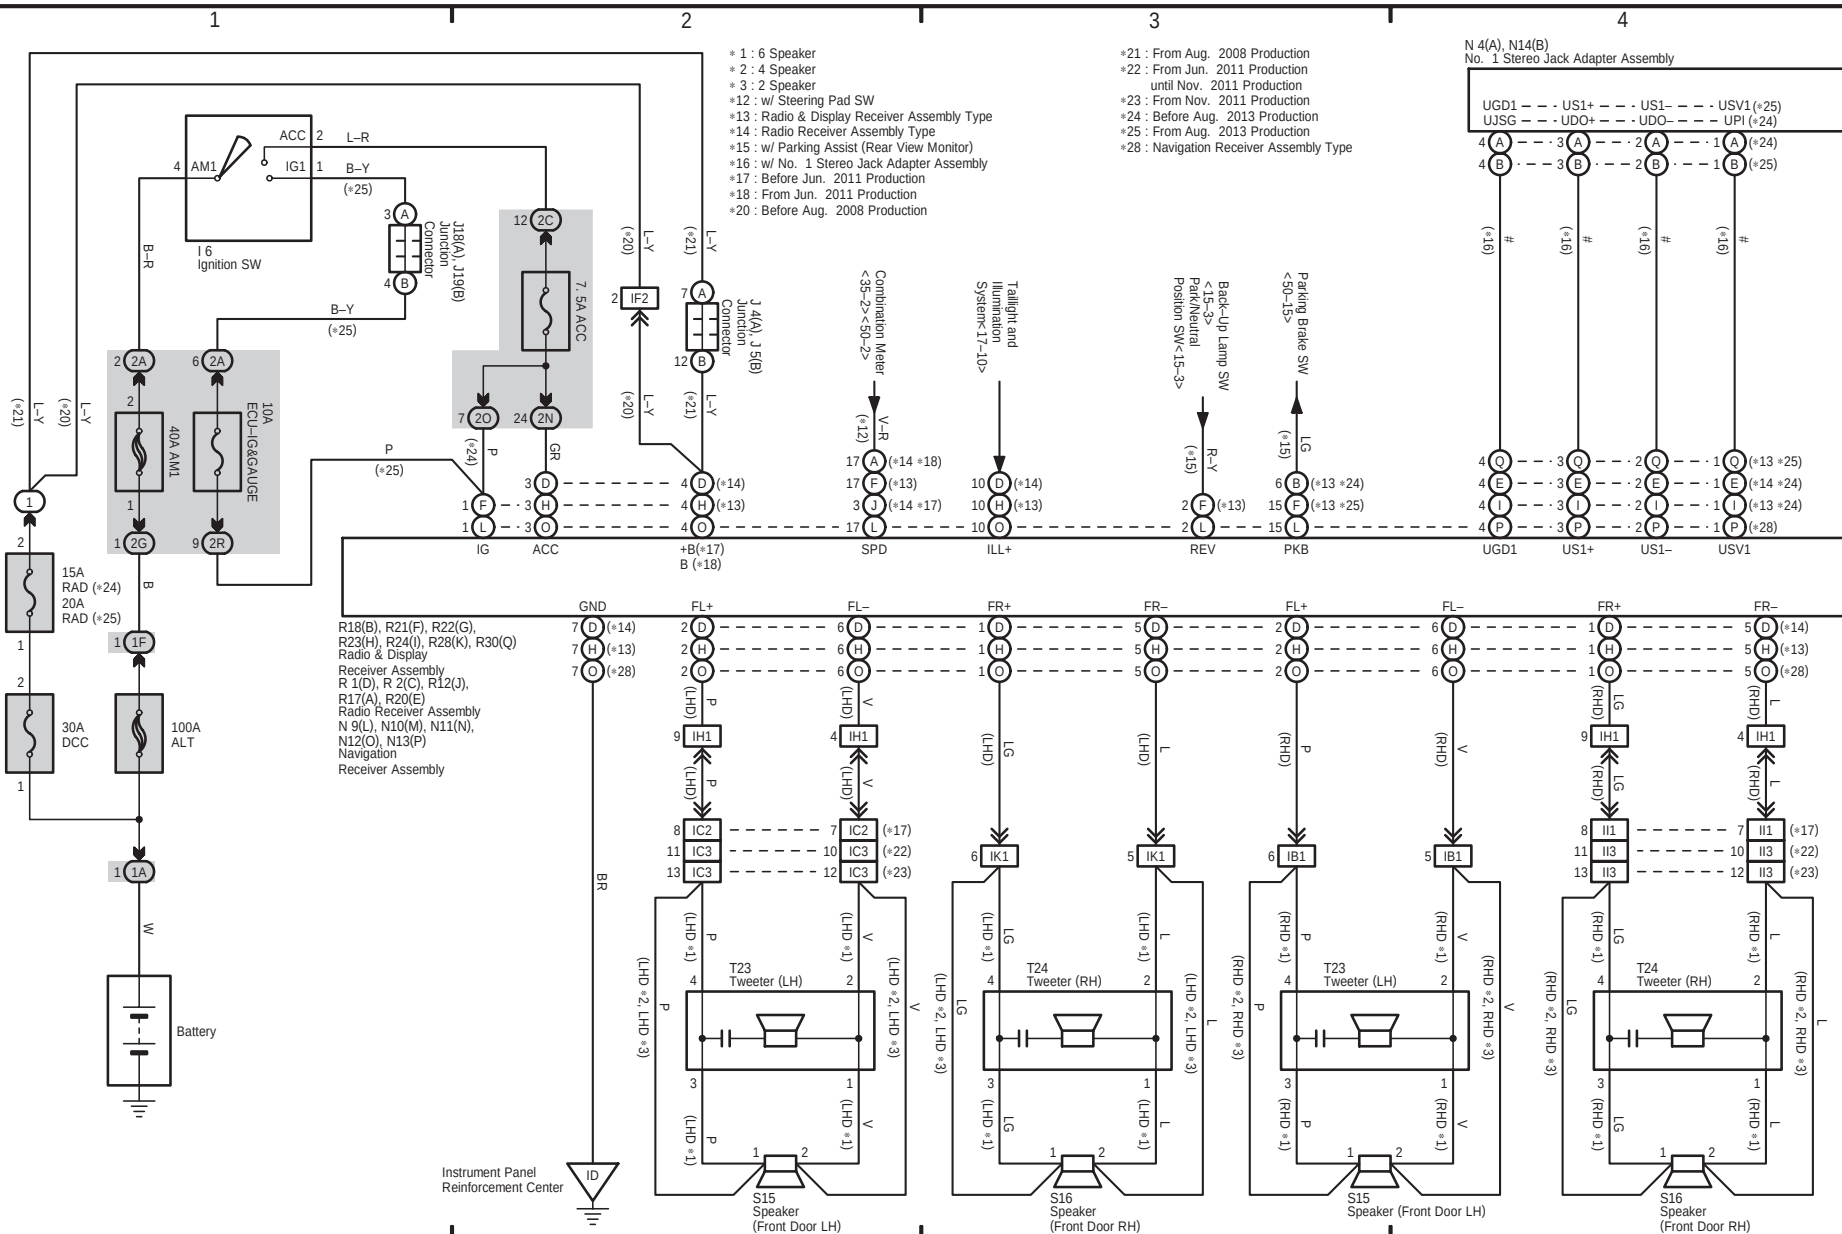
# : There is no wire color information.

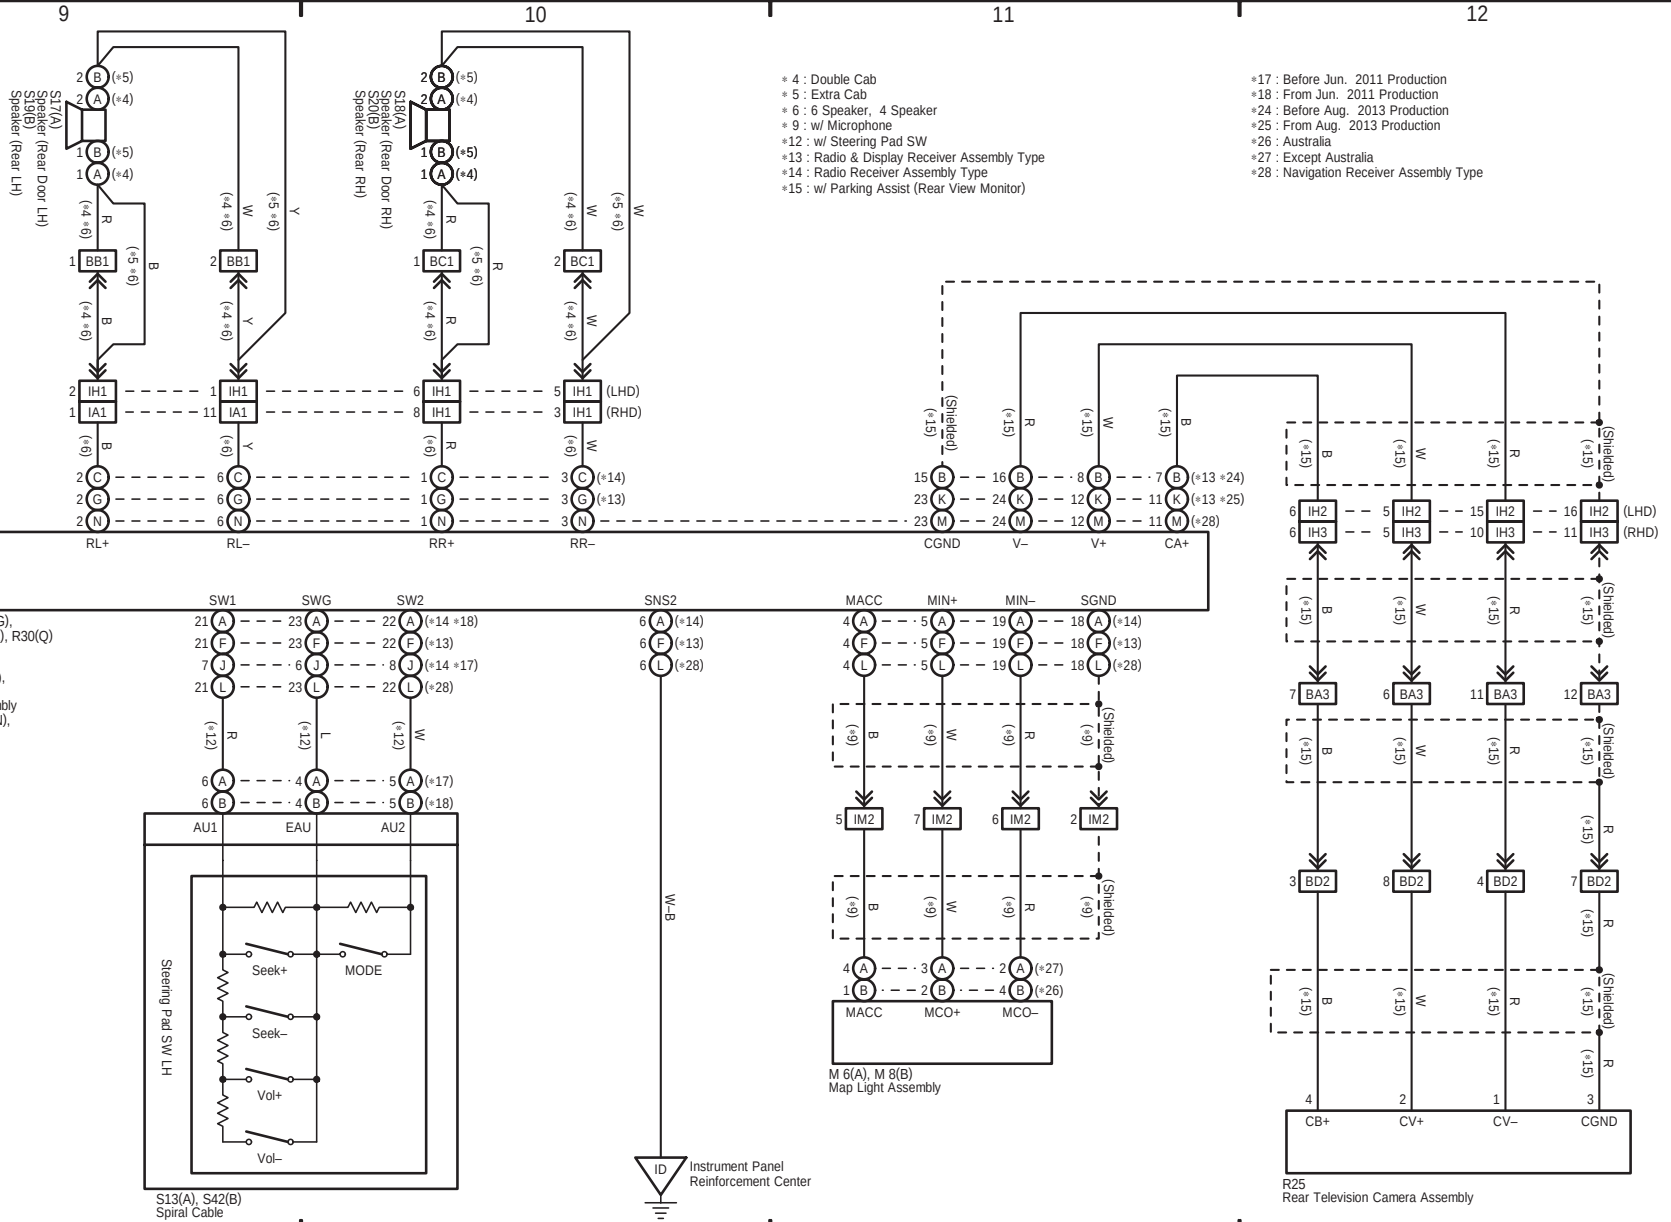
Audio System, Navigation System and  
Parking Assist (Rear View Monitor)
