## Interior Light

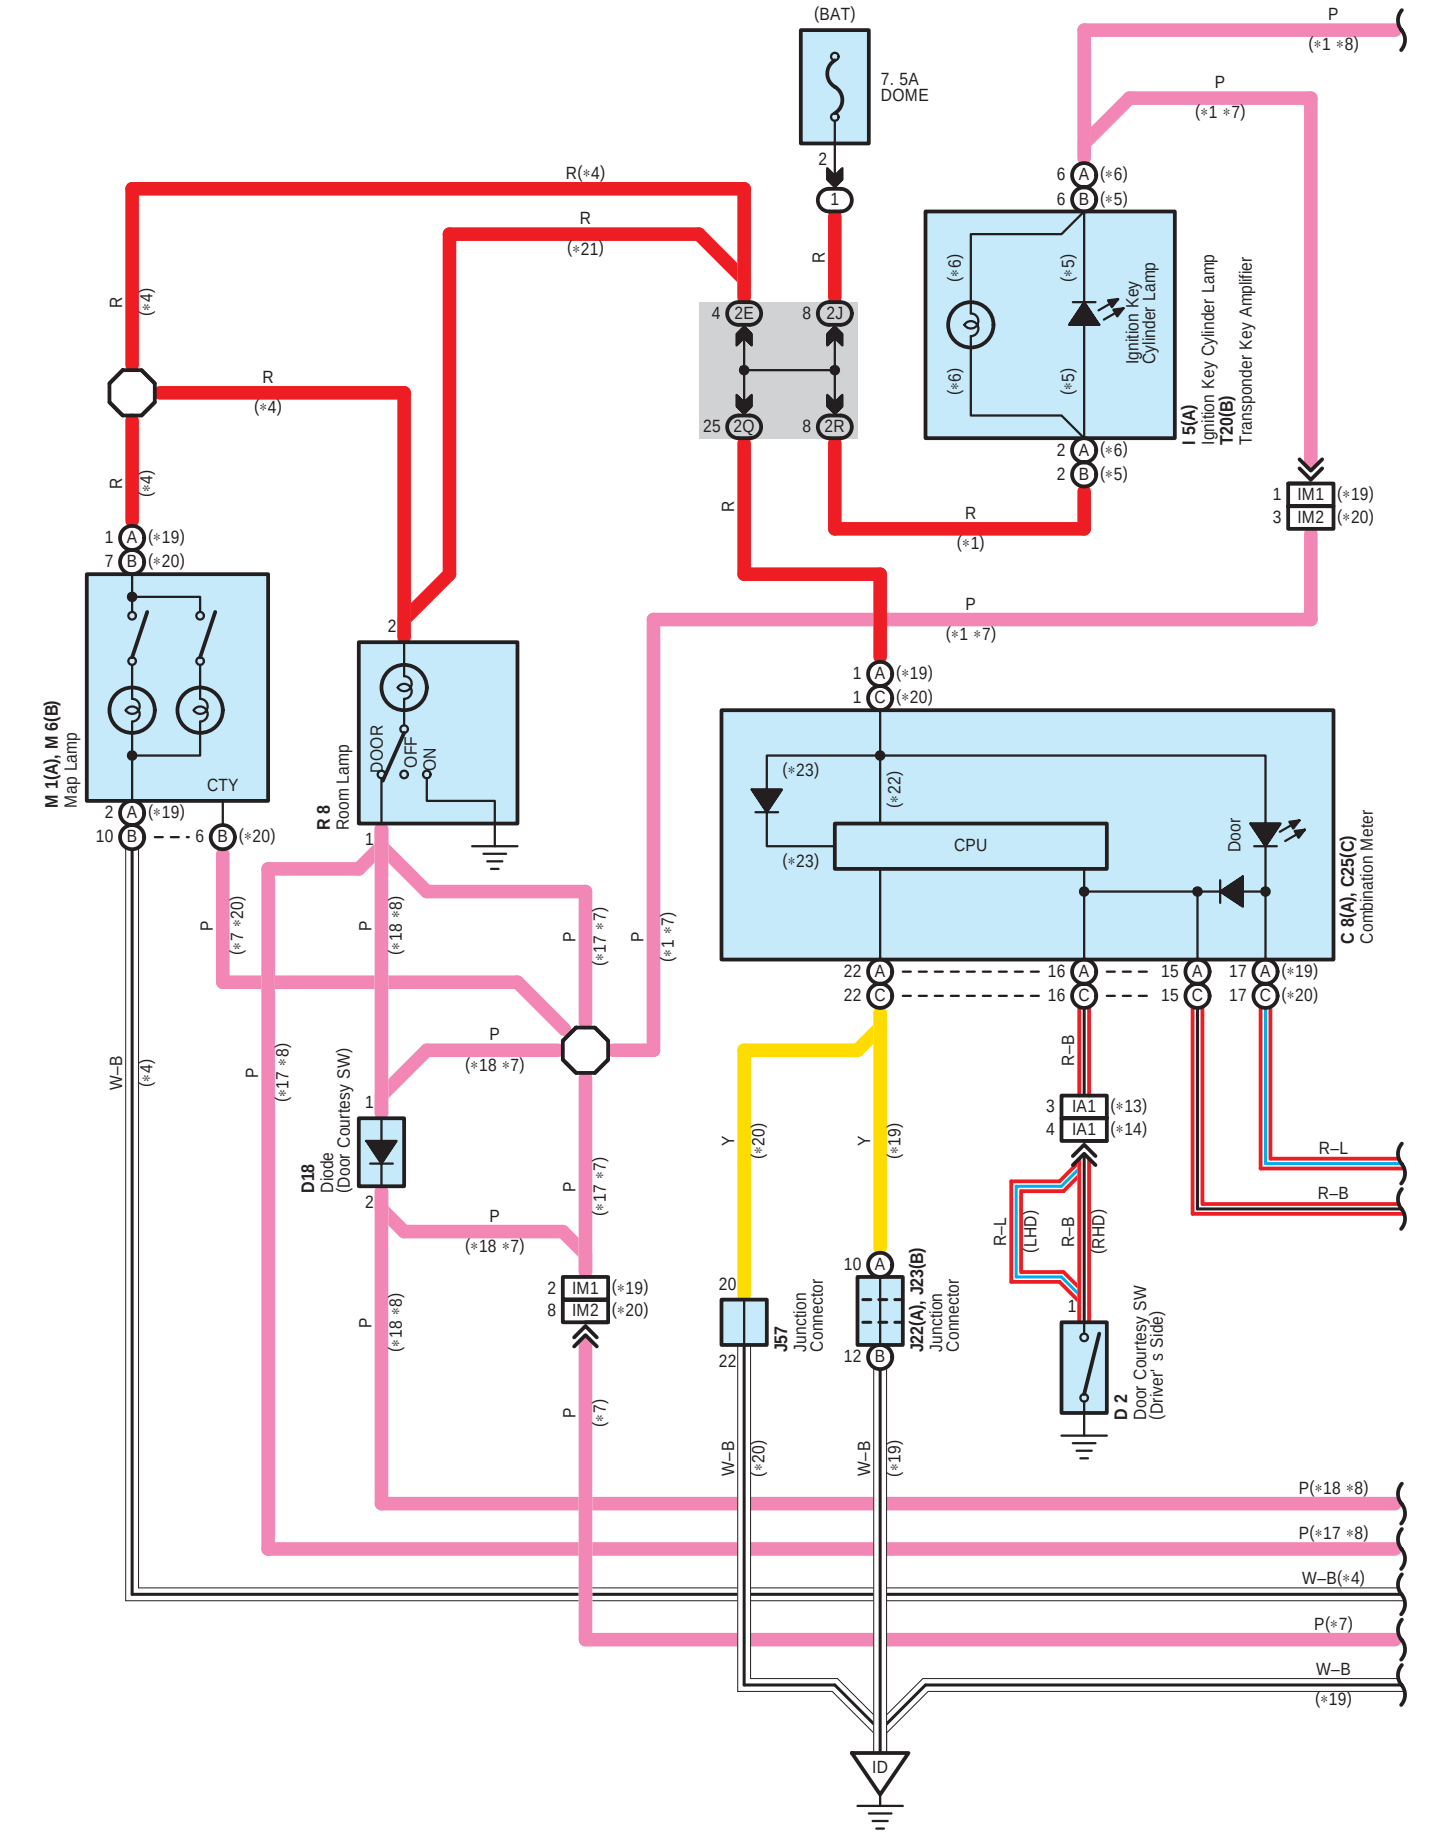
- \* 4 : w/ Map Lamp
- \*10 : w/ Theft Deterrent
- \*19 : Before Jun. 2011 Production
- \*24 : South Africa
- \*26 : RHD \*10 \*24 \*27
- \*27 : From Aug. 2012 Production
