## FRONT A/C EVAPORATOR ON-VEHICLE INSPECTION

AC1T8-01

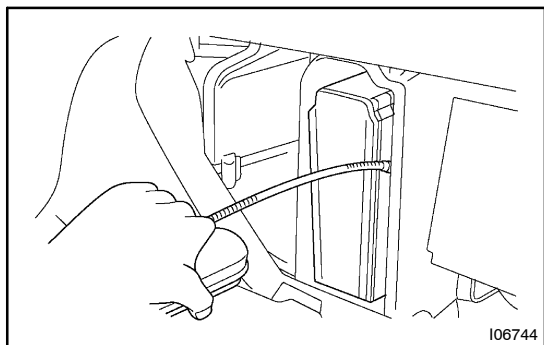
- (a) Remove these parts:
  - (1) Glove compartment door
  - (2) Lower No. 2 finish panel  
(See [page BO-127](#))
- (b) Remove the No.1 cooler cover.
  - (1) Disconnect the connector clamp.
  - (2) Remove the 8 screws and cover.

- (c) Using a gas leak detector, check for leakage of refrigerant.

If there is leakage of refrigerant, check the tightening torque at the joints or check the evaporator.
