| DTC | B2796/99 | No Communication in Immobiliser system |

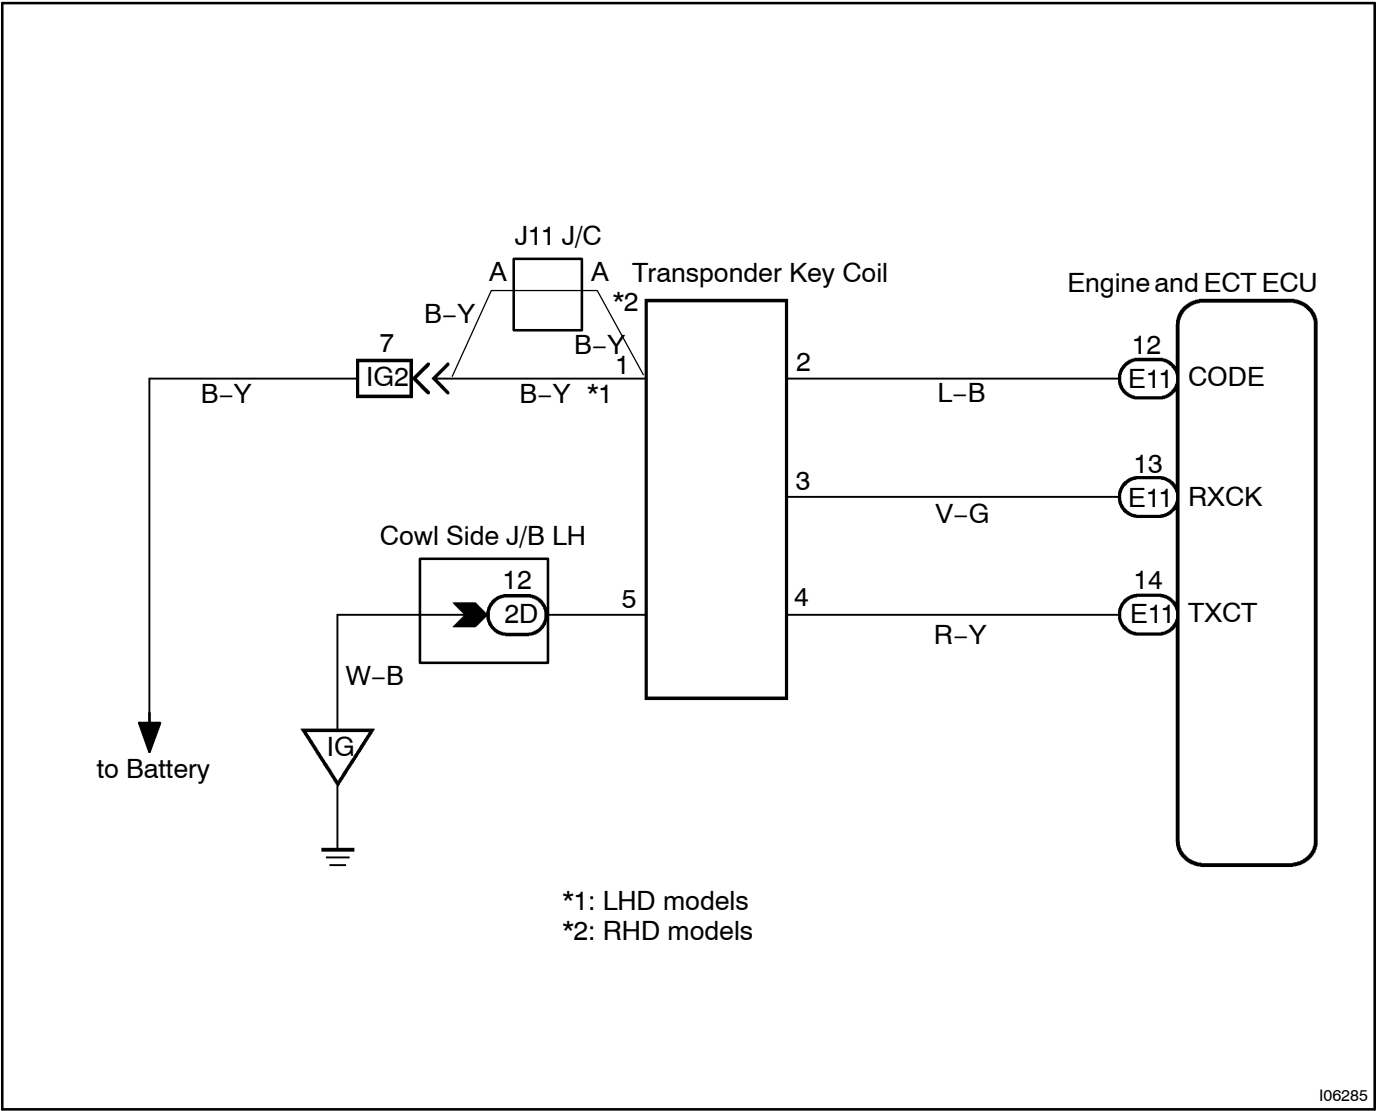
WIRING DIAGRAM

CIRCUIT DESCRIPTION

**2** Check harness and connector between transponder key amplifier and Engine and ECT ECU.
