| DTC | B2798/99 | Communication malfunction No.2 |

CIRCUIT DESCRIPTION

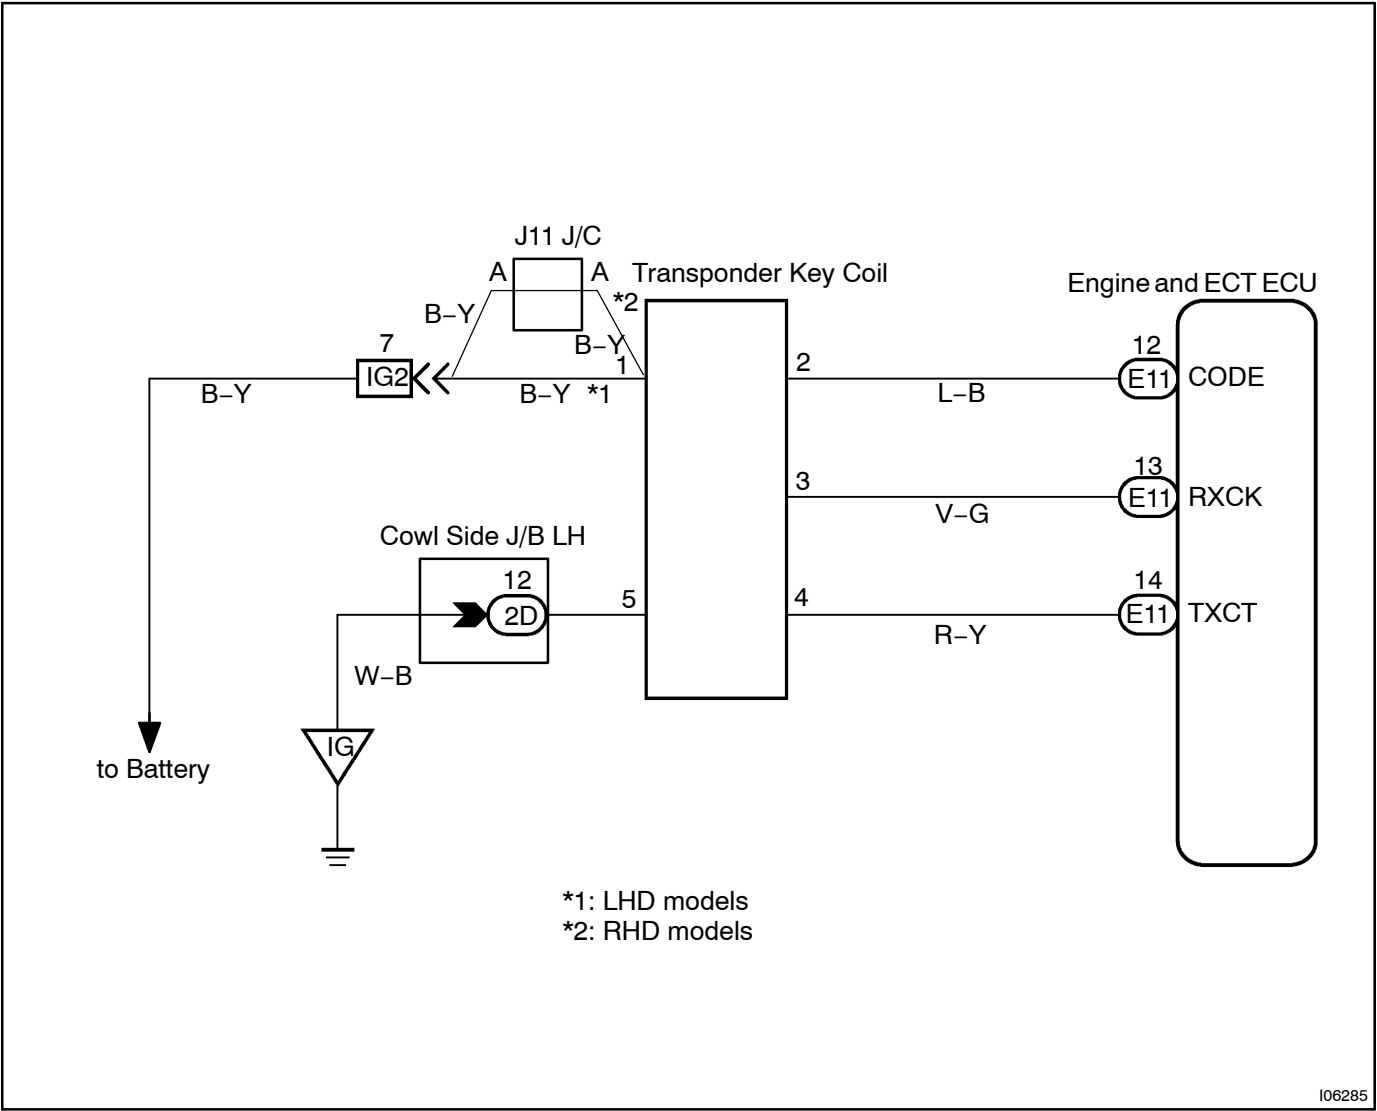
WIRING DIAGRAM

| DTC No. | DTC Detecting Condition | Trouble Area |
|---|---|---|
| B2798/99 | Communication error | <ul style="list-style-type: none"><li>• Key</li><li>• Transponder Key Coil</li><li>• Transponder Key Amplifier</li><li>• Wire harness</li><li>• Engine and ECT ECU</li></ul> |

**2** Check harness and connector between transponder key amplifier and Engine and ECT ECU.
