| <b>DTC</b> | <b>B1215 / 15</b> | <b>Door system communication bus malfunction (GND short)</b> |

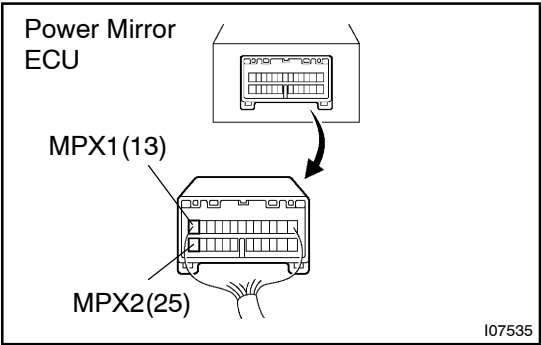
| <b>1</b> | <b>Check the communication circuit inside power mirror ECU.</b> |

#### PREPARATION:

Disconnect the connector power mirror ECU.

#### CHECK:

Check the DTC.

#### OK:

Code B1215/15 is not output

| <b>OK</b> | <b>Replace the power mirror ECU.</b> |

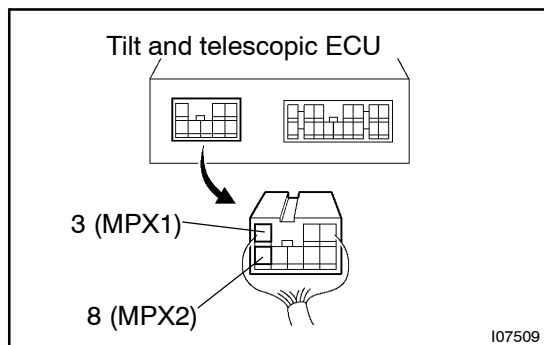
## 2 Check the communication circuit inside tilt and telescopic ECU.

### PREPARATION:

- (a) Connect the connector power mirror ECU.
- (b) Disconnect the connector tilt and telescopic ECU.

### CHECK:

Check the DTC.

### OK:

Code B1215/15 is not output

Replace the tilt and telescopic ECU.

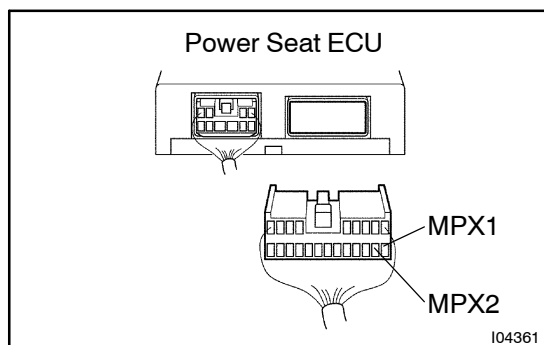
## 3 Check the communication circuit inside power seat ECU.

### PREPARATION:

- (a) Connect the connector tilt and telescopic ECU.
- (b) Disconnect the connector power seat ECU.

### CHECK:

Check the DTC.

### OK:

Code B1215/15 is not output

Replace the power seat ECU.

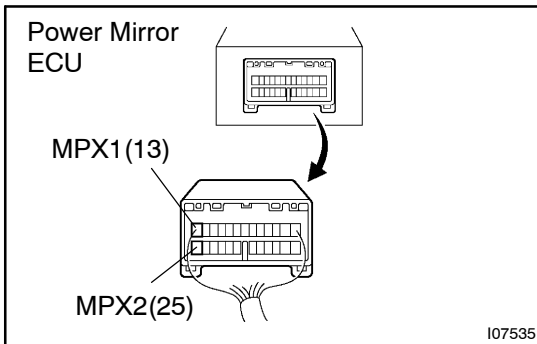
**4 Check for short circuit between body ECU and power mirror ECU.**

**PREPARATION:**

Disconnect the connector power mirror ECU.

**CHECK:**

Check the DTC.

**OK:**

Code B1215/15 is not output

**Repair or replace the wire harness between and body ECU and power mirror ECU.**

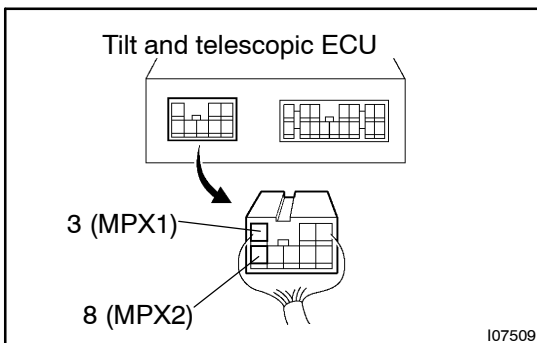
**NG****5 Check for short circuit between power mirror ECU and tilt & telescopic ECU.**

**PREPARATION:**

Disconnect the connector tilt & telescopic ECU.

**CHECK:**

Check the DTC.

**OK:**

Code B1215/15 is not output

**Repair or replace the wire harness between power mirror ECU and tilt & telescopic ECU.**

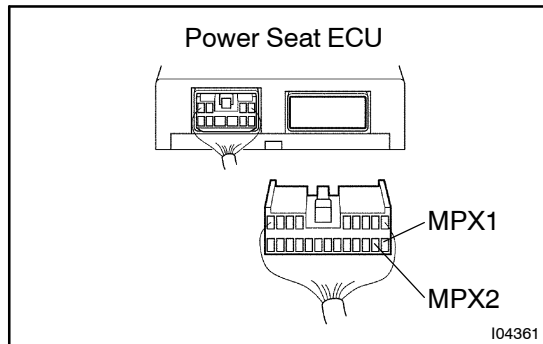
**6 Check for short circuit between tilt & telescopic ECU and power seat ECU.**

**PREPARATION:**

Disconnect the connector power seat ECU.

**CHECK:**

Check the DTC.

**OK:**

Code B1215/15 is not output

**Repair or replace the wire harness between and tilt & telescopic ECU and power seat ECU**
