## CIRCUIT DESCRIPTION

INSPECTION PROCEDURE

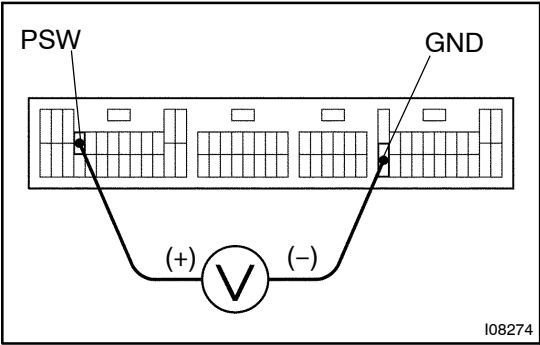
| 1 | Check voltage between terminal PSW and GND of A/C amplifier. |

PREPARATION:

Install the manifold gauge set.

- (a) Turn ignition switch ON.
- (b) Check voltage between terminal PRE of ECM connector and body ground when A/C gas pressure is changed.

The voltage changes with gas pressure, as shown in the diagram below.

| Low Pressure Cut Side | Reference : High Pressure Cut Side |
|---|---|
| ON (0V)<br>196 kPa<br>OFF (12V) | ON (0V)<br>2,550 kPa<br>3,140 kPa<br>OFF (12V) |

| NG | Go to step 2. |

Proceed to next circuit inspection shown on problem symptoms table (See page DI-630). However, if RrDEF and FRS indicator light is light up, check and replace A/C amplifier.

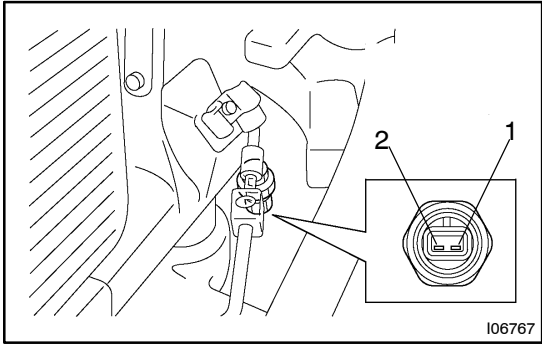
2 Check pressure switch.

Disconnect pressure switch connector.

- (a) Turn ignition switch ON.
- (b) Check continuity between terminals 1 and 2 of pressure switch when A/C gas pressure is changed.

The continuity changes with gas pressure as shown below.

| Low Pressure Cut Side | Reference : High Pressure Cut Side |
|---|---|
| ON (continuity)<br>196 kPa<br>OFF (continuity) | ON (continuity)<br>2,550 kPa<br>3,140 kPa<br>OFF (continuity) |

Replace pressure switch.
