| <b>DTC</b> | <b>B1215 / 15</b> | <b>Door system communication bus malfunction (GND short)</b> |

## CIRCUIT DESCRIPTION

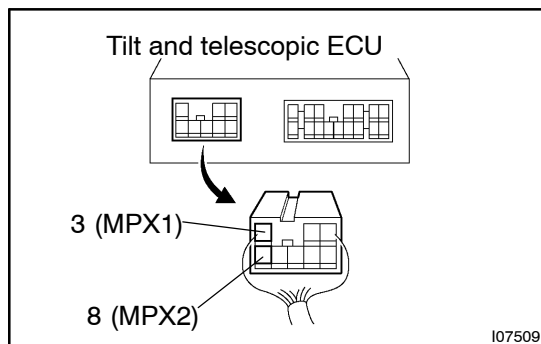
| <b>1</b> | <b>Check the communication circuit inside tilt and telescopic ECU.</b> |

### PREPARATION:

Disconnect the connector tilt and telescopic ECU.

### CHECK:

Check the DTC.

### OK:

Code B1215/15 is not output

**OK**

**Replace the tilt and telescopic ECU.**

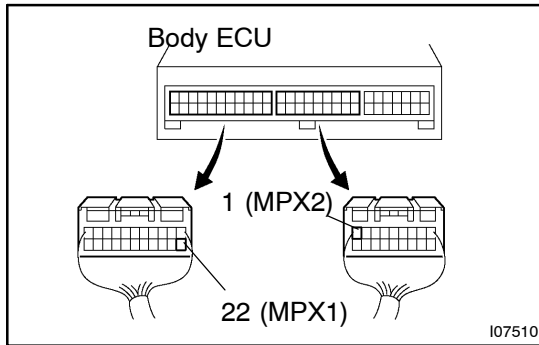
**2****Check for short circuit between tilt & telescopic ECU and body ECU.**

**PREPARATION:**

Disconnect the connector body ECU.

**CHECK:**

Check the DTC.

**OK:**

Code B1215/15 is not output

**OK****Repair or replace the wireharness between tilt & telescopic ECU and body ECU.****NG****Replace the body ECU.**
