| <b>DTC</b> | <b>B0135/73</b> | <b>Short in P/T Squib (LH) Circuit</b> |

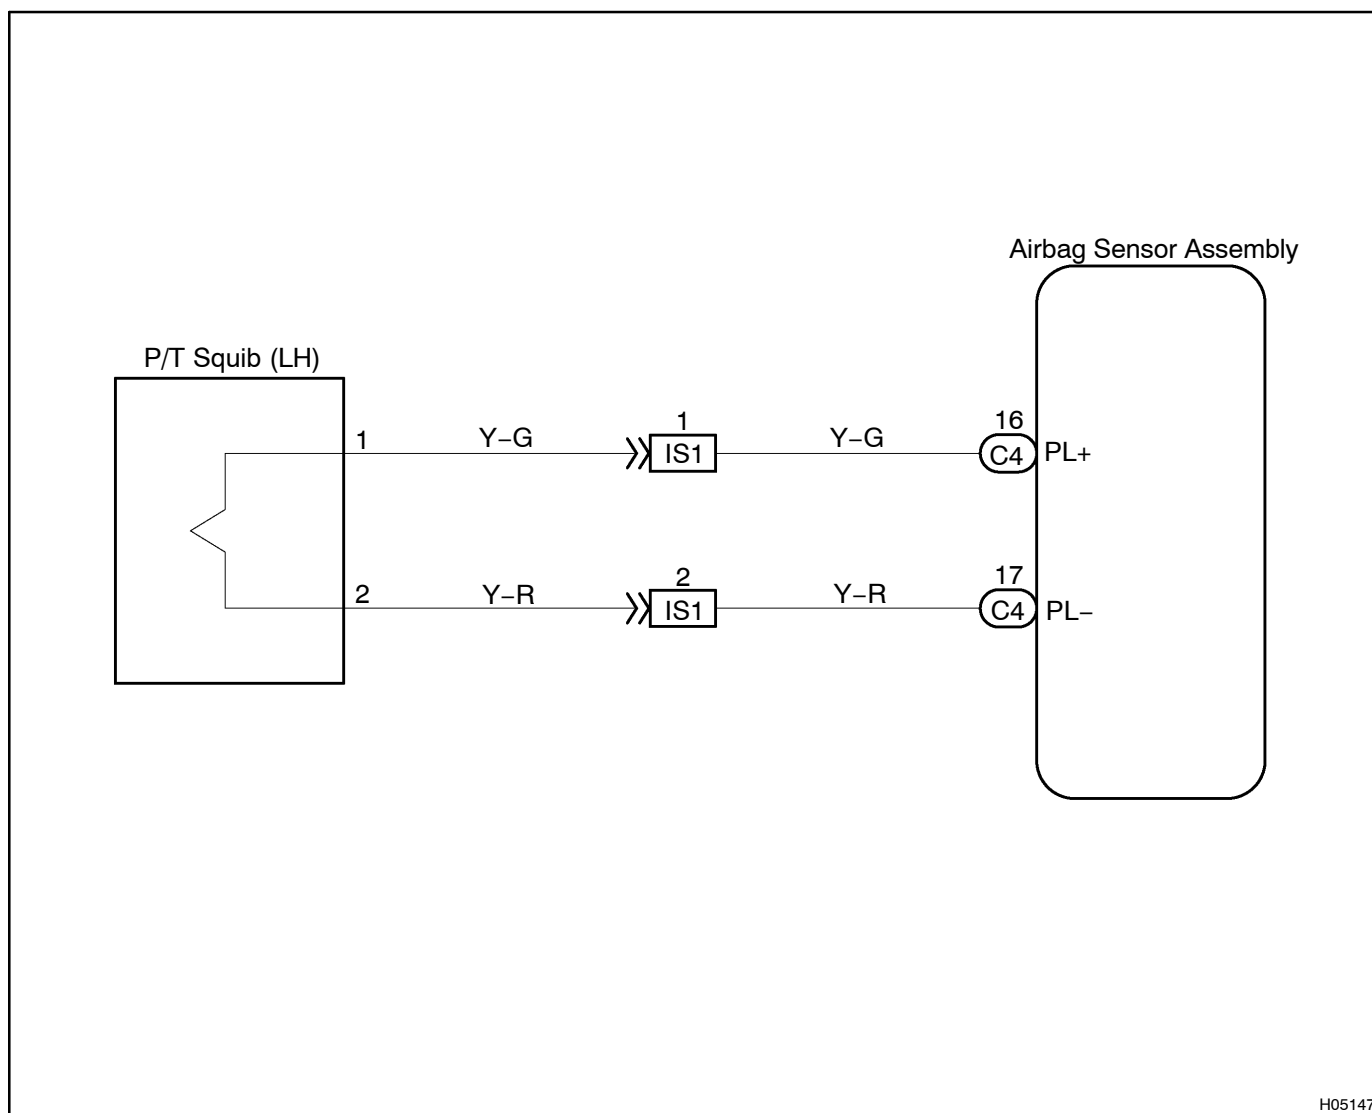
H05147

The P/T squib (LH) circuit consists of the airbag sensor assembly and seat belt pretensioner (LH). It causes the seat belt pretensioner (LH) to activate when the seat belt pretensioner (LH) activation conditions are satisfied.

## WIRING DIAGRAM

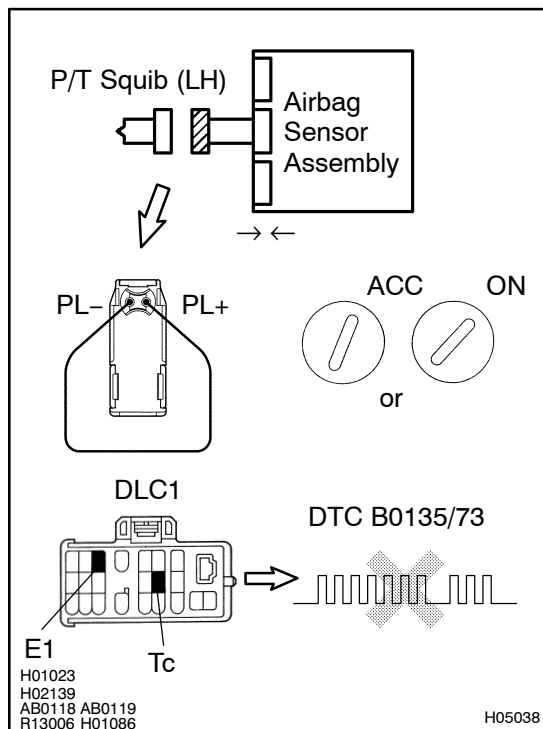
### 3 Check airbag sensor assembly.

#### PREPARATION:

- Connect the connector to the airbag sensor assembly.
- Using a service wire, connect PL+ and PL- of the connector (on the seat belt pretensioner side) between the airbag sensor assembly and the seat belt pretensioner (LH).
- Connect negative (-) terminal cable to the battery, and wait at least for 2 seconds.

- Turn ignition switch to ACC or ON and wait at least for 20 seconds.
- Clear DTC stored in memory.  
(See page [DI-342](#))
- Turn ignition switch to LOCK, and wait at least for 20 seconds.
- Turn ignition switch to ACC or ON, and wait at least for 20 seconds.
- Check DTC.  
(See page [DI-342](#))

**DTC B0135/73 is not output.**

**Replace airbag sensor assembly.**

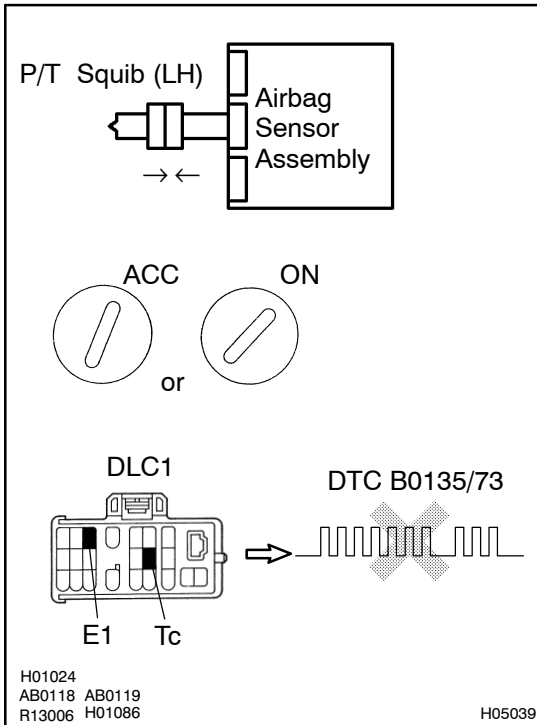
**4 Check P/T squib (LH).**

**PREPARATION:**

- Turn ignition switch to LOCK.
- Disconnect negative (-) terminal cable from the battery, and wait at least for 90 seconds.
- Connect the side airbag assembly (LH) connector.
- Connect negative (-) terminal cable to the battery, and wait at least for 2 seconds.

- Turn ignition switch to LOCK, and wait at least for 20 seconds.
- Turn ignition switch to ACC or ON, and wait at least for 20 seconds.
- Clear DTC stored in memory.  
(See page [DI-342](#))
- Turn ignition switch to LOCK, and wait at least for 20 seconds.
- Turn ignition switch to ACC or ON, and wait at least for 20 seconds.
- Check DTC.  
(See page [DI-342](#))

**OK:****DTC B0135/73 is not output.****HINT:**

**NG****Replace seat belt pretensioner (LH).****OK**
