| <b>DTC</b> | <b>B0136/74</b> | <b>Open in P/T Squib (LH) Circuit</b> |

## CIRCUIT DESCRIPTION

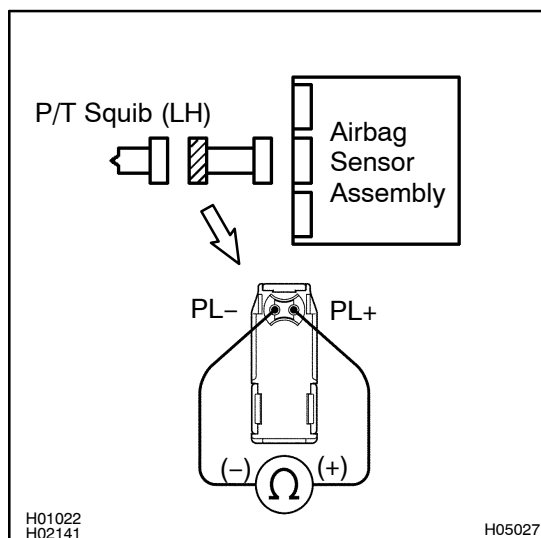
| <b>2</b> | <b>Check P/T squib (LH) circuit.</b> |

### CHECK:

For the connector (on the seat belt pretensioner (LH) and the airbag sensor assembly, measure the resistance between PL+ and PL-.

### OK:

**Resistance: Below 1 Ω**

**Replace harness and connector between seat belt pretensioner (LH) and airbag sensor assembly.**

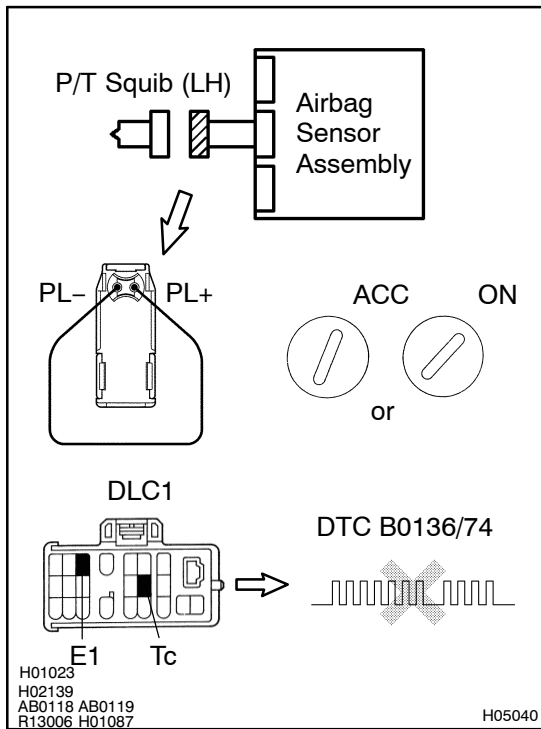
### 3 Check airbag sensor assembly.

#### PREPARATION:

- Connect the connector to the airbag sensor assembly.
- Using a service wire, connect PL+ and PL- of the connector (on the seat belt pretensioner side) between the seat belt pretensioner (LH) and the airbag sensor assembly.
- Connect negative (-) terminal cable to the battery, and wait at least for 2 seconds.

#### CHECK:

- Turn ignition switch to ACC or ON and wait at least for 20 seconds.
- Clear DTC stored in memory.  
(See page [DI-342](#))
- Turn ignition switch to LOCK, and wait at least for 20 seconds.
- Turn ignition switch to ACC or ON, and wait at least for 20 seconds.
- Check DTC.  
(See page [DI-342](#))

#### OK:

**DTC B0136/74 is not output.**

**Replace airbag sensor assembly.**

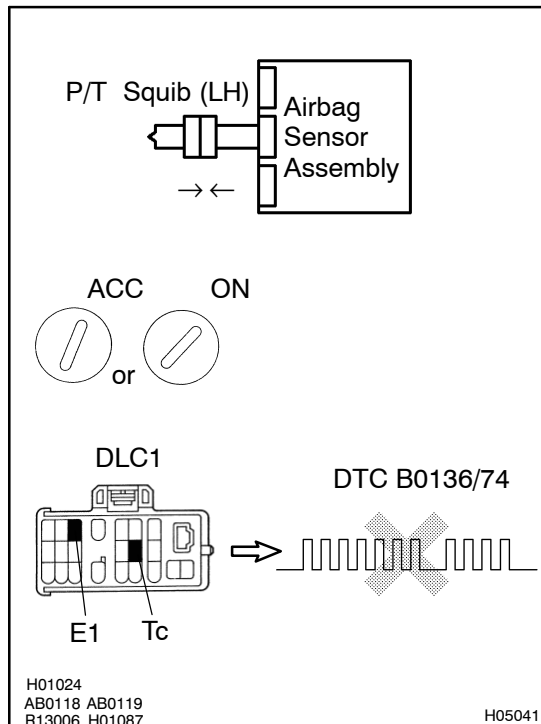
**4 Check P/T squib (LH).**

**PREPARATION:**

- Turn ignition switch to LOCK.
- Disconnect negative (-) terminal cable from the battery, and wait at least for 90 seconds.
- Connect the seat belt pretensioner (LH) connector.
- Connect negative (-) terminal cable to the battery, and wait at least for 2 seconds.

**CHECK:**

- Turn ignition switch to ACC or ON, and wait at least for 20 seconds.
- Clear DTC stored in memory.  
(See page [DI-342](#))
- Turn ignition switch to LOCK, and wait at least for 20 seconds.
- Turn ignition switch to ACC or ON, and wait at least for 20 seconds.
- Check DTC.  
(See page [DI-342](#))

**OK:**

**DTC B0136/74 is not output.**

**Replace seat belt pretensioner (LH).**
