| <b>DTC</b> | <b>B2797/99</b> | <b>Communication Malfunction No.1</b> |

## CIRCUIT DESCRIPTION

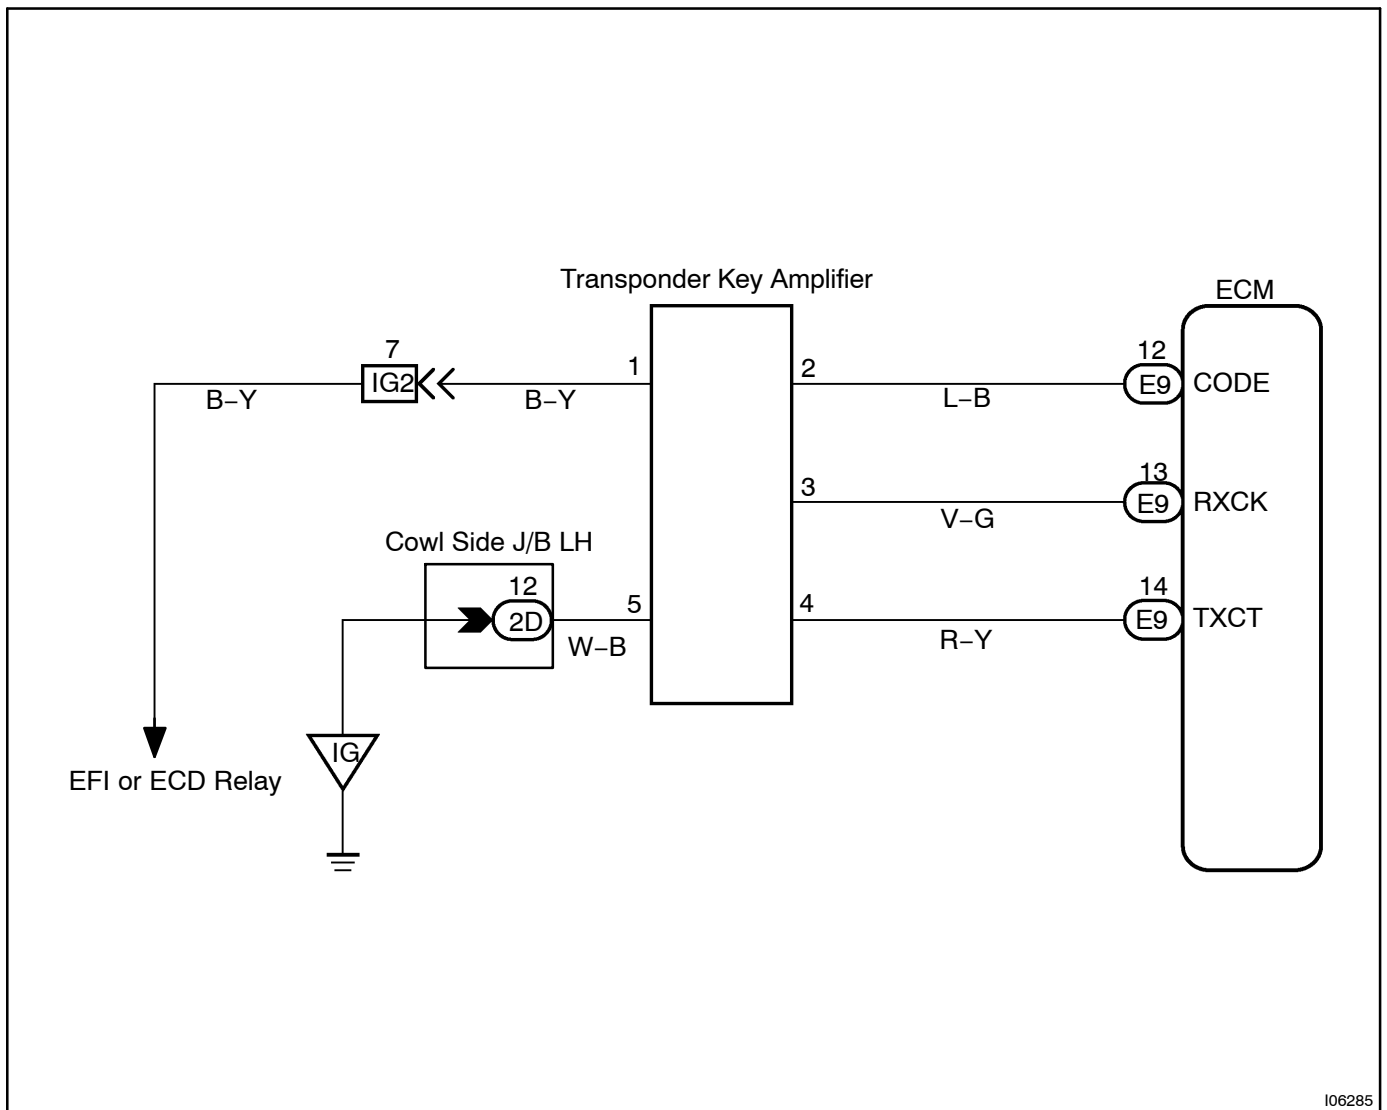
I06285

This code is detected when although the communication has been performed normally, an error occurs.  
(Example. Some noise is included in communication line.)

## WIRING DIAGRAM

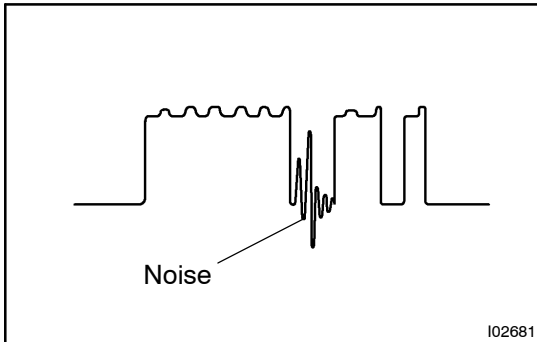
**INSPECTION PROCEDURE****1 Noise check**

Using an oscilloscope or TOYOTA hand-held tester, check that noise is included in the signals sent to the CODE terminal of ECM.

**No noise is detected.**

**Try to find the cause of the noise and remove it.**
