| <b>DTC</b> | <b>B0130/63</b> | <b>Short in P/T Squib (RH) Circuit</b> |

## CIRCUIT DESCRIPTION

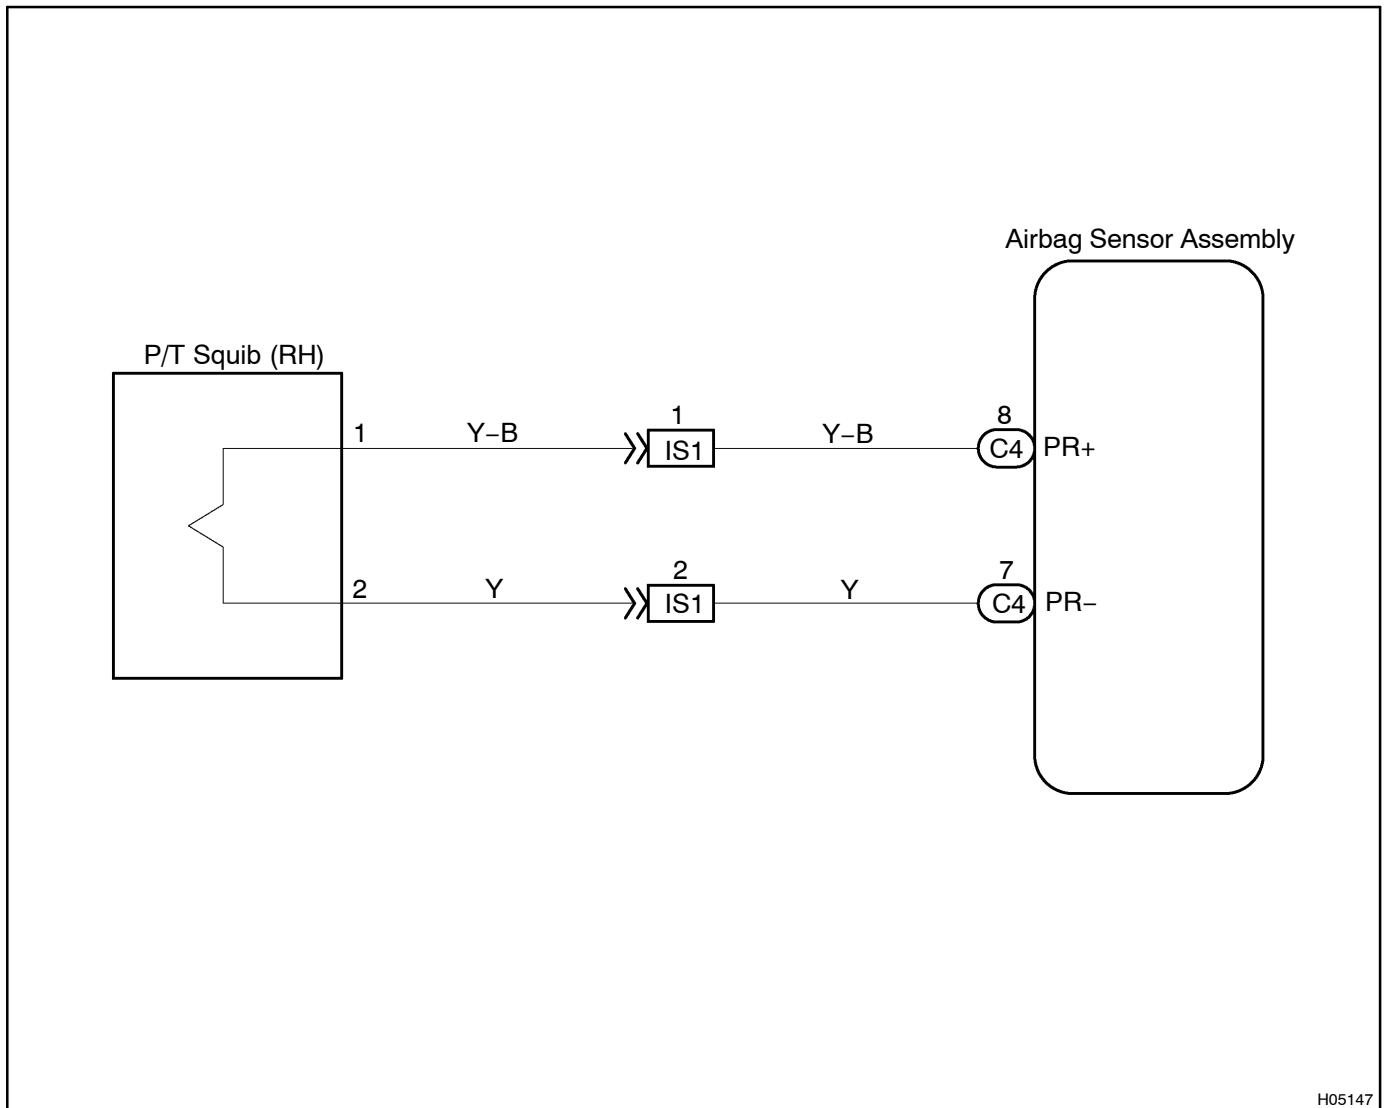
## WIRING DIAGRAM

The P/T squib (RH) circuit consists of the airbag sensor assembly and seat belt pretensioner (RH). It causes the seat belt pretensioner (RH) to activate when the seat belt pretensioner (RH) activation conditions are satisfied.

DTC B0130/63 is recorded when a short is detected in the P/T squib (RH) circuit.

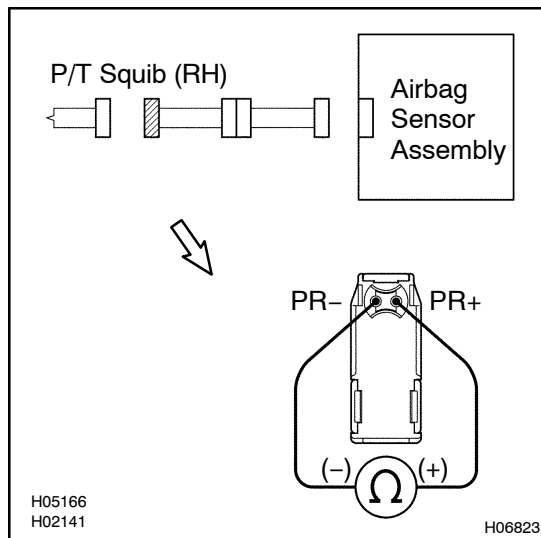
**2** Check P/T squib (RH) circuit.

Release airbag activation prevention mechanism of the connector (on the airbag sensor assembly side) between the airbag sensor assembly and the seat belt pretensioner (RH).  
(See page [DI-344](#))

For the connector (on the seat belt pretensioner side) between the seat belt pretensioner (RH) and the airbag sensor assembly, measure the resistance between PR+ and PR-.

**Resistance: 1 MΩ or Higher**

**Go to step 5.**

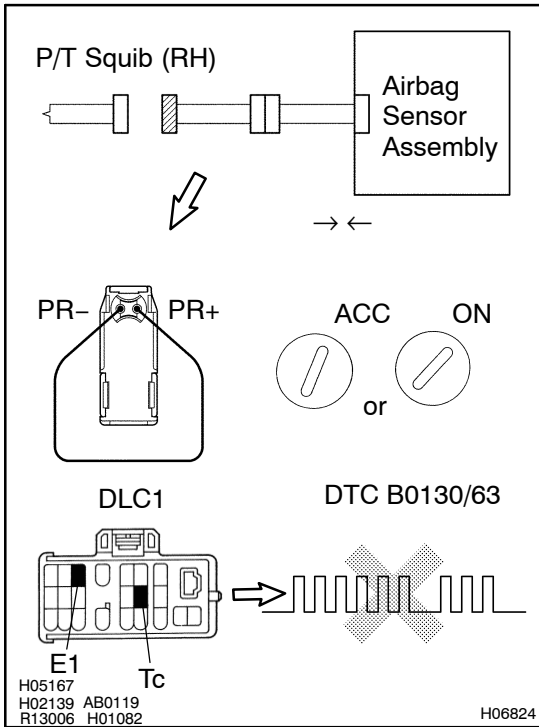
### 3 Check airbag sensor assembly.

- Connect the connector to the airbag sensor assembly.
- Using a service wire, connect PR+ and PR- of the connector (on the seat belt pretensioner side) between the airbag sensor assembly and the seat belt pretensioner (RH).
- Connect negative (-) terminal cable to the battery, and wait at least for 2 seconds.

- Turn ignition switch to ACC or ON and wait at least for 20 seconds.
- Clear DTC stored in memory.  
(See page [DI-344](#))
- Turn ignition switch to LOCK, and wait at least for 20 seconds.
- Turn ignition switch to ACC or ON, and wait at least for 20 seconds.
- Check DTC.  
(See page [DI-344](#))

**DTC B0130/63 is not output.**

**Replace airbag sensor assembly.**

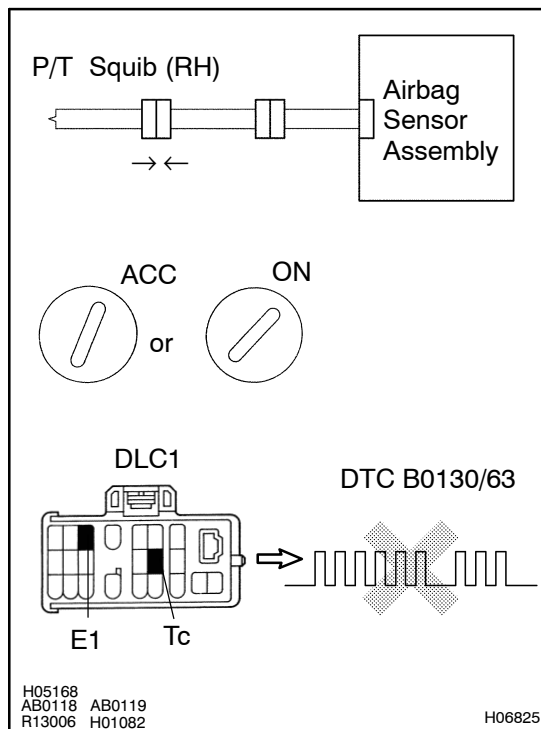
**4 Check P/T squib (RH).**

- Turn ignition switch to LOCK.
- Disconnect negative (-) terminal cable from the battery, and wait at least for 90 seconds.
- Connect the seat belt pretensioner (RH) connector.
- Connect negative (-) terminal cable to the battery, and wait at least for 2 seconds.

- Turn ignition switch to LOCK, and wait at least for 20 seconds.
- Turn ignition switch to ACC or ON, and wait at least for 20 seconds.
- Clear DTC stored in memory.  
(See page [DI-344](#))
- Turn ignition switch to LOCK, and wait at least for 20 seconds.
- Turn ignition switch to ACC or ON, and wait at least for 20 seconds.
- Check DTC.  
(See page [DI-344](#))

**OK:****DTC B0130/63 is not output.****HINT:**

**NG****Replace seat belt pretensioner (RH).****OK**

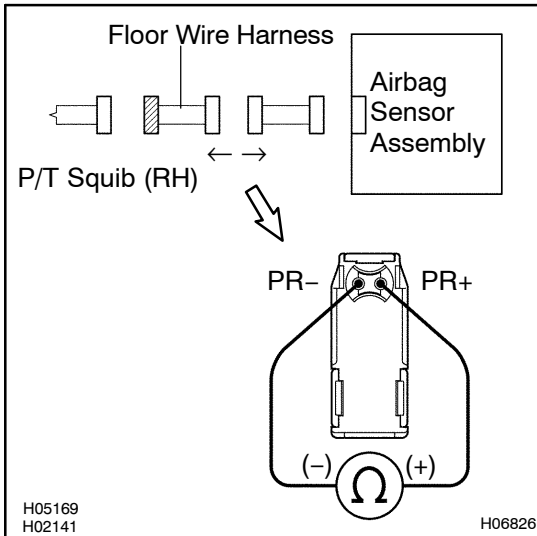
## 5 Check floor wire harness.

- Disconnect floor wire harness connector on the airbag sensor assembly side.
- Release airbag activation prevention mechanism of the floor wire harness connector on the airbag sensor assembly side. (See page [DI-344](#))

For the connector (on the floor wire harness side) between the seat belt pretensioner and the floor wire harness, measure the resistance between PR+ and PR-.

**Resistance: 1 MΩ or Higher**

**Replace floor wire harness.**

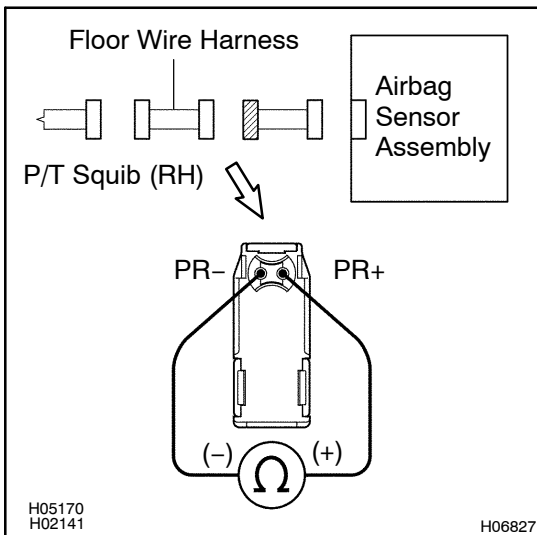
## 6 Check harness between airbag sensor assembly and floor wire harness.

Release airbag activation prevention mechanism of the airbag sensor assembly connector. (See page [DI-344](#))

For the connector (on the floor wire harness side) between the airbag sensor assembly and floor wire harness, measure the resistance between PR+ and PR-.

**Resistance: 1 MΩ or Higher**

**Replace harness and connector between airbag sensor assembly and floor wire harness.**
