## CIRCUIT INSPECTION

| <b>DTC</b> | <b>RrDEF, FACE</b> | <b>Front Room Temperature Sensor Circuit</b> |

## CIRCUIT DESCRIPTION

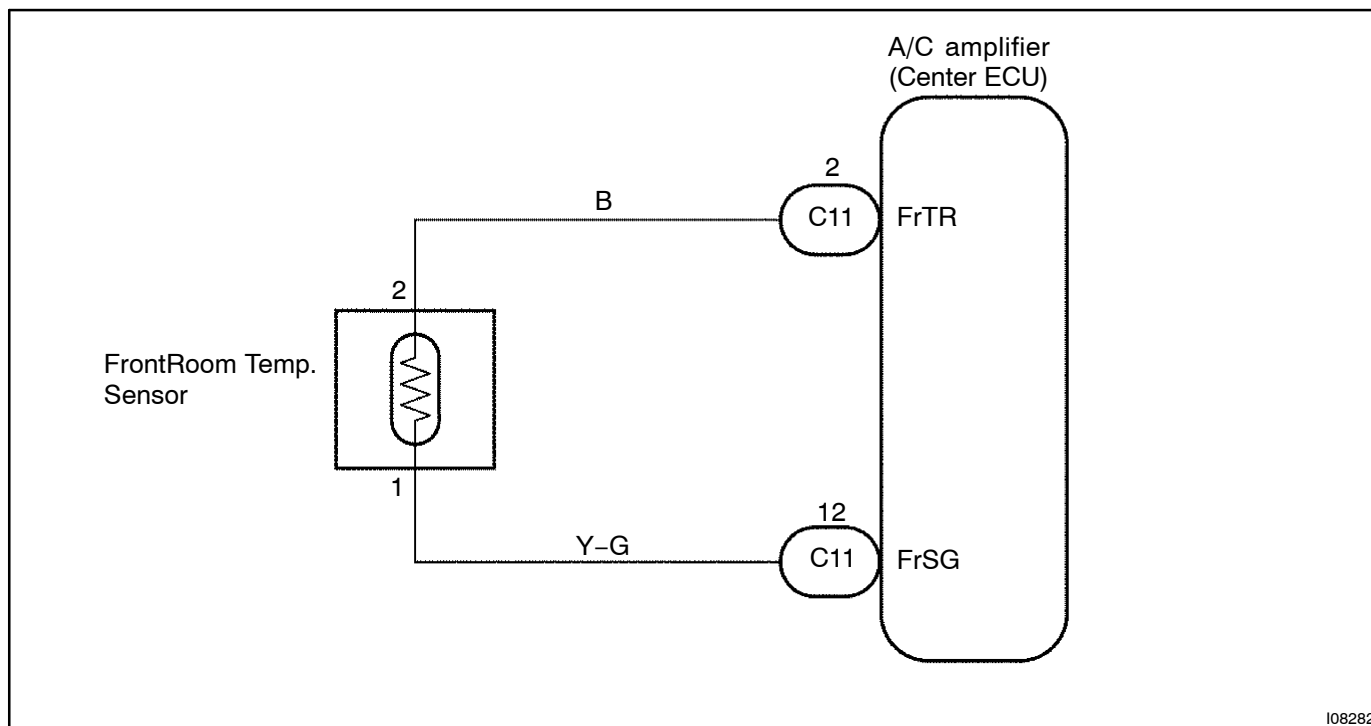
I08282

This sensor detects the temperature inside the cabin and sends the appropriate signals to the A/C amplifier.

## WIRING DIAGRAM

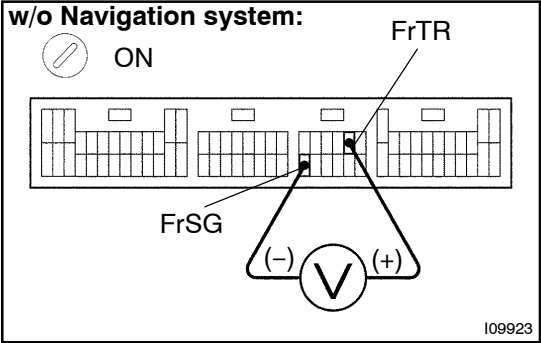
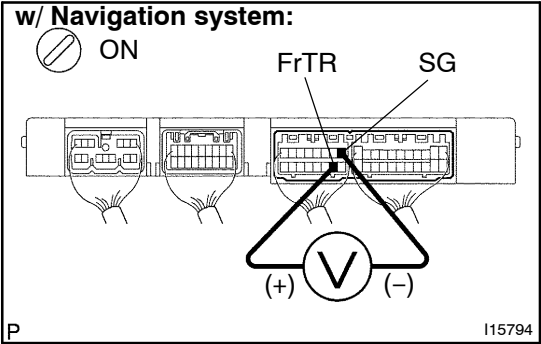
| 1 | Check voltage between terminals FrTR and FrSG (or SG) of A/C amplifier connector. |

Remove A/C amplifier with connectors still connected.

- (a) Turn ignition switch to ON.
- (b) Measure voltage between terminals FrTR and FrSG (or SG) of A/C amplifier connector at each temperature.

**at 25°C (77°F) : 1.8 – 2.2 V**

**at 40°C (104°F) : 1.2 – 1.6 V**

As the temperature increases, the voltage decreases.

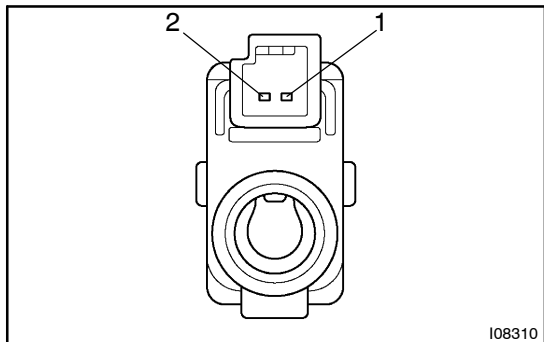
**2 Check front room temperature sensor.**

Disconnect room temperature sensor connector.

Measure resistance between terminals 1 and 2 of room temperature sensor connector at each temperature.

at 25°C (77°F) : 1.65 – 1.75 kΩ

at 50°C (122°F) : 0.55 – 0.65 kΩ

As the temperature increases, the resistance decreases.
