| <b>DTC</b> | <b>B0135/73</b> | <b>Short in P/T Squib (LH) Circuit</b> |

## CIRCUIT DESCRIPTION

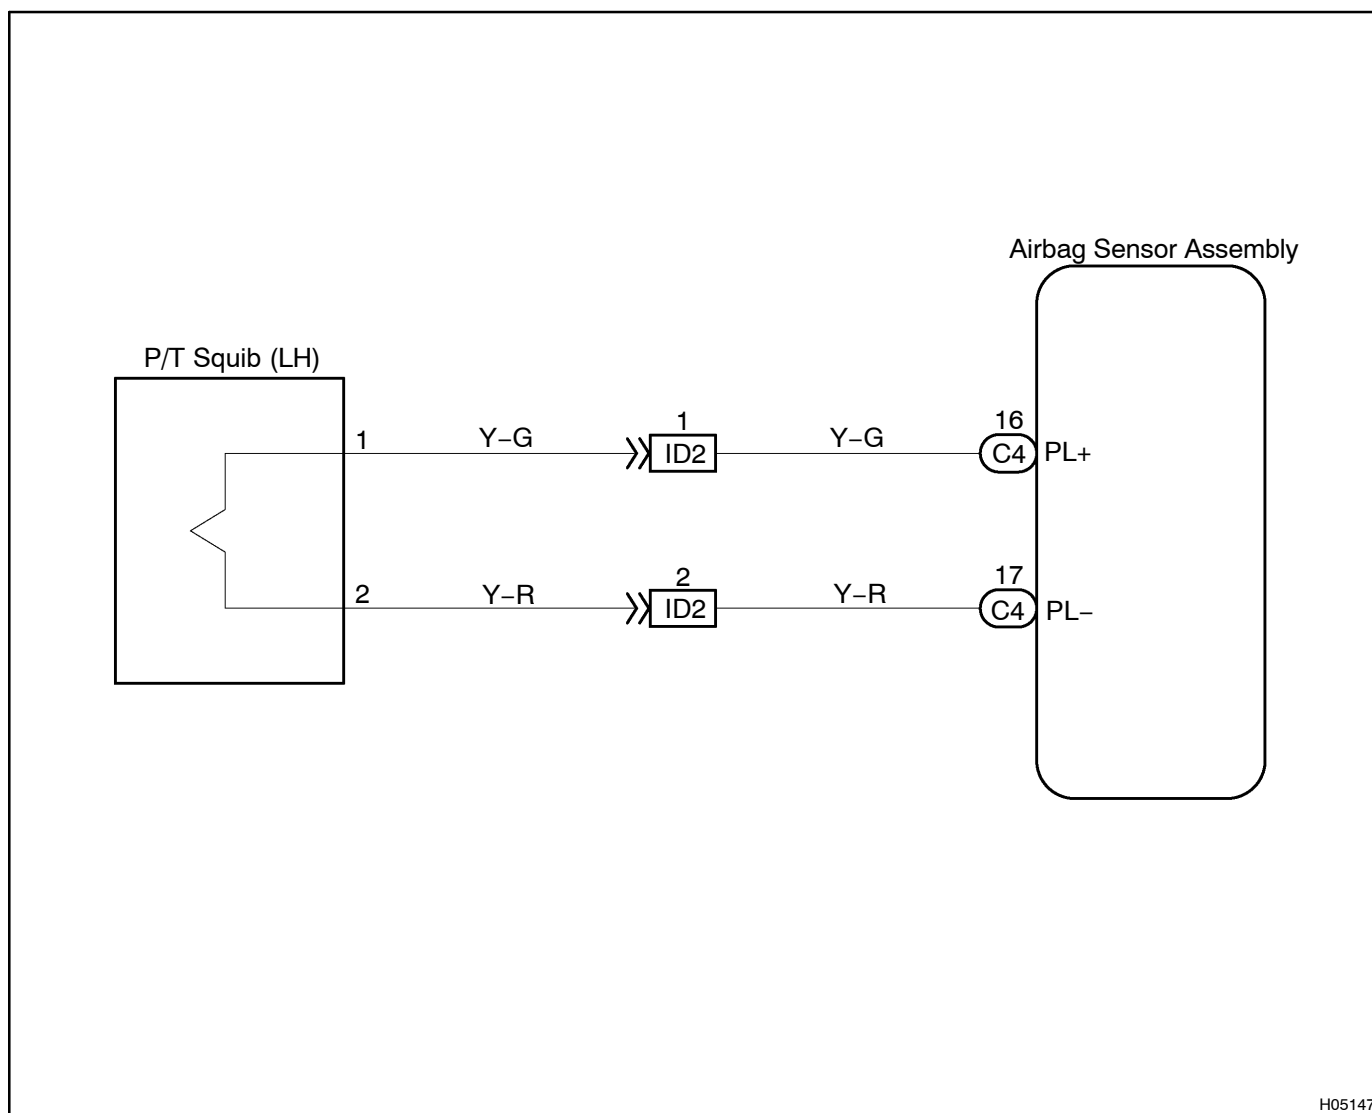
H05147

The P/T squib (LH) circuit consists of the airbag sensor assembly and seat belt pretensioner (LH). It causes the seat belt pretensioner (LH) to activate when the seat belt pretensioner (LH) activation conditions are satisfied.

DTC B0135/73 is recorded when a short is detected in the P/T squib (LH) circuit.

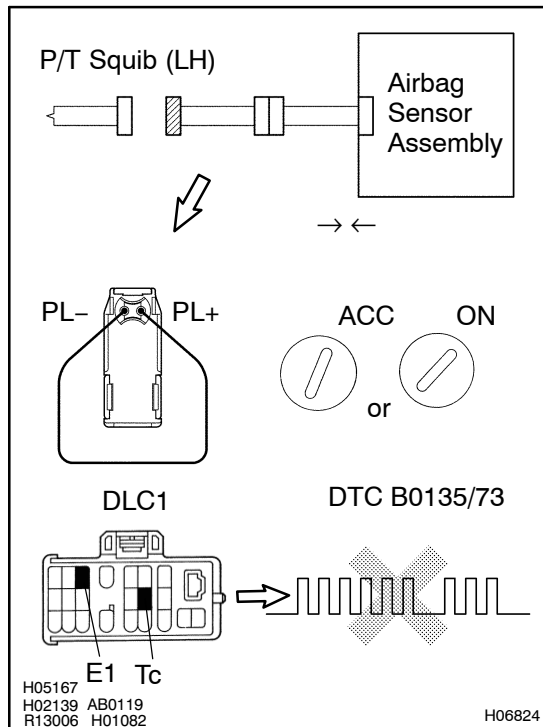
### 3 Check airbag sensor assembly.

- Connect the connector to the airbag sensor assembly.
- Using a service wire, connect PL+ and PL- of the connector (on the seat belt pretensioner side) between the airbag sensor assembly and the seat belt pretensioner (LH).
- Connect negative (-) terminal cable to the battery, and wait at least for 2 seconds.

- Turn ignition switch to ACC or ON and wait at least for 20 seconds.
- Clear DTC stored in memory.  
(See page [DI-486](#))
- Turn ignition switch to LOCK, and wait at least for 20 seconds.
- Turn ignition switch to ACC or ON, and wait at least for 20 seconds.
- Check DTC.  
(See page [DI-486](#))

**DTC B0135/73 is not output.**

**Replace airbag sensor assembly.**
