| <b>DTC</b> | <b>B0135/73</b> | <b>Short in P/T Squib (LH) Circuit</b> |

## CIRCUIT DESCRIPTION

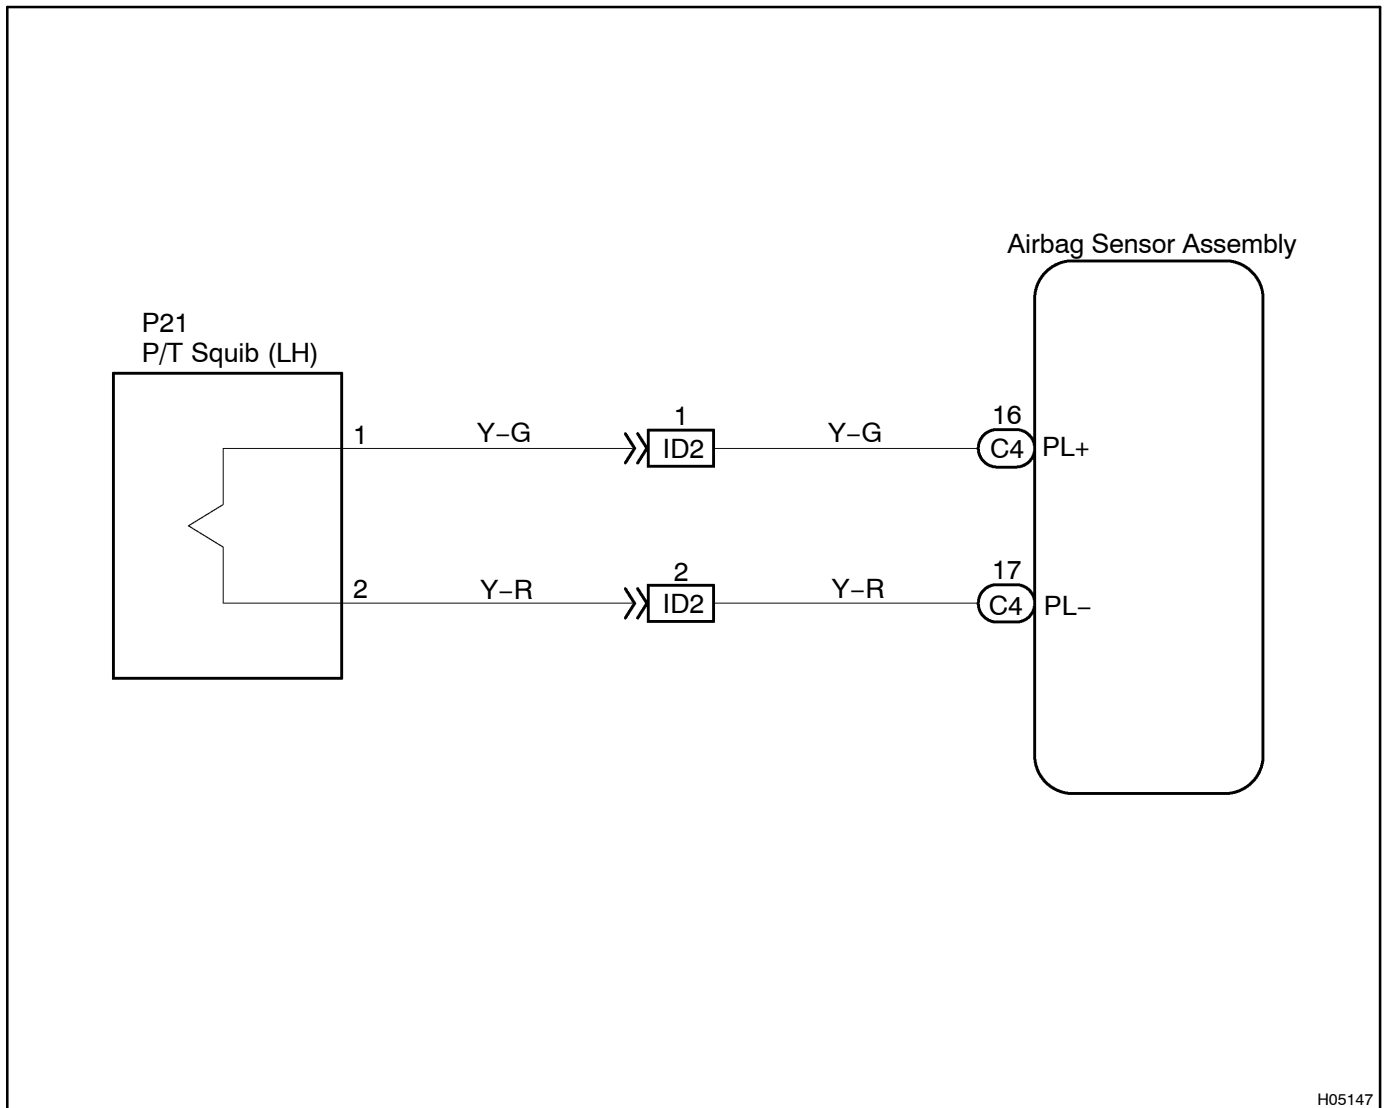
H05147

The P/T squib (LH) circuit consists of the airbag sensor assembly and seat belt pretensioner (LH). It causes the seat belt pretensioner (LH) to activate when the seat belt pretensioner (LH) activation conditions are satisfied.

## WIRING DIAGRAM

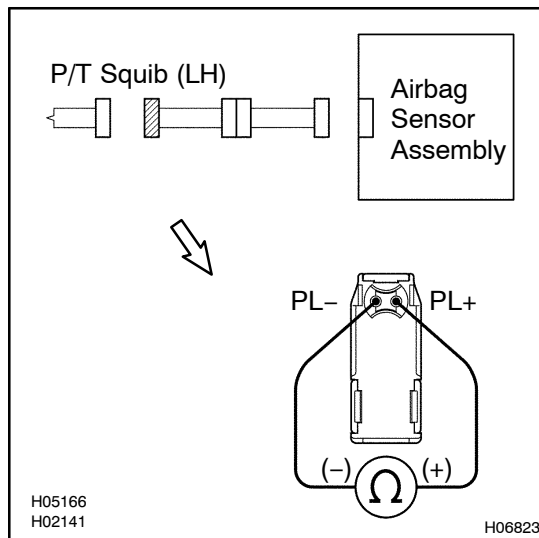
2 Check P/T squib (LH) circuit.

Release airbag activation prevention mechanism of the connector (on the airbag sensor assembly side) between the airbag sensor assembly and the seat belt pretensioner (LH).

For the connector (on the seat belt pretensioner side) between the seat belt pretensioner (LH) and the airbag sensor assembly, measure the resistance between PL+ and PL-.

**Resistance: 1 MΩ or Higher**

Go to step 5.

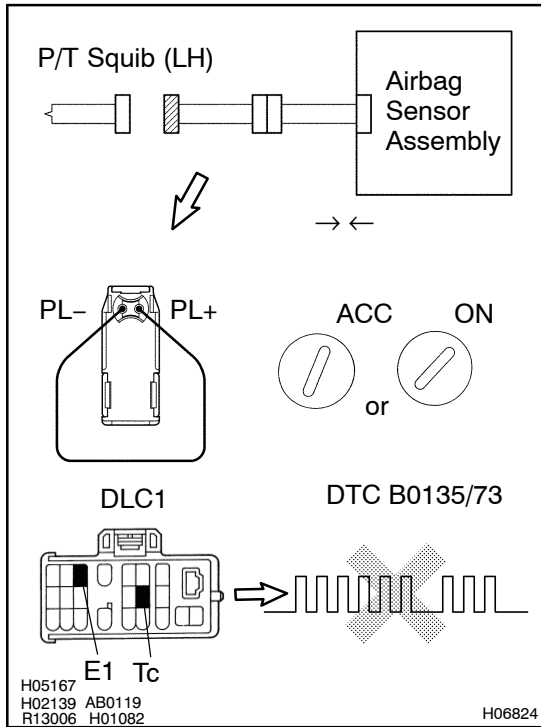
### 3 Check airbag sensor assembly.

- Connect the connector to the airbag sensor assembly.
- Using a service wire, connect PL+ and PL- of the connector (on the seat belt pretensioner side) between the airbag sensor assembly and the seat belt pretensioner (LH).
- Connect negative (-) terminal cable to the battery, and wait at least for 2 seconds.

- Turn ignition switch to ACC or ON and wait at least for 20 seconds.
- Clear DTC stored in memory.  
(See page [DI-503](#))
- Turn ignition switch to LOCK, and wait at least for 20 seconds.
- Turn ignition switch to ACC or ON, and wait at least for 20 seconds.
- Check DTC.  
(See page [DI-503](#))

**DTC B0135/73 is not output.**

**Replace airbag sensor assembly.**

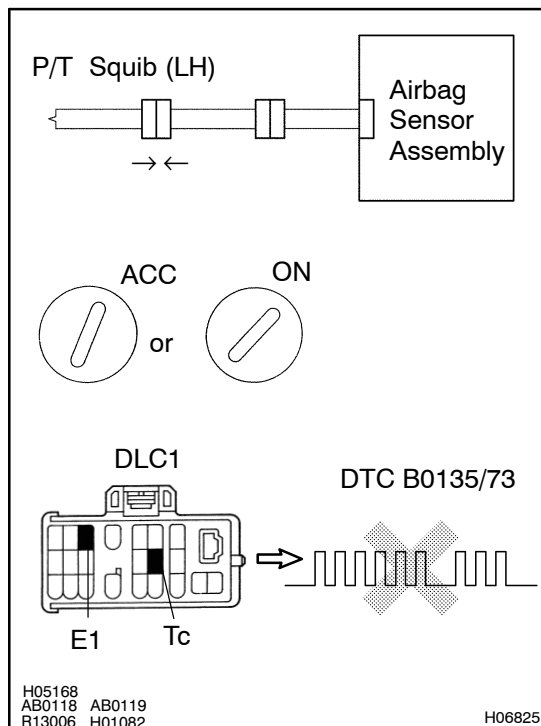
# 4 Check P/T squib (LH).

- Turn ignition switch to LOCK.
- Disconnect negative (-) terminal cable from the battery, and wait at least for 90 seconds.
- Connect the seat belt pretensioner (LH) connector.
- Connect negative (-) terminal cable to the battery, and wait at least for 2 seconds.

- Turn ignition switch to LOCK, and wait at least for 20 seconds.
- Turn ignition switch to ACC or ON, and wait at least for 20 seconds.
- Clear DTC stored in memory.  
(See page [DI-503](#))
- Turn ignition switch to LOCK, and wait at least for 20 seconds.
- Turn ignition switch to ACC or ON, and wait at least for 20 seconds.
- Check DTC.  
(See page [DI-503](#))

**DTC B0135/73 is not output.**

**Replace seat belt pretensioner (LH).**

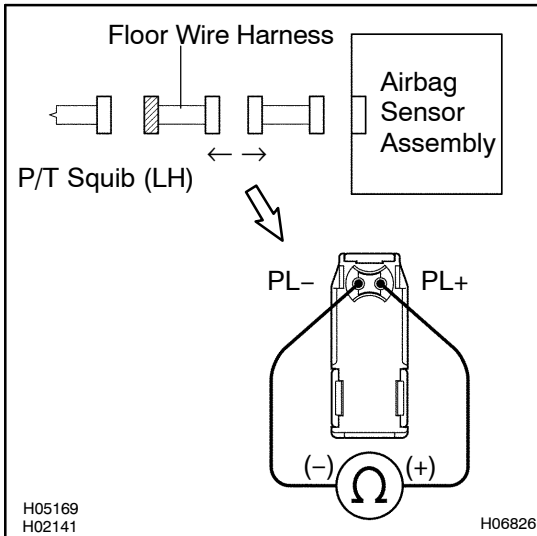
**5 Check floor wire harness.**

- Disconnect floor wire harness connector on the airbag sensor assembly side.
- Release airbag activation prevention mechanism of the floor wire harness connector on the airbag sensor assembly side. (See page [DI-503](#))

For the connector (on the floor wire harness side) between the seat belt pretensioner and the floor wire harness, measure the resistance between PL+ and PL-.

**Resistance: 1 MΩ or Higher**

**Replace floor wire harness.**

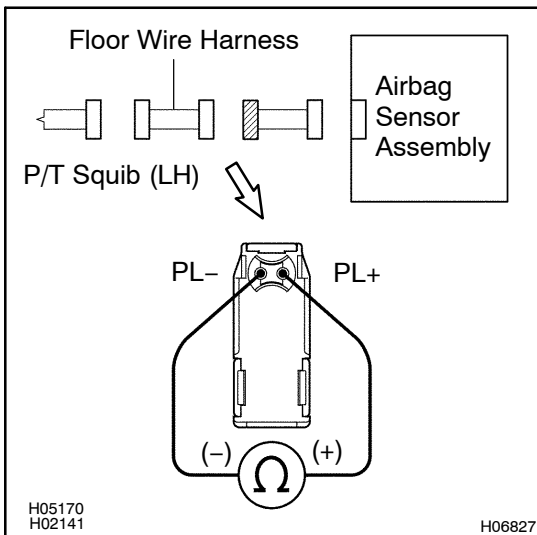
**6 Check harness between airbag sensor assembly and floor wire harness.**

Release airbag activation prevention mechanism of the airbag sensor assembly connector. (See page [DI-503](#))

For the connector (on the floor wire harness side) between the airbag sensor assembly and floor wire harness, measure the resistance between PL+ and PL-.

**Resistance: 1 MΩ or Higher**

**Replace harness and connector between airbag sensor assembly and floor wire harness.**
