# REAR HEATER RELAY INSPECTION

AC3Q3-01

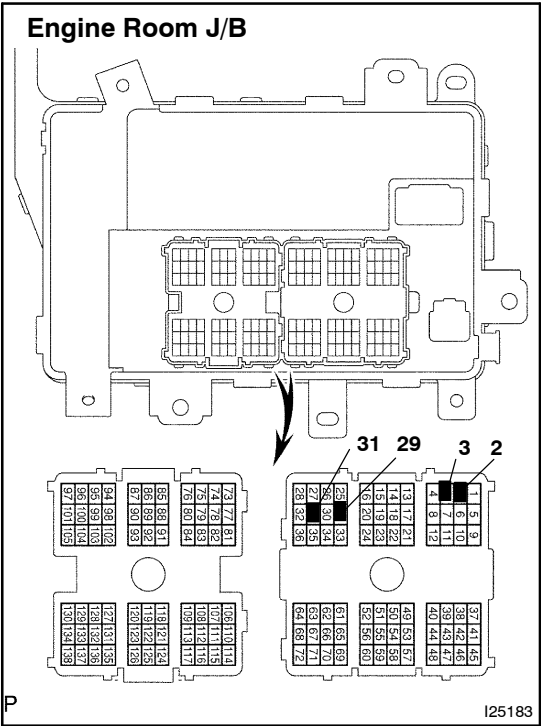
1. REMOVE ENGINE ROOM J/B
2. INSPECT REAR HEATER RELAY CONTINUITY

| Condition | Tester connection | Specified condition |
| Constant | 29 – 31 | Continuity |
| Apply B+ between terminals 29 and 31. | 2 – 3 | Continuity |

If continuity is not as specified, replace the engine room J/B.
