| DTC | B2797 | Communication Malfunction No.1 |

CIRCUIT DESCRIPTION

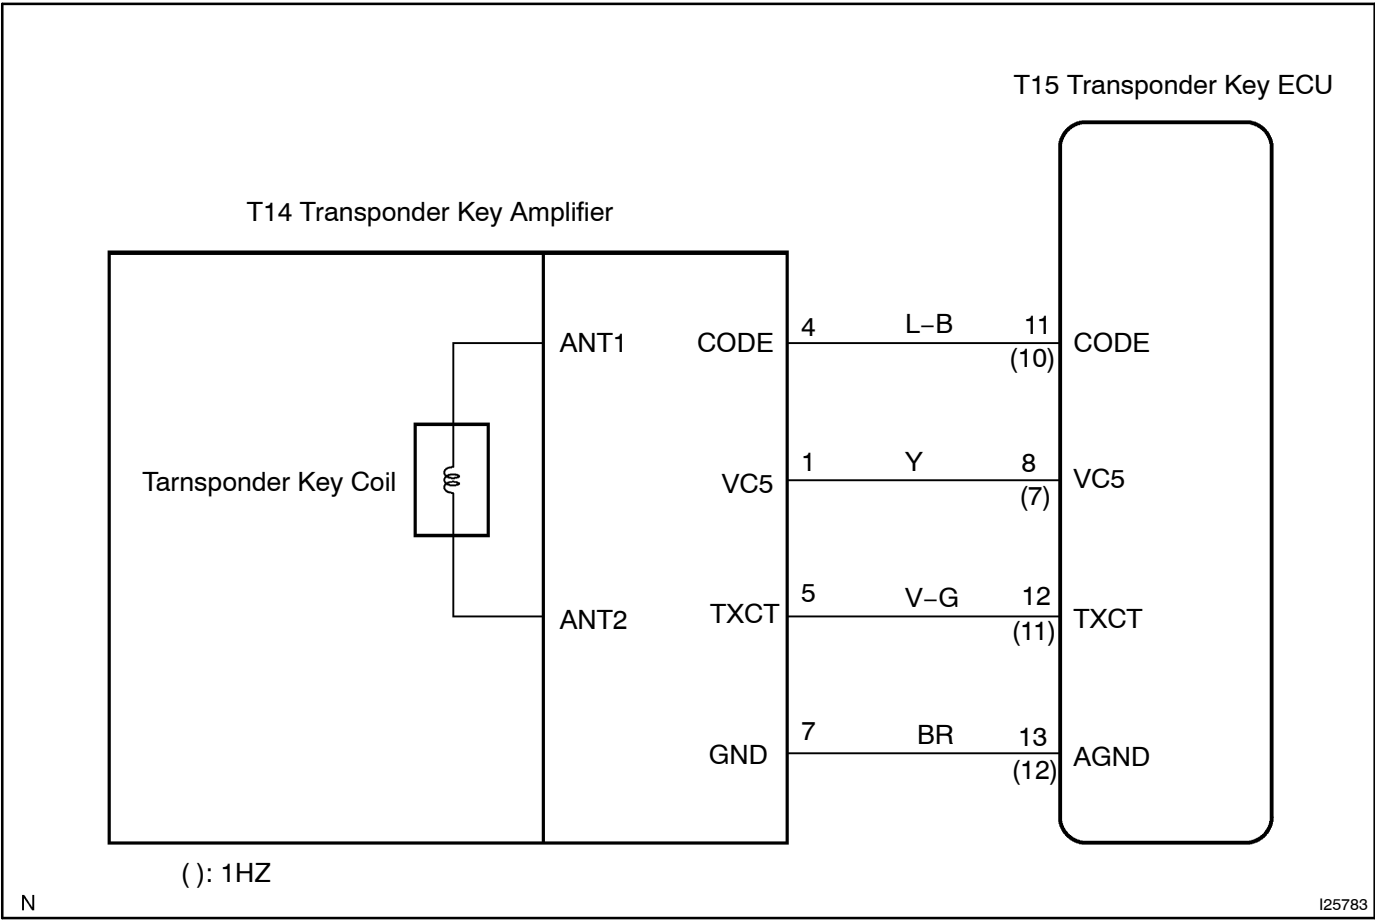
WIRING DIAGRAM

This DTC is detected when an error occurs, although the communication has been performed normally (Example. Some noise is included in communication line.).

| DTC No. | DTC Detecting Condition | Trouble Area |
|---|---|---|
| B2797 | Communication error | <ul style="list-style-type: none"><li>•Key</li><li>•Wire harness</li><li>•Transponder Key Amplifier with coil</li><li>•Transponder Key ECU</li></ul> |
