| <b>DTC</b> | <b>B2798</b> | <b>Communication malfunction No.2</b> |

## CIRCUIT DESCRIPTION

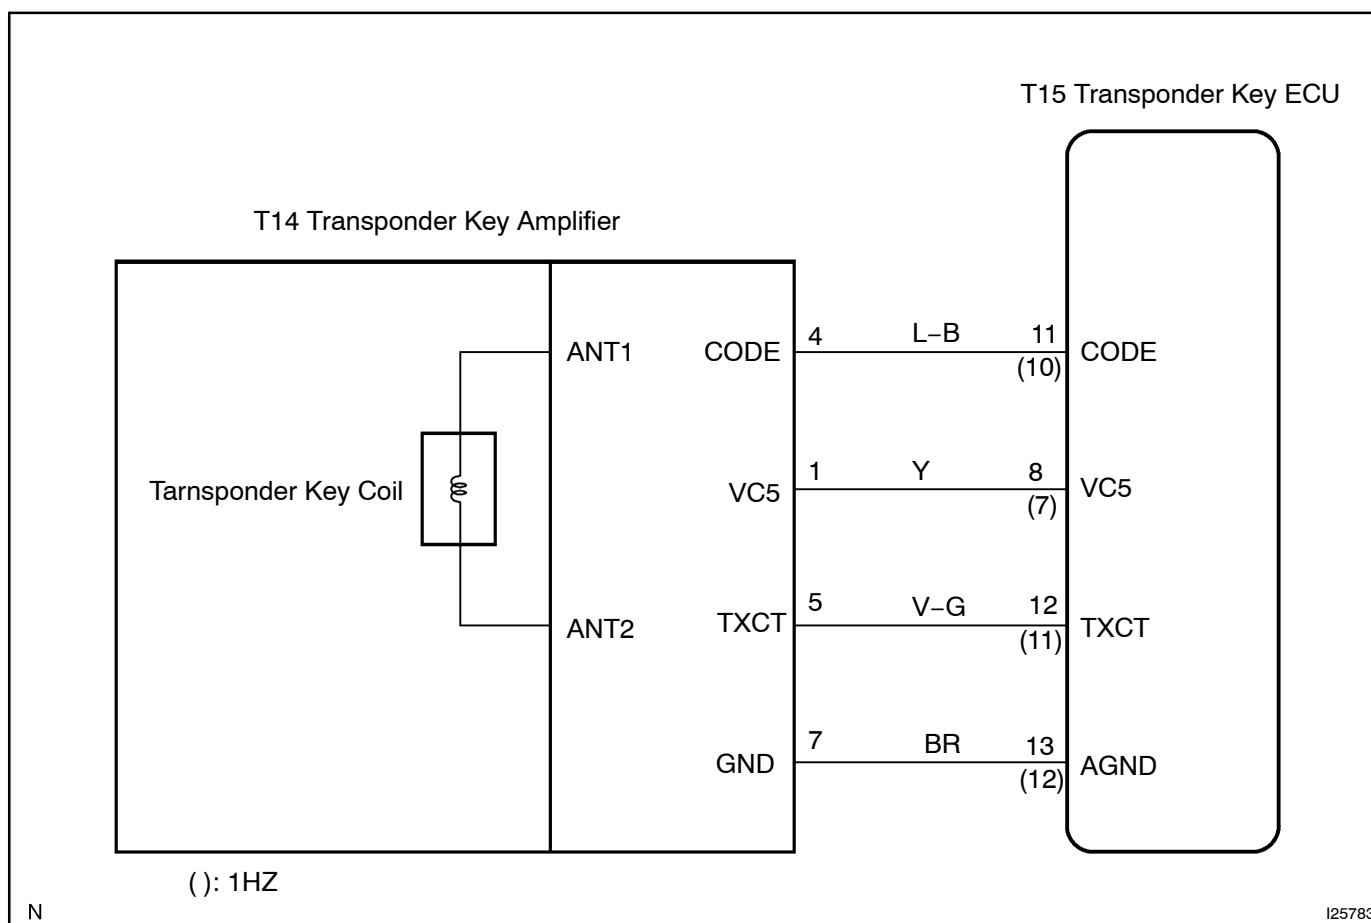
## WIRING DIAGRAM

This code is detected when an error occurs, although the communication has been performed normally.  
(Example. Some noise is included in communication line.)

| DTC No. | DTC Detecting Condition | Trouble Area |
|---|---|---|
| B2798 | Communication error | <ul style="list-style-type: none"> <li>• Key</li> <li>• Transponder Key Amplifier with coil</li> <li>• Wire harness</li> <li>• Transponder key ECU</li> </ul> |

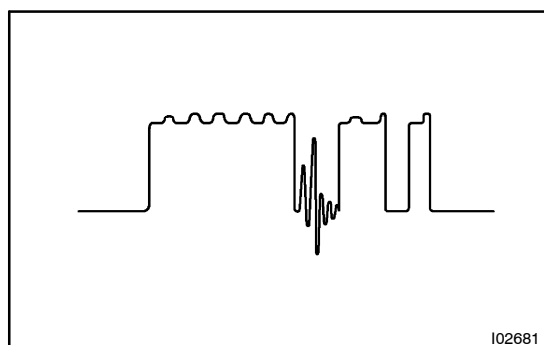
| 2 | <b>Noise check</b> |

Insert the already registered master key in the ignition key cylinder.

Using oscilloscope or the hand-held tester, check that noise is included in the signals sent to the CODE terminal of the Transponder key ECU.

**No noise is detected.**

**NG****Try to find the cause of the noise nad remove it.****OK**
