# Front Wiper Position Circuit

## CIRCUIT DESCRIPTION

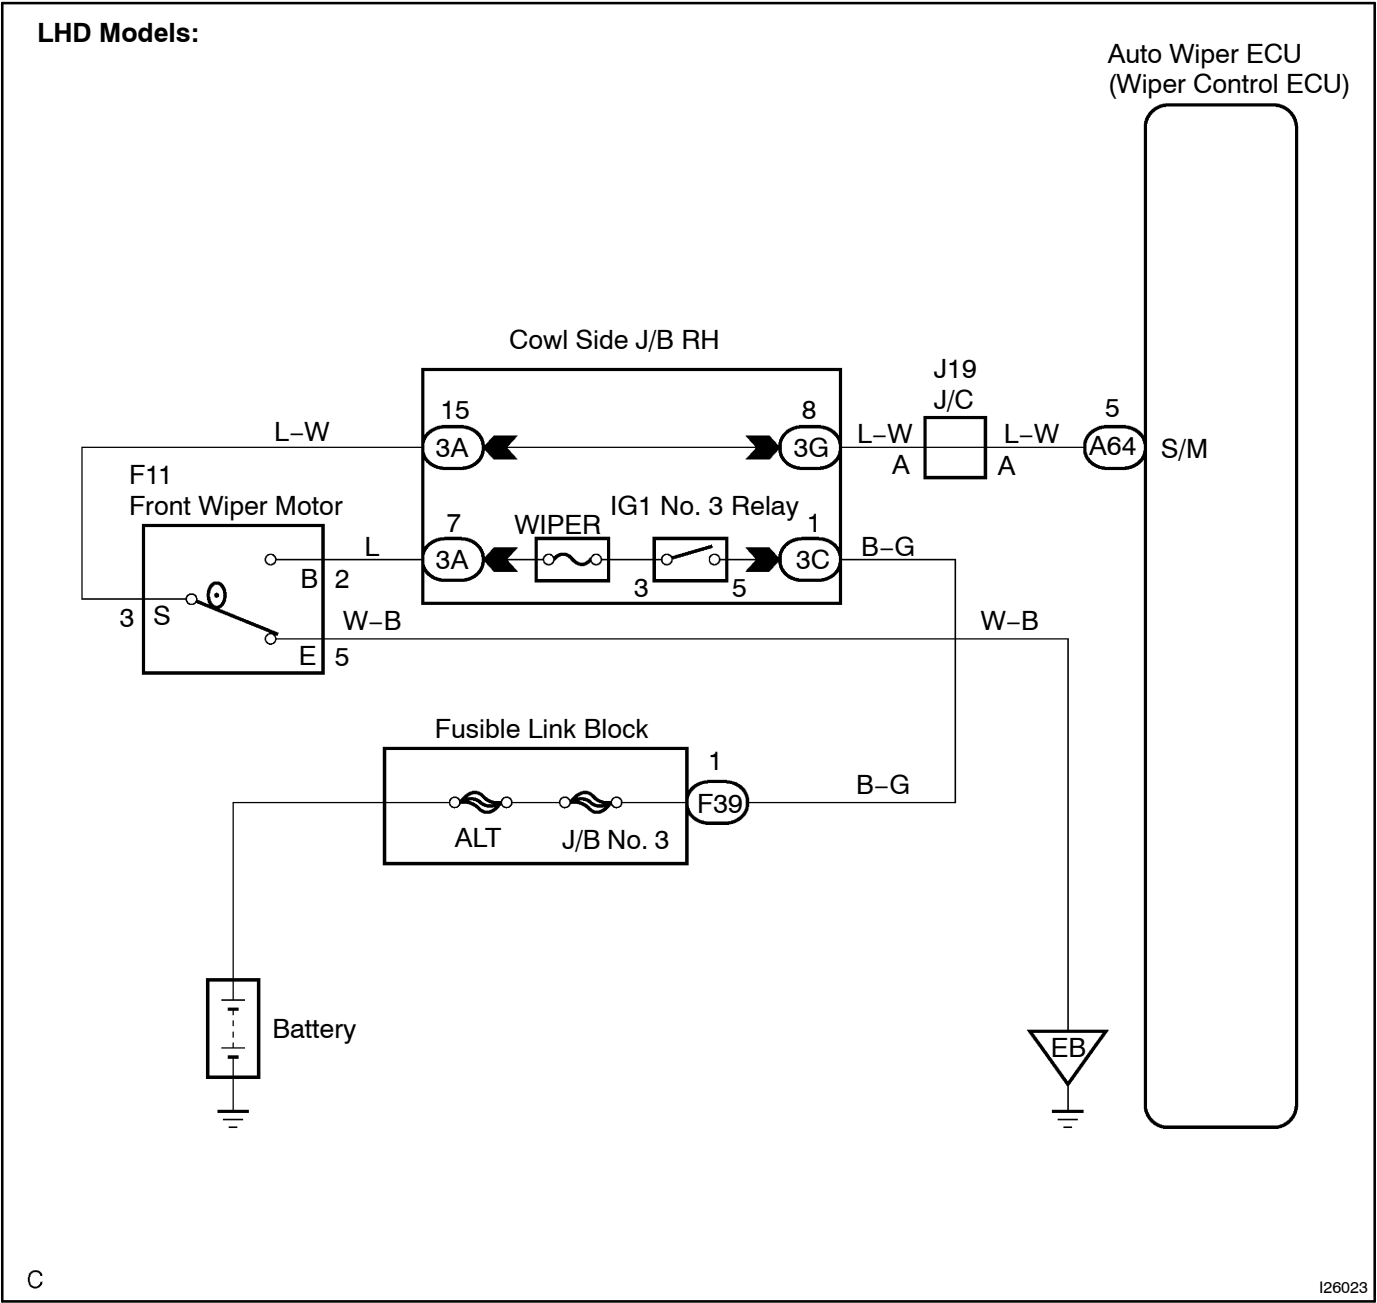
## WIRING DIAGRAM

This signal is taken into Body ECU. If this signal cannot be received, Body ECU does not perform reverse linked function control.

| 1 | Check wire harness between wiper control ECU and front wiper motor ( <a href="#">See page IN-38</a> ). |

| 2 | Check wire harness between wiper control ECU and body ECU ( <a href="#">See page IN-38</a> ). |
