## ON-VEHICLE INSPECTION

### 1. INSPECT REFRIGERANT VOLUME

## 2. INSPECT REFRIGERANT PRESSURE WITH MANIFOLD GAUGE SET

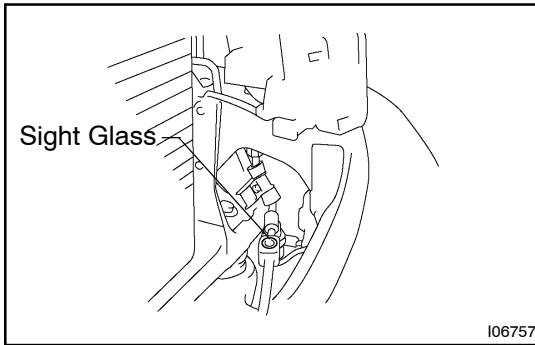
Observe the sight glass on the liquid tube.

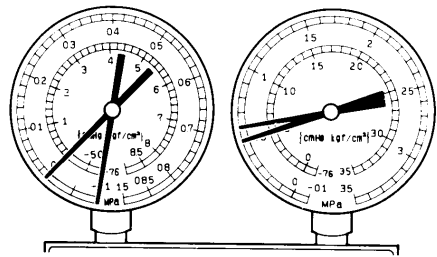
I01389

(4) Poor circulation of refrigerant.

Condition: Insufficient cooling

| Symptom seen in refrigeration system | Probable cause | Diagnosis | Remedy |
|---|---|---|---|
| <ul style="list-style-type: none"><li>• Pressure low in both low and high pressure sides</li><li>• Frost on tube from condenser to unit</li></ul> | Refrigerant flow obstructed by dirt in condenser | condenser clogged | Replace condenser |

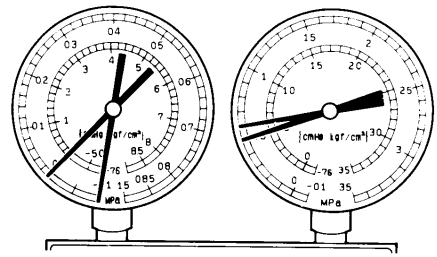
I01449

(5) Refrigerant does not circulate.

Condition: Does not cool (Cools from time to time in some cases)

| Symptom seen in refrigeration system | Probable cause | Diagnosis | Remedy |
|---|---|---|---|
| <ul style="list-style-type: none"><li>• Vacuum indicated on low pressure side, very low pressure indicated on high pressure side</li><li>• Frost or dew seen on piping before and after condenser/ drier or expansion valve</li></ul> | <ul style="list-style-type: none"><li>• Refrigerant flow obstructed by moisture or dirt in refrigeration system</li><li>• Refrigerant flow obstructed by gas leakage from expansion valve</li></ul> | Refrigerant does not circulate | <ul style="list-style-type: none"><li>(1) Check expansion valve</li><li>(2) Clean out dirt in expansion valve by blowing with air</li><li>(3) Replace condenser</li><li>(4) Evacuate air and charge new refrigerant to proper amount</li><li>(5) For gas leakage from expansion valve, replace expansion valve</li></ul> |

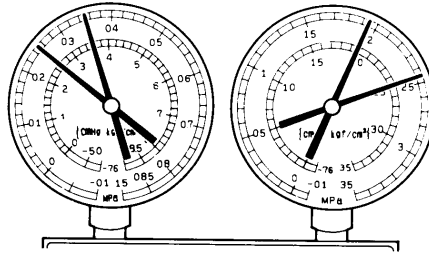
I01390

(6) Refrigerant overcharged or insufficient cooling of condenser.

Condition: Insufficient cooling

| Symptom seen in refrigeration system | Probable cause | Diagnosis | Remedy |
|---|---|---|---|
| <ul style="list-style-type: none"> <li>Pressure too high on both low and high pressure sides</li> <li>No air bubbles seen through the sight glass even when the engine rpm is lowered</li> </ul> | <ul style="list-style-type: none"> <li>Unable to develop sufficient performance due to excessive refrigeration system</li> <li>Insufficient cooling of condenser</li> </ul> | <ul style="list-style-type: none"> <li>Excessive refrigerant in cycle → refrigerant over charged</li> <li>Condenser cooling → condenser fins clogged or cooling fan faulty</li> </ul> | <ol style="list-style-type: none"> <li>Clean condenser</li> <li>Check cooling fan with fluid coupling operation</li> <li>If (1) and (2) are in normal state, check amount of refrigerant, and charge proper amount of refrigerant</li> </ol> |

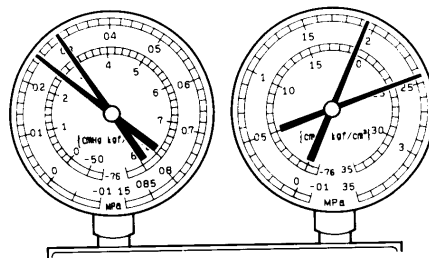
I01392

(7) Air present in refrigeration system.

Condition: Insufficient cooling

NOTE : These gauge indications are shown when the refrigeration system has been opened and the refrigerant charged without vacuum purging.

| Symptom seen in refrigeration system | Probable cause | Diagnosis | Remedy |
|---|---|---|---|
| <ul style="list-style-type: none"> <li>Pressure too high on both low and high pressure sides</li> <li>The low pressure piping hot to touch</li> <li>Bubbles seen in sight glass</li> </ul> | Air entered in refrigeration system | <ul style="list-style-type: none"> <li>Air present in refrigeration system</li> <li>Insufficient vacuum purging</li> </ul> | <ol style="list-style-type: none"> <li>Check compressor oil to see if it is dirty or insufficient</li> <li>Evacuate air and charge new refrigerant</li> </ol> |

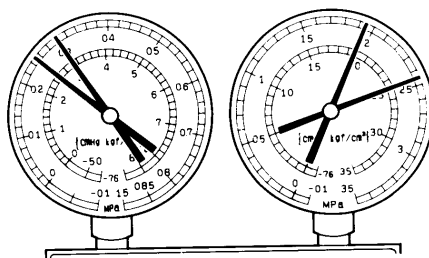
I01450

## (8) Expansion valve improperly.

Condition: Insufficient cooling

| Symptom seen in refrigeration system | Probable cause | Diagnosis | Remedy |
|---|---|---|---|
| <ul style="list-style-type: none"> <li>Pressure too high on both low and high pressure sides</li> <li>Frost or large amount of dew on piping on low pressure side</li> </ul> | Trouble in expansion valve | <ul style="list-style-type: none"> <li>Excessive refrigerant in low pressure piping</li> <li>Expansion valve opened too wide</li> </ul> | Check expansion valve, and replace if defective |

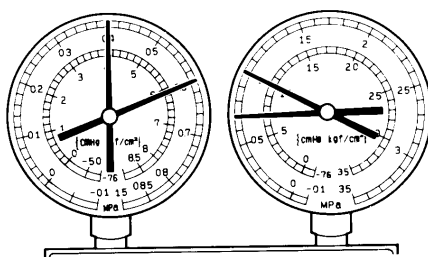
I01393

## (9) Defective compression compressor.

Condition : Does not cool

| Symptom seen in refrigeration system | Probable cause | Diagnosis | Remedy |
|---|---|---|---|
| <ul style="list-style-type: none"> <li>Pressure too high on low and high pressure sides</li> <li>Pressure too low on high pressure side</li> </ul> | Internal leak in compressor | <ul style="list-style-type: none"> <li>Compression defective</li> <li>Valve leaking or broken sliding parts</li> </ul> | Repair or replace compressor |
