# MAGNETIC CLUTCH RELAY INSPECTION

AC1LY-03

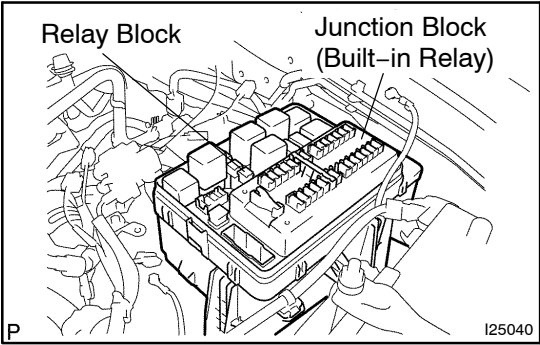
The magnetic clutch relay is built in the engine room junction block. Since the relay is constructed with a relay block that is in the junction block as a unit, it is impossible to disconnect the wire harness connecting with the relay block.

- 1. REMOVE ENGINE ROOM J/B
- 2. INSPECT MAGNETIC CLUTCH RELAY CONTINUITY

| Condition | Tester connection | Specified condition |
| Constant | 57 – 65 | Continuity |
| Apply B+ between terminals 57 and 65. | 63 – 65 | Continuity |

If continuity is not as specified, replace the engine room J/B.
