| <b>DTC</b> | <b>B1214</b> | <b>Door system communication bus malfunction (+B short)</b> |

| <b>DTC</b> | <b>B1215</b> | <b>Door system communication bus malfunction (GND short)</b> |

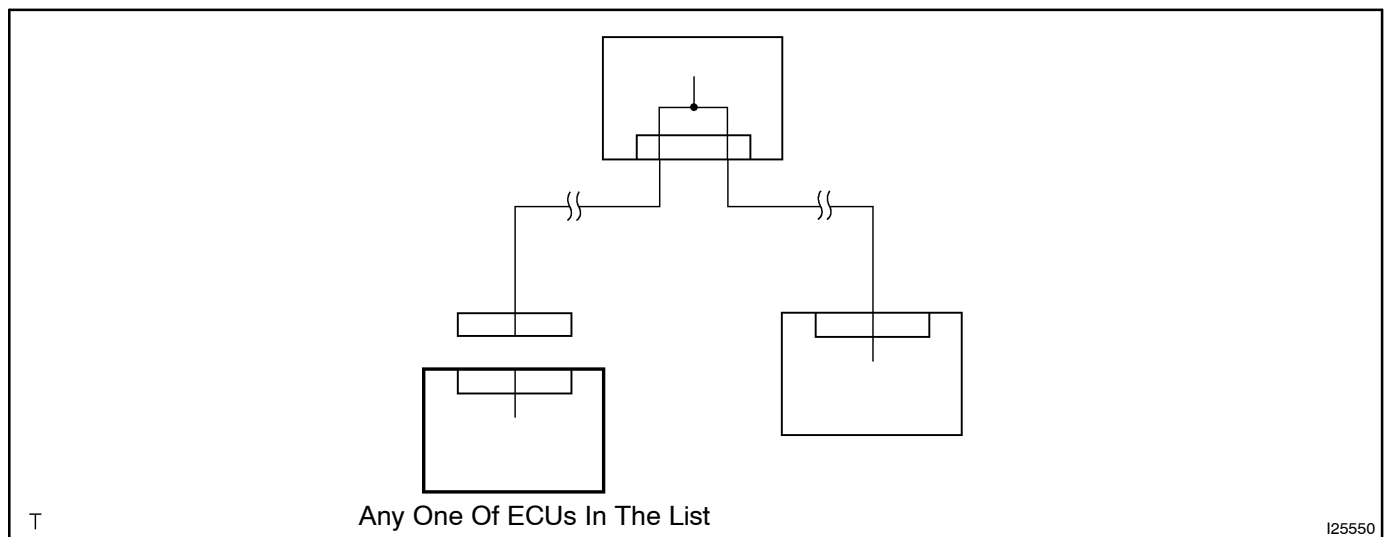
Disconnect the following ECU connectors in order from the top downward.

| Disconnect ECU connector | Connector No. |
| Power window master switch (Driver door ECU) | P12 |
| Power window switch (Front RH door ECU) | P18 |
| Power window switch (Rear LH door ECU) | P19 |
| Power window switch (Rear RH door ECU) | P20 |

Check the DTC every time each connector is disconnect.

DTC B1214 or B1215 is not output.

**Replace corresponding ECU (ECU for which DTC is deleted is defective.)  
(See page [IN-36](#)).**

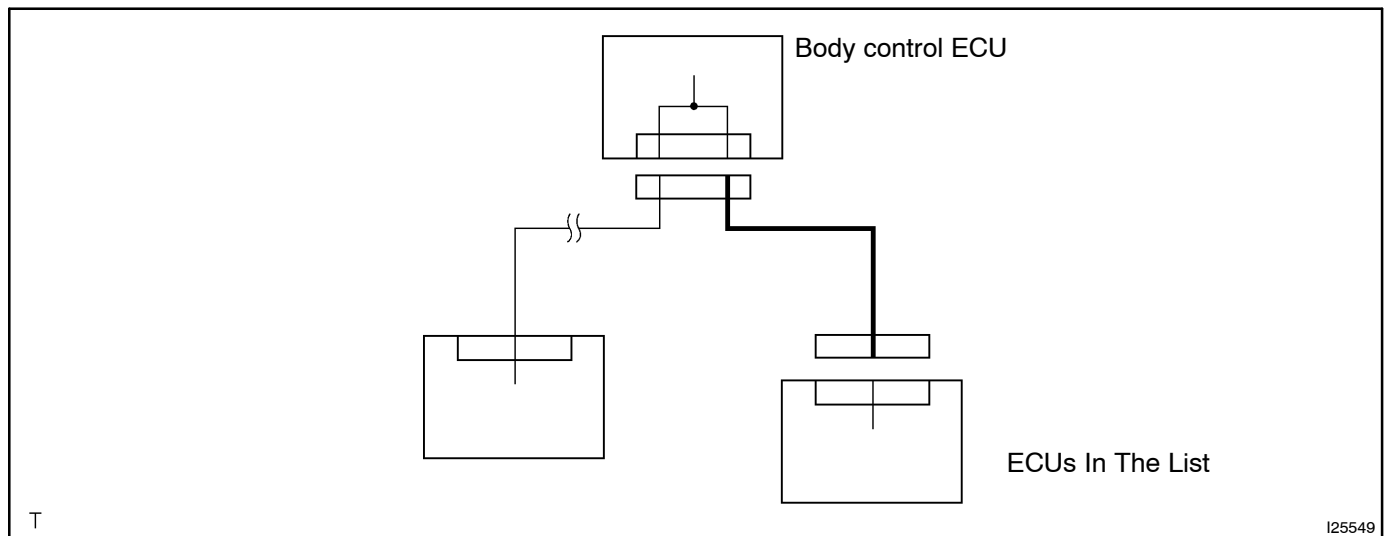
Disconnect the following connectors of ECU.

| Disconnect ECU connector | Connector No. |
| Body ECU<br>Power window master switch (Driver door ECU) | B7<br>P12 |
| Body ECU<br>Power window switch (Front RH door ECU ) | B7<br>P18 |
| Body ECU<br>Power window switch (Rear LH door ECU ) | B8<br>P19 |
| Body ECU<br>Power window switch (Rear RH door ECU ) | B8<br>P20 |

Check whether or not there is +B short and GND short between the above connectors.

**No +B short and GND short.**

**Repair or replace corresponding wire harness.**

**Replace Body control ECU**  
(See page [IN-36](#)).
