| <b>DTC</b> | <b>B1185/57</b> | <b>Short in P Squib (2nd step) Circuit</b> |

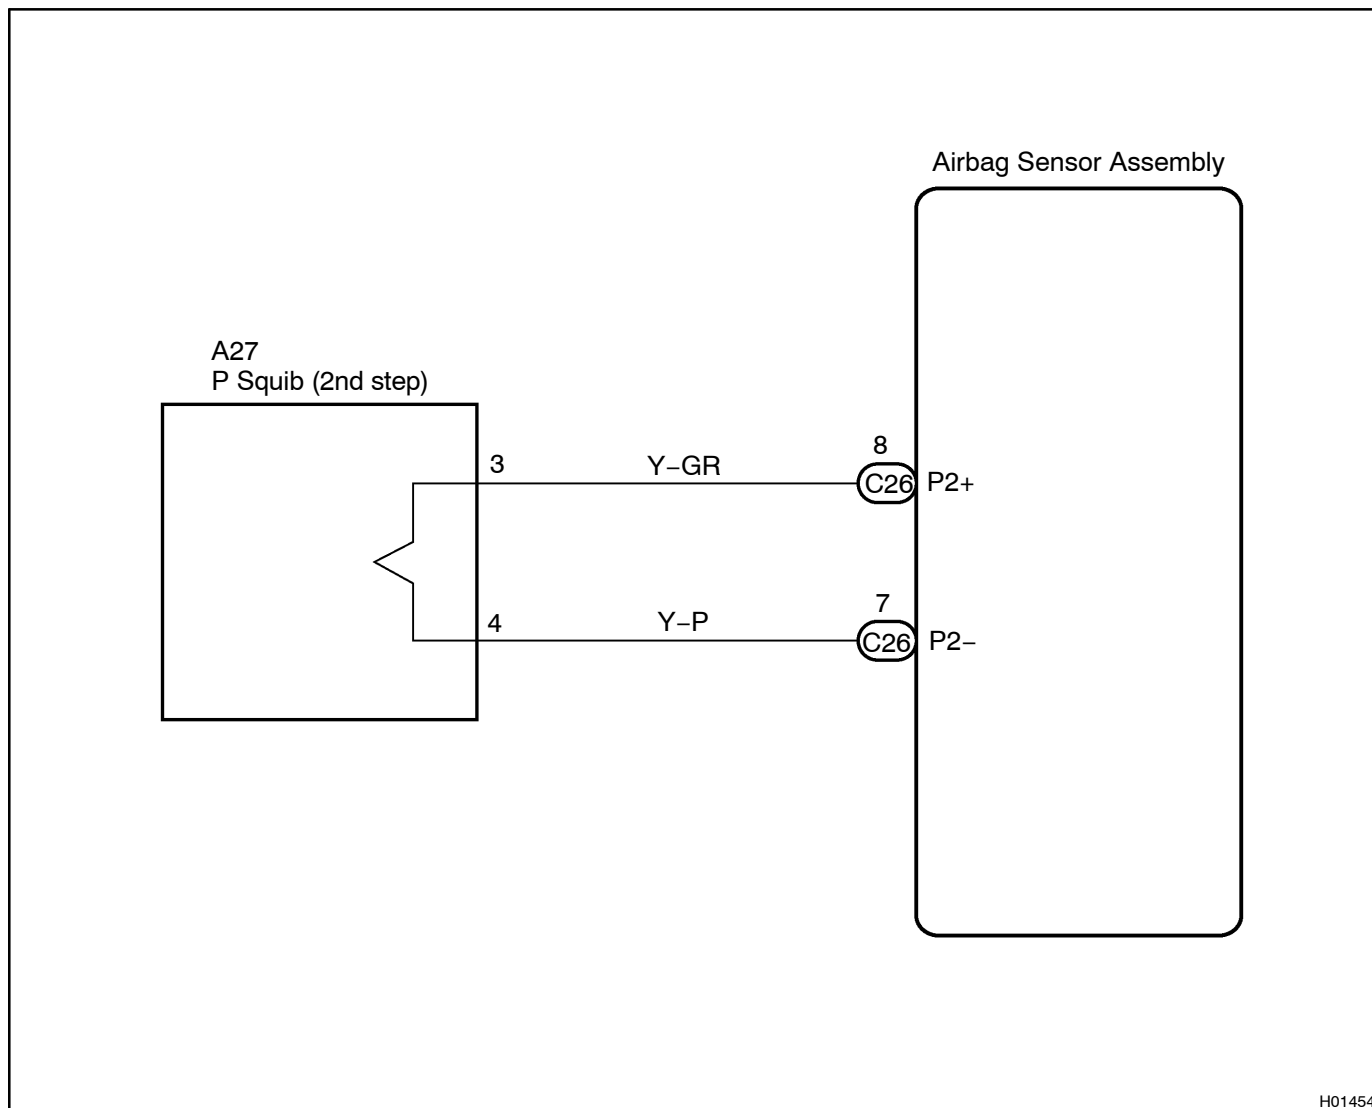
H01454

The P squib (2nd step) circuit consists of the airbag sensor assembly and the front passenger airbag assembly. It causes the SRS to deploy when the SRS deployment conditions are satisfied.

DTC B1185/57 is recorded when a short is detected in the P squib (2nd step) circuit.

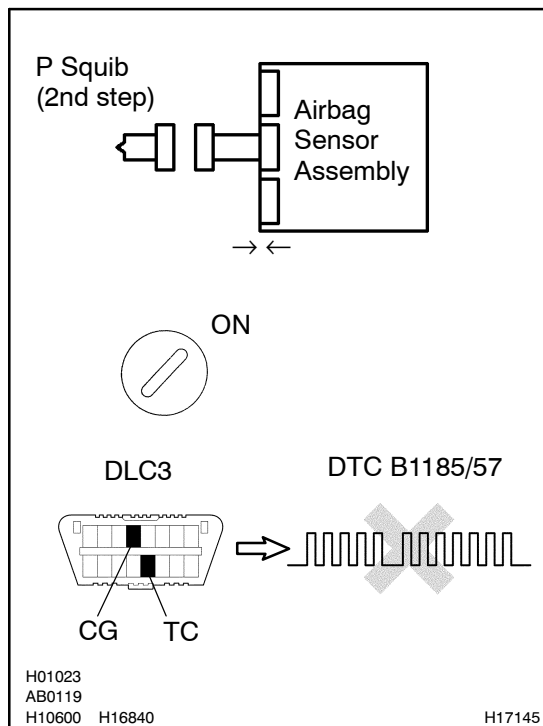
### 3 Check airbag sensor assembly.

- Connect the connector to the airbag sensor assembly.
- Connect the negative (-) terminal cable to the battery, and wait at least for 2 seconds.

- Turn the ignition switch to ON, and wait at least for 10 seconds.
- Clear the DTC stored in memory (See page [DI-523](#)).
- Turn the ignition switch to LOCK, and wait at least for 10 seconds.
- Turn the ignition switch to ON, and wait at least for 10 seconds.
- Check the DTC (See page [DI-523](#)).

**DTC B1185/57 is not output.**

**Replace airbag sensor assembly.**
