## FRONT A/C EVAPORATOR ON-VEHICLE INSPECTION

AC1L9-05

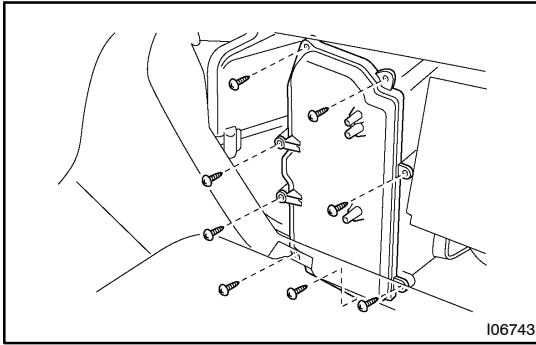
- (a) Remove the glove compartment door.
- (b) Remove the lower No. 2 finish panel  
(See page [BO-84](#)).
- (c) Remove the No. 1 cooler cover.
  - (1) Disconnect the connector clamp.
  - (2) Remove the 8 screws and No. 1 cooler cover.
- (d) Using a gas leak detector, check for leaks of refrigerant. If there is a leakage of refrigerant, check the tightening torque at the joints or check the evaporator.
- (e) Install the No. 1 cooler cover.
