| <b>DTC</b> | <b>B2798</b> | <b>Communication malfunction No. 2</b> |

## CIRCUIT DESCRIPTION

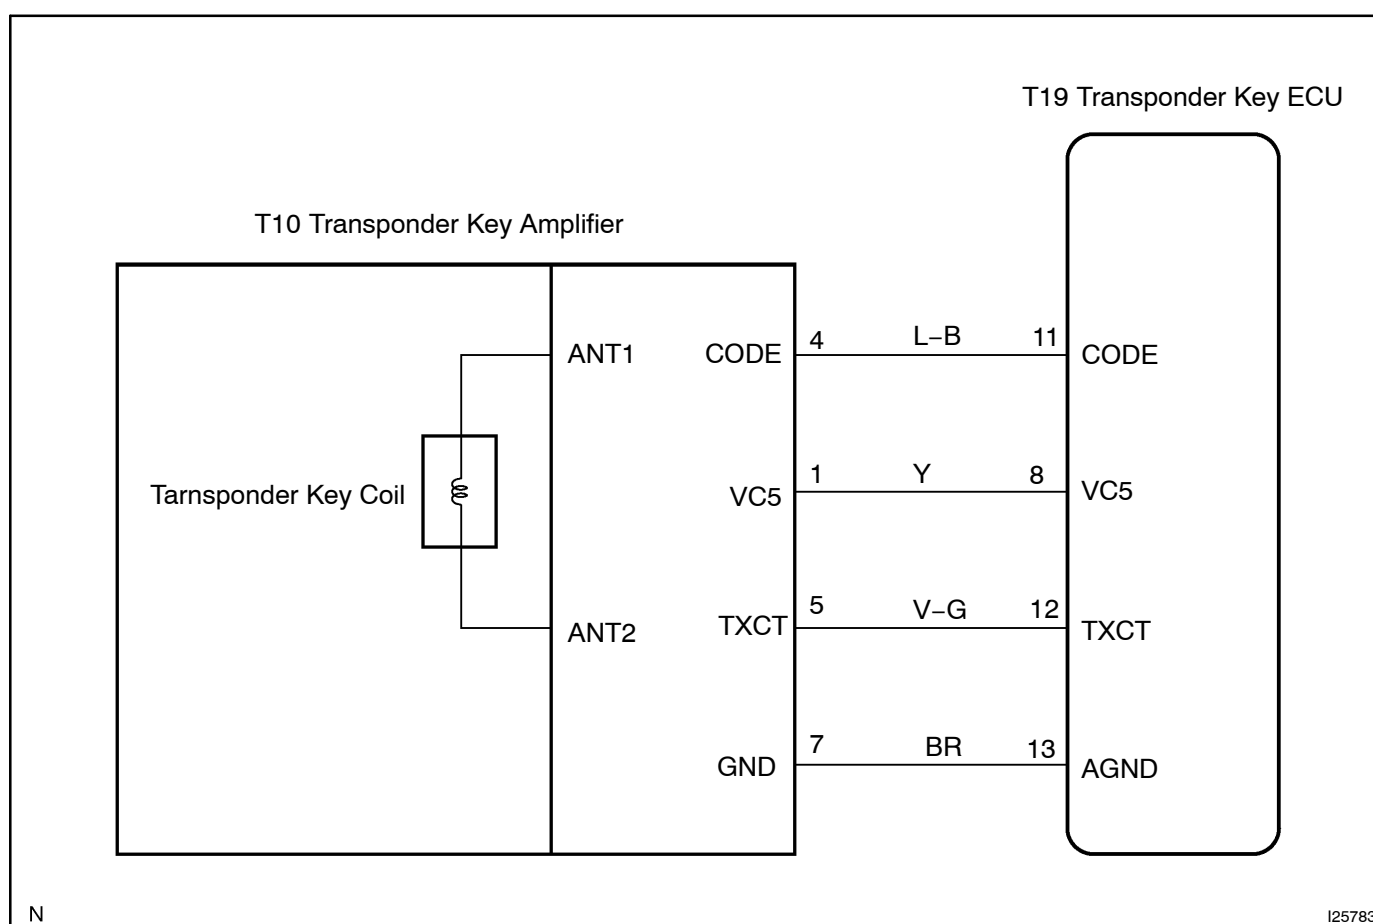
## WIRING DIAGRAM

This code is detected when an error occurs, although the communication has been performed normally.  
(Example. Some noise is included in communication line.)
