| <b>DTC</b> | <b>B1214</b> | <b>Door system communication bus malfunction (+B short)</b> |

| <b>DTC</b> | <b>B1215</b> | <b>Door system communication bus malfunction (GND short)</b> |

## CIRCUIT DESCRIPTION

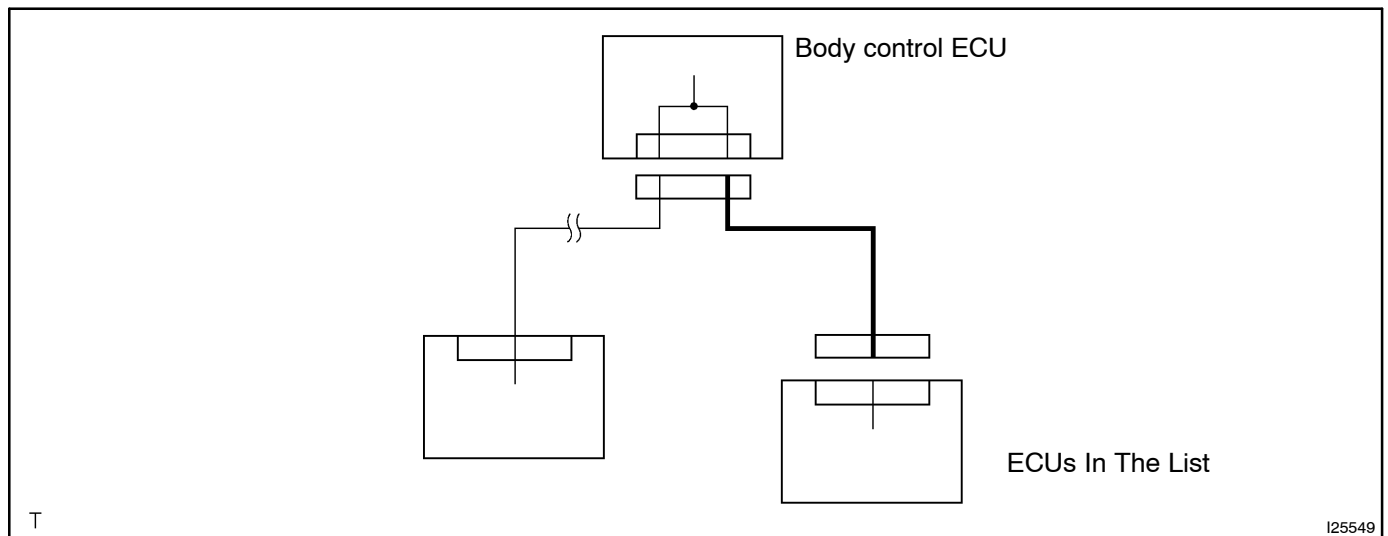
Disconnect the following connectors of ECU.

| Disconnect ECU connector | Connector No. |
| Body ECU<br>Power window master switch (Driver door ECU) | B7<br>P12 |
| Body ECU<br>Power window switch (Front RH door ECU ) | B7<br>P18 |
| Body ECU<br>Power window switch (Rear LH door ECU ) | B8<br>P19 |
| Body ECU<br>Power window switch (Rear RH door ECU ) | B8<br>P20 |

Check whether or not there is +B short and GND short between the above connectors.

**No +B short and GND short.**

**Repair or replace corresponding wire harness.**

**Replace Body control ECU**  
(See page [IN-36](#)).
