| <b>DTC</b> | <b>B1185/57</b> | <b>Short in P Squib (2nd step) Circuit</b> |

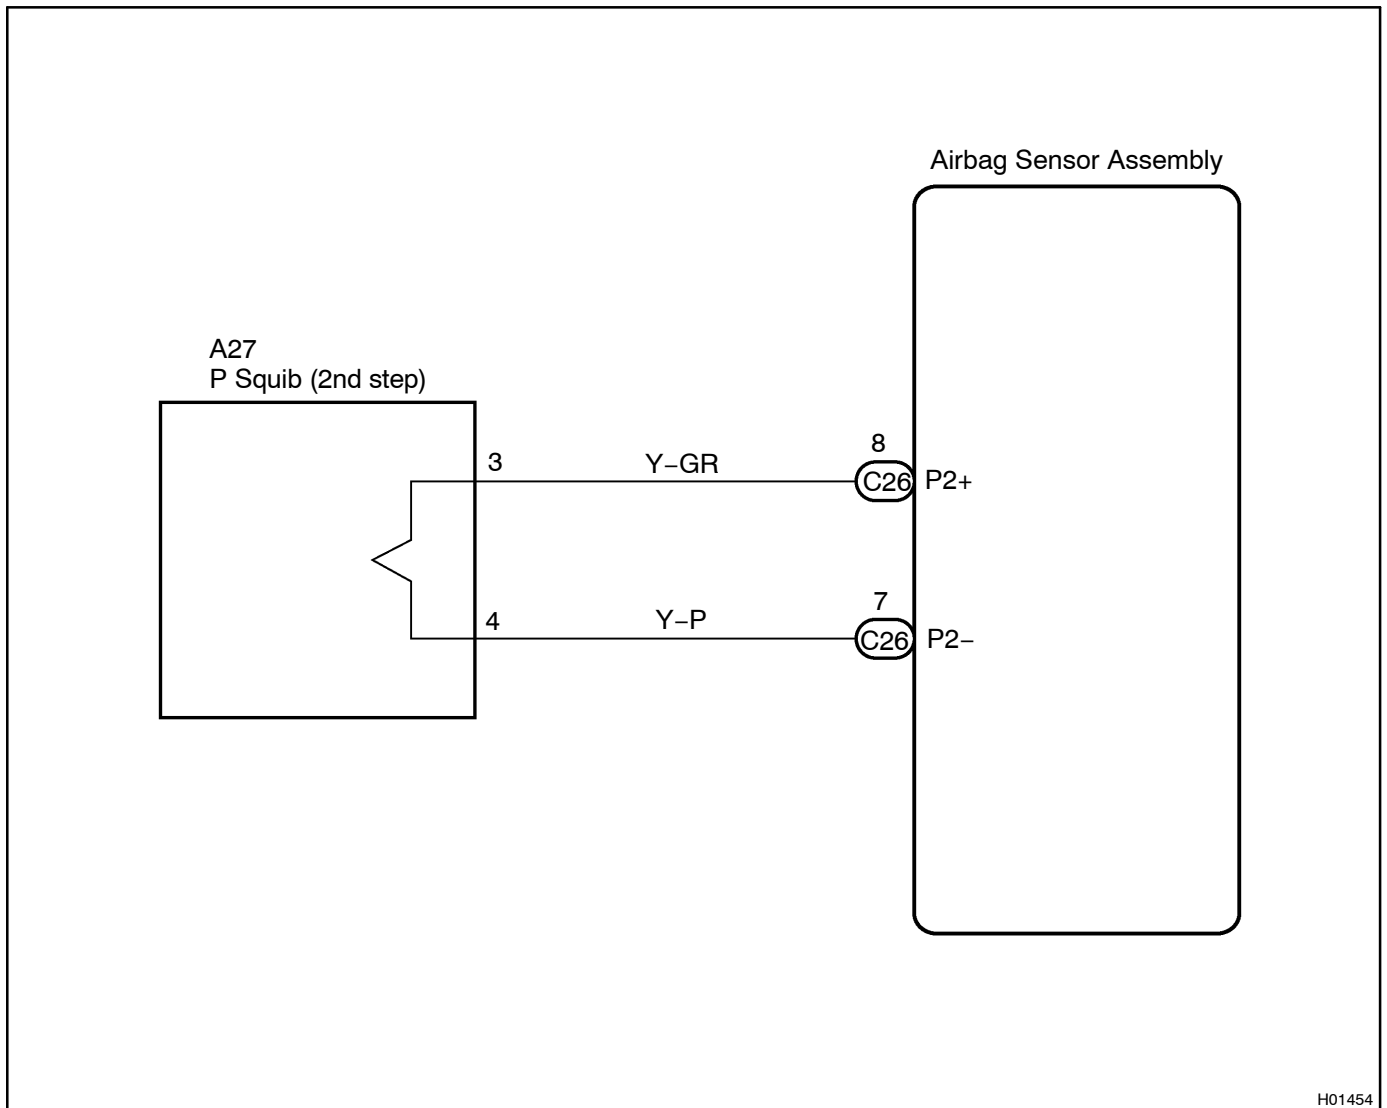
H01454

The P squib (2nd step) circuit consists of the airbag sensor assembly and the front passenger airbag assembly. It causes the SRS to deploy when the SRS deployment conditions are satisfied.

DTC B1185/57 is recorded when a short is detected in the P squib (2nd step) circuit.

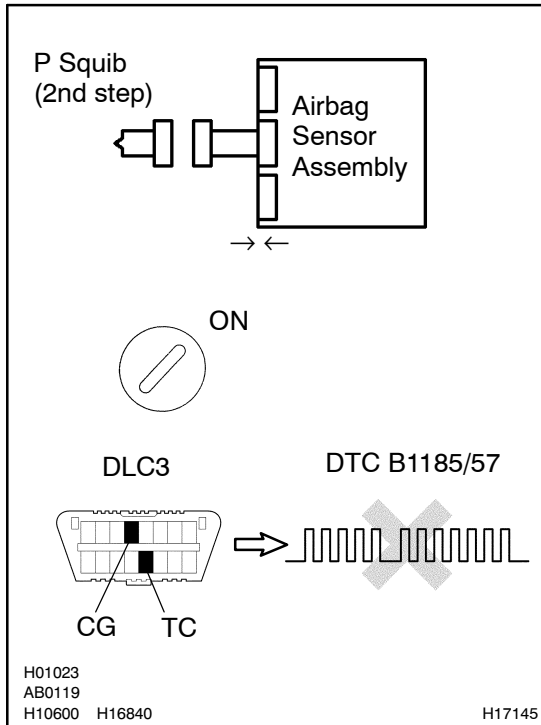
- Connect the connector to the airbag sensor assembly.
- Connect the negative (-) terminal cable to the battery, and wait at least for 2 seconds.

- Turn the ignition switch to ON, and wait at least for 10 seconds.
- Clear the DTC stored in memory (See page [DI-692](#)).
- Turn the ignition switch to LOCK, and wait at least for 10 seconds.
- Turn the ignition switch to ON, and wait at least for 10 seconds.
- Check the DTC (See page [DI-692](#)).

**DTC B1185/57 is not output.**

**Replace airbag sensor assembly.**

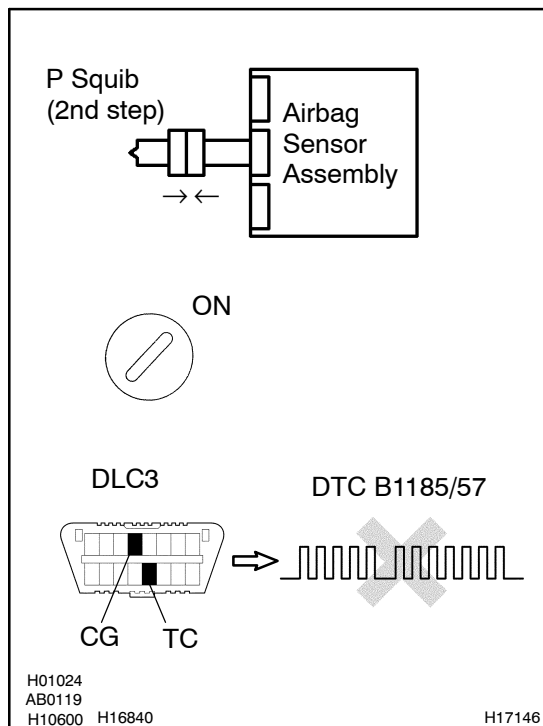
- Turn the ignition switch to LOCK.
- Disconnect the negative (-) terminal cable from the battery, and wait at least for 90 seconds.
- Connect the front passenger airbag assembly (P squib (2nd step)) connector.
- Connect the negative (-) terminal cable to the battery, and wait at least for 2 seconds.

- Turn the ignition switch to ON, and wait at least for 10 seconds.
- Clear the DTC stored in memory (See page [DI-692](#)).
- Turn the ignition switch to LOCK, and wait at least for 10 seconds.
- Turn the ignition switch to ON, and wait at least for 10 seconds.
- Check the DTC (See page [DI-692](#)).

**DTC B1185/57 is not output.**

**Replace front passenger airbag assembly (P squib (2nd step)).**
