## ON-VEHICLE INSPECTION

### 1. INSPECT REFRIGERANT VOLUME

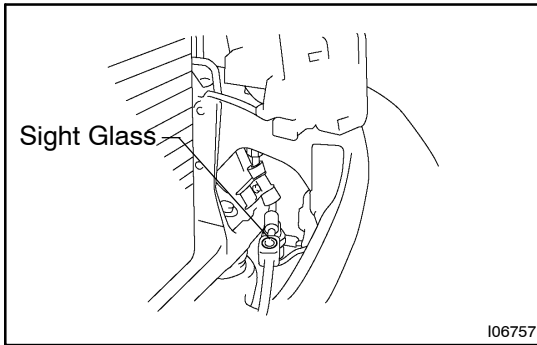
I06757

Observe the sight glass on the liquid tube.

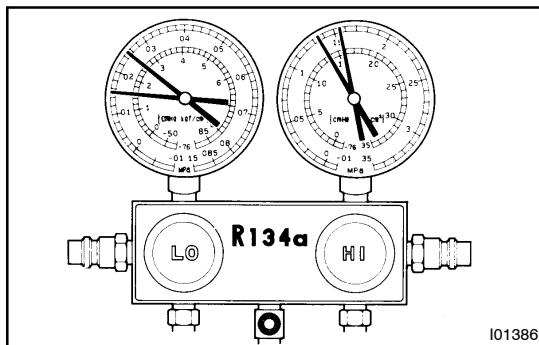
(1) Normally functioning refrigeration system.

**Gauge reading:**

**Low pressure side:**

**0.15 – 0.25 MPa (1.5 – 2.5 kgf/cm<sup>2</sup>)**

**High pressure side:**

**1.37 – 1.57 MPa (14 – 15 kgf/cm<sup>2</sup>)**

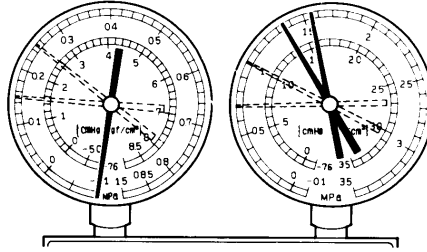
I01387

## (2) Moisture present in refrigeration system.

Condition : Periodically cools and then fails to cool

| Symptom seen in refrigeration system | Probable cause | Diagnosis | Remedy |
|---|---|---|---|
| During operation, pressure on low pressure side sometimes become a vacuum and sometime normal | Moisture entered in refrigeration system freezes at expansion valve orifice and temporarily stops cycle, but normal state is restored after a time when the ice melts | <ul style="list-style-type: none"> <li>• Drier in over-saturated state</li> <li>• Moisture in refrigeration system freezes at expansion valve orifice and blocks circulation of refrigerant</li> </ul> | (1) Replace condenser<br>(2) Remove moisture in cycle through repeatedly evacuating air<br>(3) Charge proper amount of new refrigerant |

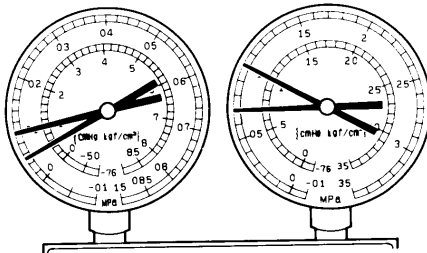
I01388

## (3) Insufficient cooling.

Condition: Insufficient cooling

| Symptom seen in refrigeration system | Probable cause | Diagnosis | Remedy |
|---|---|---|---|
| <ul style="list-style-type: none"> <li>• Pressure low on both low and high pressure sides</li> <li>• Bubbles seen in sight glass continuously</li> <li>• Insufficient cooling performance</li> </ul> | Gas leakage at some place in refrigeration system | <ul style="list-style-type: none"> <li>• Insufficient refrigerant in system</li> <li>• Refrigerant leaking</li> </ul> | (1) Check for gas leakage with gas leak detector and repair if necessary<br>(2) Charge proper amount of refrigerant<br>(3) If indicated pressure value is near 0 when connected to gauge, create the vacuum after inspecting and repairing the location of the leak |

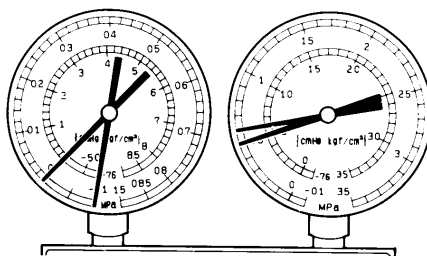
I01389

## (4) Poor circulation of refrigerant.

Condition: Insufficient cooling

| Symptom seen in refrigeration system | Probable cause | Diagnosis | Remedy |
|---|---|---|---|
| <ul style="list-style-type: none"> <li>• Pressure low in both low and high pressure sides</li> <li>• Frost on tube from condenser to unit</li> </ul> | Refrigerant flow obstructed by dirt in condenser | condenser clogged | Replace condenser |

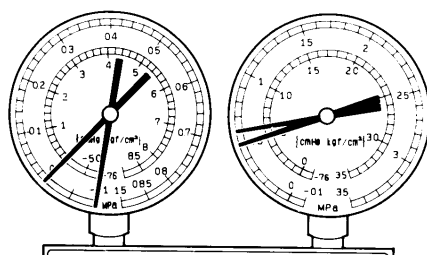
I01449

## (5) Refrigerant does not circulate.

Condition: Does not cool (Cools from time to time in some cases)

| Symptom seen in refrigeration system | Probable cause | Diagnosis | Remedy |
|---|---|---|---|
| <ul style="list-style-type: none"> <li>• Vacuum indicated on low pressure side, very low pressure indicated on high pressure side</li> <li>• Frost or dew seen on piping before and after condenser/ drier or expansion valve</li> </ul> | <ul style="list-style-type: none"> <li>• Refrigerant flow obstructed by moisture or dirt in refrigeration system</li> <li>• Refrigerant flow obstructed by gas leakage from expansion valve</li> </ul> | Refrigerant does not circulate | <ol style="list-style-type: none"> <li>(1) Check expansion valve</li> <li>(2) Clean out dirt in expansion valve by blowing with air</li> <li>(3) Replace condenser</li> <li>(4) Evacuate air and charge new refrigerant to proper amount</li> <li>(5) For gas leakage from expansion valve, replace expansion valve</li> </ol> |

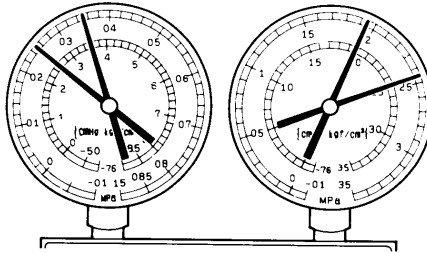
I01390

(6) Refrigerant overcharged or insufficient cooling of condenser.

Condition: Insufficient cooling

| Symptom seen in refrigeration system | Probable cause | Diagnosis | Remedy |
|---|---|---|---|
| <ul style="list-style-type: none"> <li>Pressure too high on both low and high pressure sides</li> <li>No air bubbles seen through the sight glass even when the engine rpm is lowered</li> </ul> | <ul style="list-style-type: none"> <li>Unable to develop sufficient performance due to excessive refrigeration system</li> <li>Insufficient cooling of condenser</li> </ul> | <ul style="list-style-type: none"> <li>Excessive refrigerant in cycle → refrigerant over charged</li> <li>Condenser cooling → condenser fins clogged or cooling fan faulty</li> </ul> | <ol style="list-style-type: none"> <li>Clean condenser</li> <li>Check cooling fan with fluid coupling operation</li> <li>If (1) and (2) are in normal state, check amount of refrigerant, and charge proper amount of refrigerant</li> </ol> |

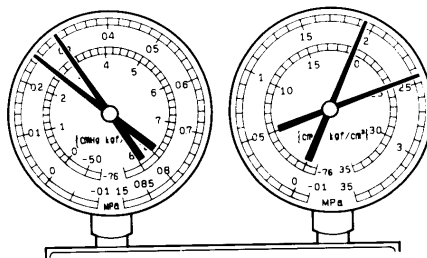
I01392

(7) Air present in refrigeration system.

Condition: Insufficient cooling

NOTE : These gauge indications are shown when the refrigeration system has been opened and the refrigerant charged without vacuum purging.

| Symptom seen in refrigeration system | Probable cause | Diagnosis | Remedy |
|---|---|---|---|
| <ul style="list-style-type: none"> <li>Pressure too high on both low and high pressure sides</li> <li>The low pressure piping hot to touch</li> <li>Bubbles seen in sight glass</li> </ul> | Air entered in refrigeration system | <ul style="list-style-type: none"> <li>Air present in refrigeration system</li> <li>Insufficient vacuum purging</li> </ul> | <ol style="list-style-type: none"> <li>Check compressor oil to see if it is dirty or insufficient</li> <li>Evacuate air and charge new refrigerant</li> </ol> |

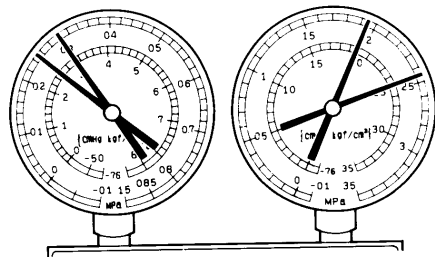
I01450

(8) Expansion valve improperly.

Condition: Insufficient cooling

| Symptom seen in refrigeration system | Probable cause | Diagnosis | Remedy |
|---|---|---|---|
| <ul style="list-style-type: none"><li>• Pressure too high on both low and high pressure sides</li><li>• Frost or large amount of dew on piping on low pressure side</li></ul> | Trouble in expansion valve | <ul style="list-style-type: none"><li>• Excessive refrigerant in low pressure piping</li><li>• Expansion valve opened too wide</li></ul> | Check expansion valve, and replace if defective |

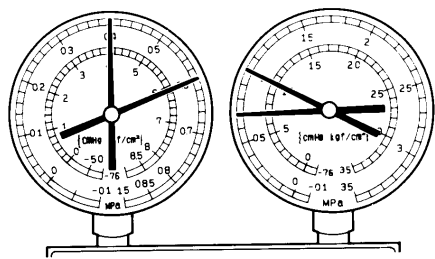
I01393

(9) Defective compression compressor.

Condition : Does not cool

| Symptom seen in refrigeration system | Probable cause | Diagnosis | Remedy |
|---|---|---|---|
| <ul style="list-style-type: none"><li>• Pressure too high on low and high pressure sides</li><li>• Pressure too low on high pressure side</li></ul> | Internal leak in compressor | <ul style="list-style-type: none"><li>• Compression defective</li><li>• Valve leaking or broken sliding parts</li></ul> | Repair or replace compressor |
