| <b>DTC</b> | <b>13</b> | <b>Front Evaporator Temperature Sensor circuit</b> |

## CIRCUIT DESCRIPTION

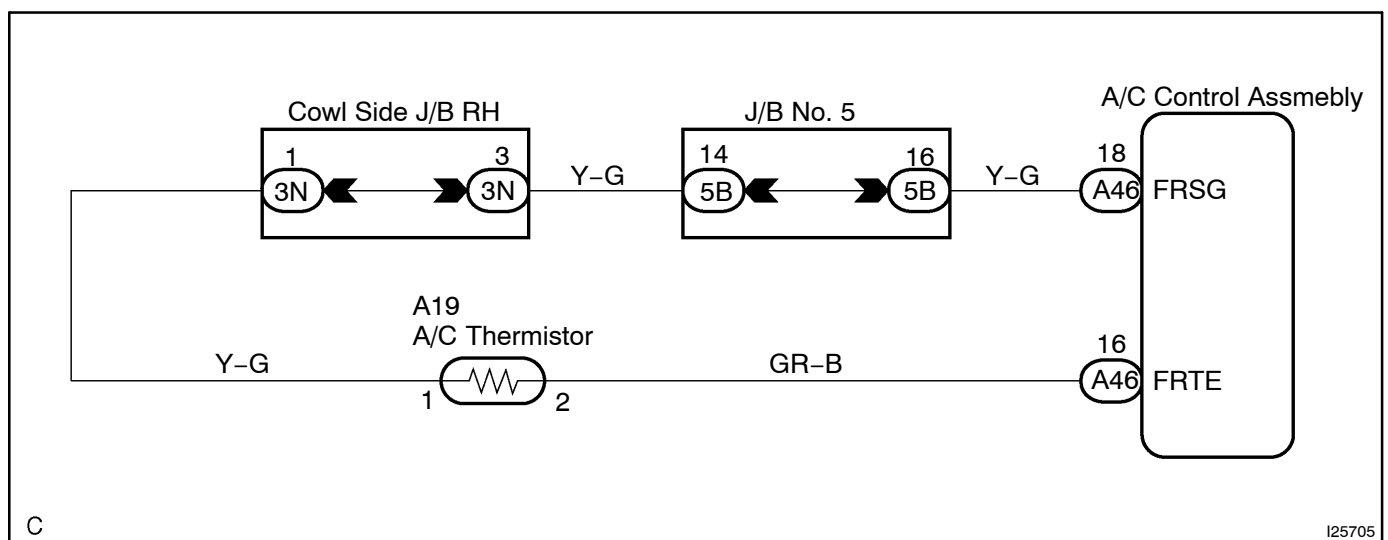
I25705

This sensor detects the temperature inside the cooling unit and sends the appropriate signals to the A/C amplifier.

## WIRING DIAGRAM

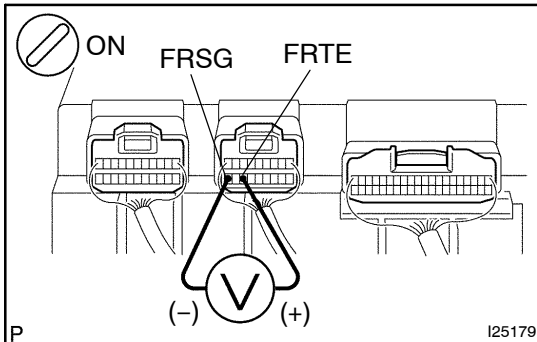
### 1 Check voltage between terminals FRTE and FRSG of A/C amplifier.

Remove A/C amplifier with connectors still connected.

- Turn ignition switch to ON.
- Measure voltage between terminals FRTE and FRSG of A/C amplifier connector at each temperature.

at 0°C (32°F) : 2.0 – 2.4 V

at 15°C (59°F) : 1.4 – 1.8 V

As the temperature increases, the voltage decreases.

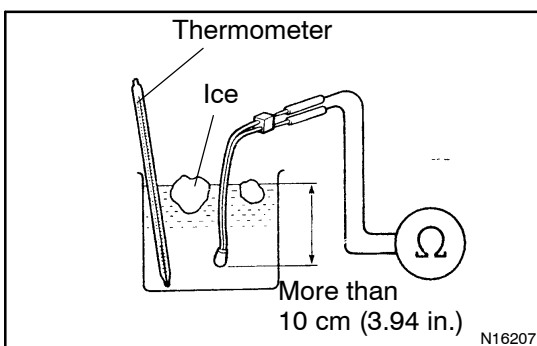
### 2 Check front evaporator temperature sensor.

Remove front evaporator temperature sensor.

Measure resistance between terminals 1 and 2 of evaporator temperature sensor connector at each temperature.

at 0°C (32°F) : 4.5 – 5.2 kΩ

at 15°C (59°F) : 2.0 – 2.7 kΩ

As the temperature increases, the resistance decreases.

**Replace front evaporator temperature sensor.**
