| <b>DTC</b> | <b>B1214</b> | <b>Door system communication bus malfunction (+B short)</b> |

| <b>DTC</b> | <b>B1215</b> | <b>Door system communication bus malfunction (GND short)</b> |

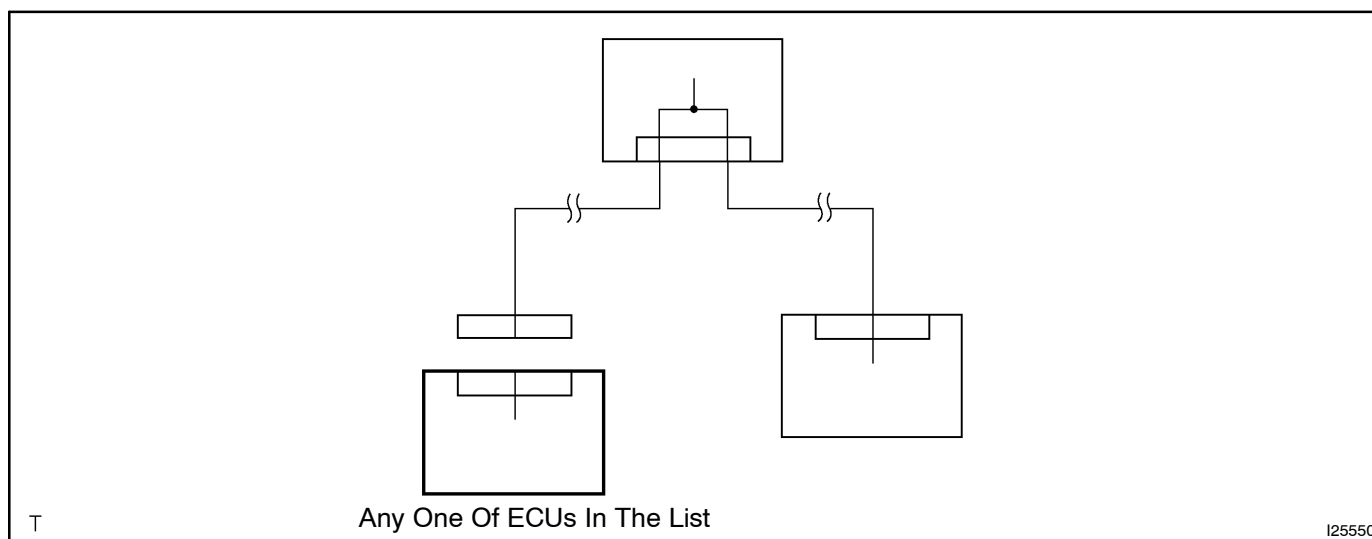
Disconnect the following ECU connectors in order from the top downward.

| Disconnect ECU connector | Connector No. |
| Power window master switch (Driver door ECU) | P12 |
| Power window switch (Front RH door ECU) | P18 |
| Power window switch (Rear LH door ECU) | P19 |
| Power window switch (Rear RH door ECU) | P20 |

Check the DTC every time each connector is disconnect.

DTC B1214 or B1215 is not output.

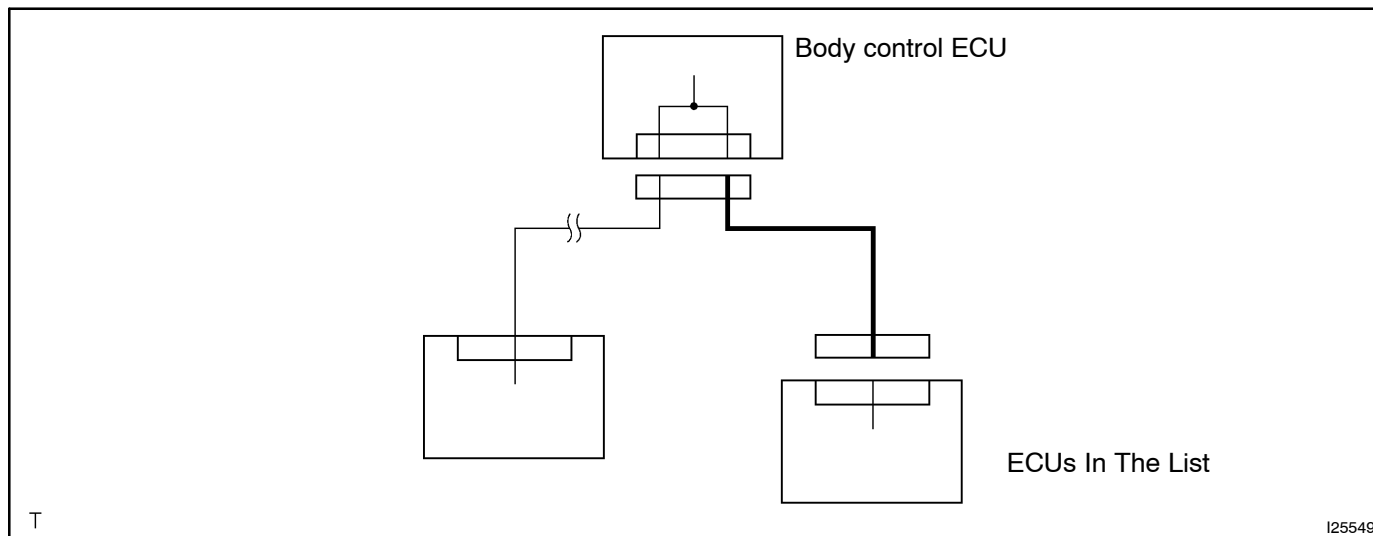
Disconnect the following connectors of ECU.

| Disconnect ECU connector | Connector No. |
| Body ECU<br>Power window master switch (Driver door ECU) | B7<br>P12 |
| Body ECU<br>Power window switch (Front RH door ECU ) | B7<br>P18 |
| Body ECU<br>Power window switch (Rear LH door ECU ) | B8<br>P19 |
| Body ECU<br>Power window switch (Rear RH door ECU ) | B8<br>P20 |

Check whether or not there is +B short and GND short between the above connectors.

**No +B short and GND short.**
