| <b>DTC</b> | <b>B1185/57</b> | <b>Short in P Squib (2nd step) Circuit</b> |

## CIRCUIT DESCRIPTION

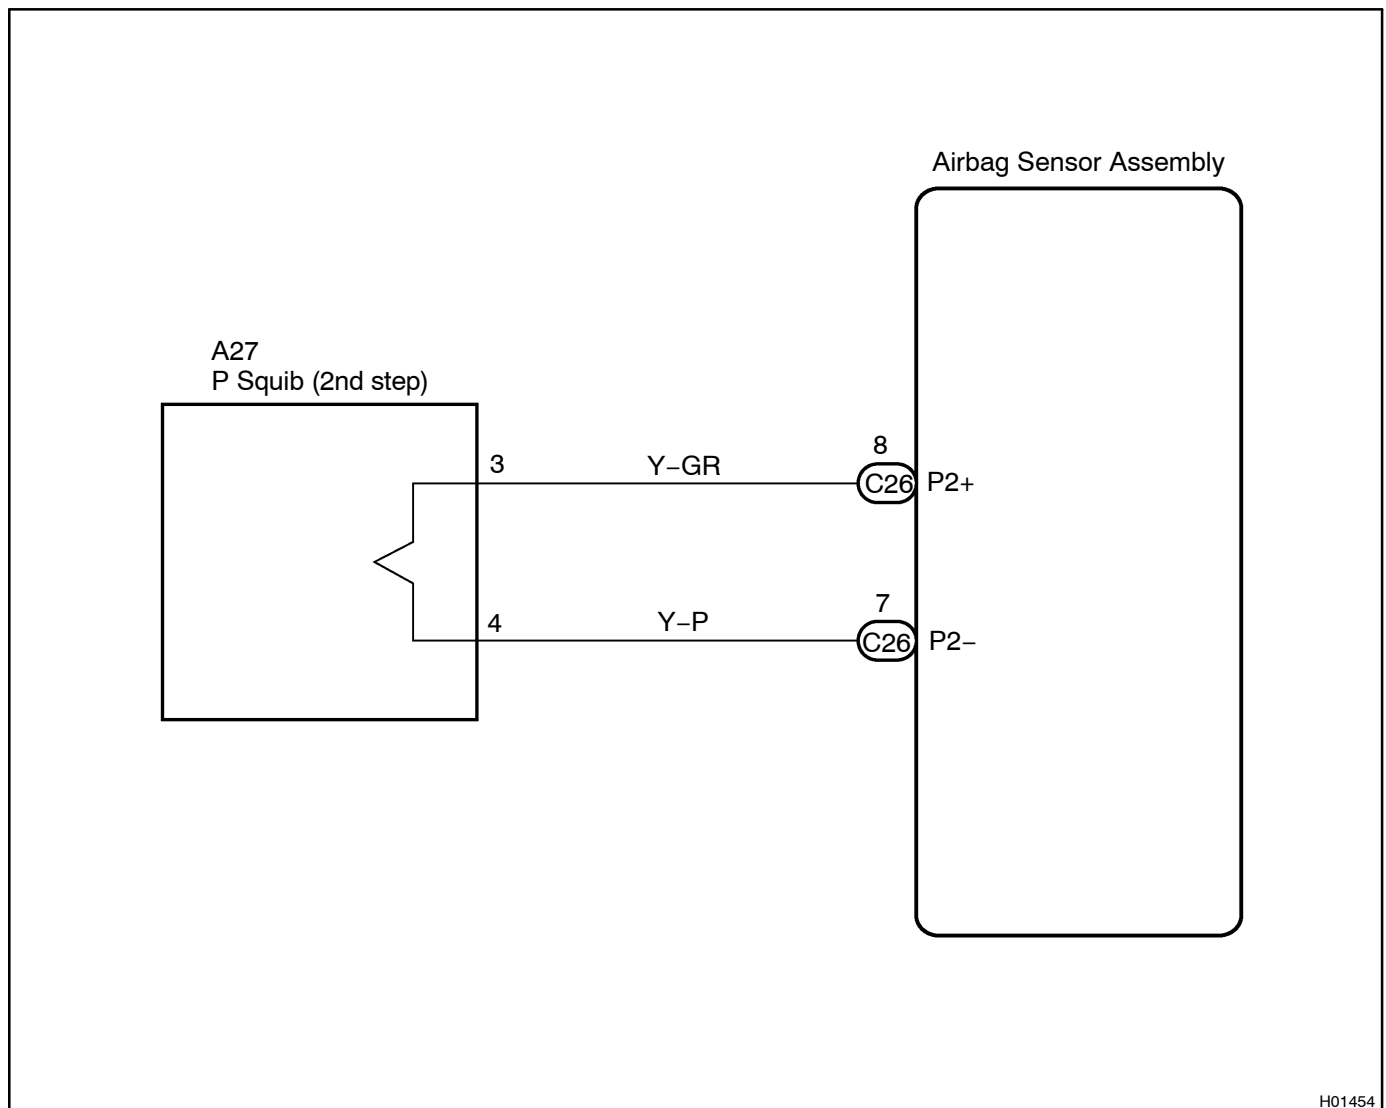
H01454

The P squib (2nd step) circuit consists of the airbag sensor assembly and the front passenger airbag assembly. It causes the SRS to deploy when the SRS deployment conditions are satisfied.

## WIRING DIAGRAM

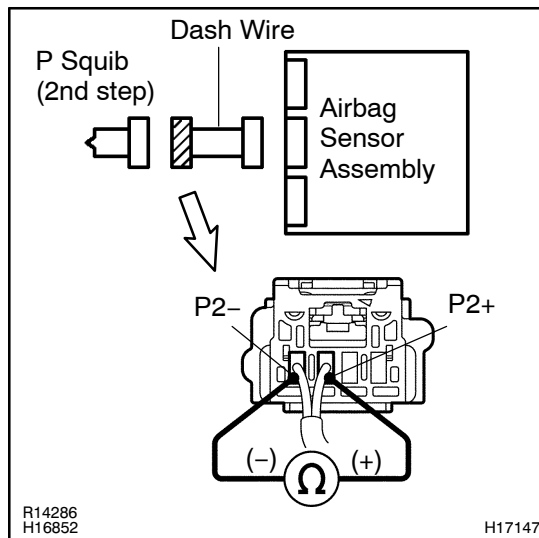
**2** Check dash wire (P squib (2nd step) circuit).

Release the airbag activation prevention mechanism built in the connector of the dash wire on the airbag sensor assembly side (See page [DI-699](#)).

Measure the resistance between P2+ and P2- of the dash wire connector on the front passenger airbag assembly (P squib (2nd step)) side.

**Resistance: 1 MΩ or Higher**

**Replace dash wire.**

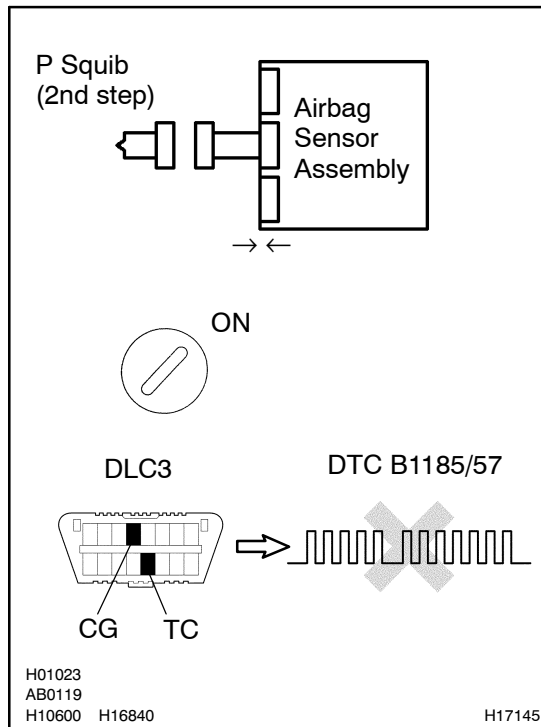
### 3 Check airbag sensor assembly.

- Connect the connector to the airbag sensor assembly.
- Connect the negative (-) terminal cable to the battery, and wait at least for 2 seconds.

- Turn the ignition switch to ON, and wait at least for 10 seconds.
- Clear the DTC stored in memory (See page [DI-699](#)).
- Turn the ignition switch to LOCK, and wait at least for 10 seconds.
- Turn the ignition switch to ON, and wait at least for 10 seconds.
- Check the DTC (See page [DI-699](#)).

**DTC B1185/57 is not output.**

**Replace airbag sensor assembly.**

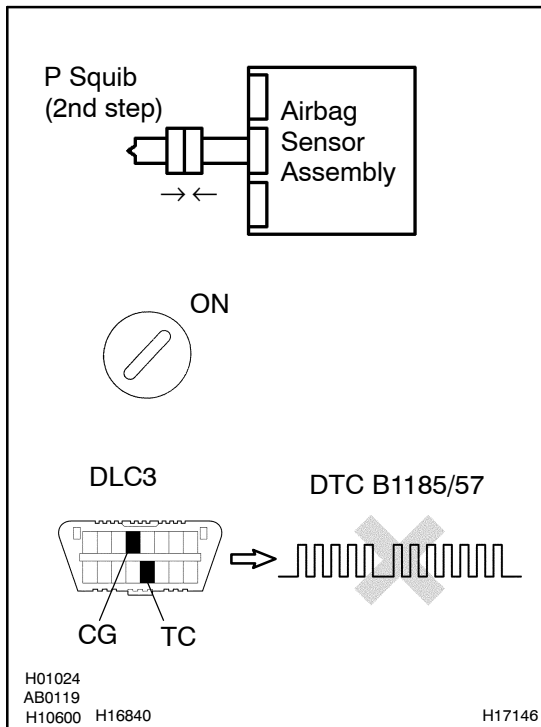
#### 4 Check P squib (2nd step).

- Turn the ignition switch to LOCK.
- Disconnect the negative (-) terminal cable from the battery, and wait at least for 90 seconds.
- Connect the front passenger airbag assembly (P squib (2nd step)) connector.
- Connect the negative (-) terminal cable to the battery, and wait at least for 2 seconds.

- Turn the ignition switch to ON, and wait at least for 10 seconds.
- Clear the DTC stored in memory (See page [DI-699](#)).
- Turn the ignition switch to LOCK, and wait at least for 10 seconds.
- Turn the ignition switch to ON, and wait at least for 10 seconds.
- Check the DTC (See page [DI-699](#)).

**DTC B1185/57 is not output.**

**Replace front passenger airbag assembly (P squib (2nd step)).**
