| <b>DTC</b> | <b>B1188/56</b> | <b>Short in P Squib (2nd step) Circuit (to B+)</b> |

## CIRCUIT DESCRIPTION

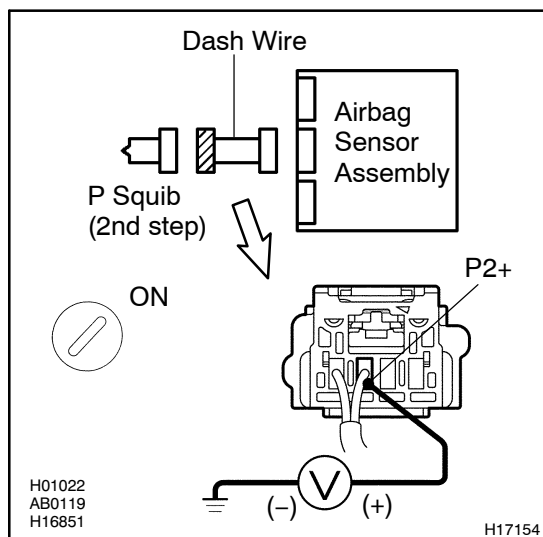
| <b>2</b> | <b>Check dash wire (P squib (2nd step) circuit).</b> |

### PREPARATION:

Connect the negative (-) terminal cable to the battery, and wait at least for 2 seconds.

### CHECK:

- Turn the ignition switch to ON.
- Measure the voltage between the body ground and P2+ of the dash wire connector on the front passenger airbag assembly (P squib (2nd step)) side.

### OK:

**Voltage: Below 1 V**

**NG**

**Replace dash wire.**

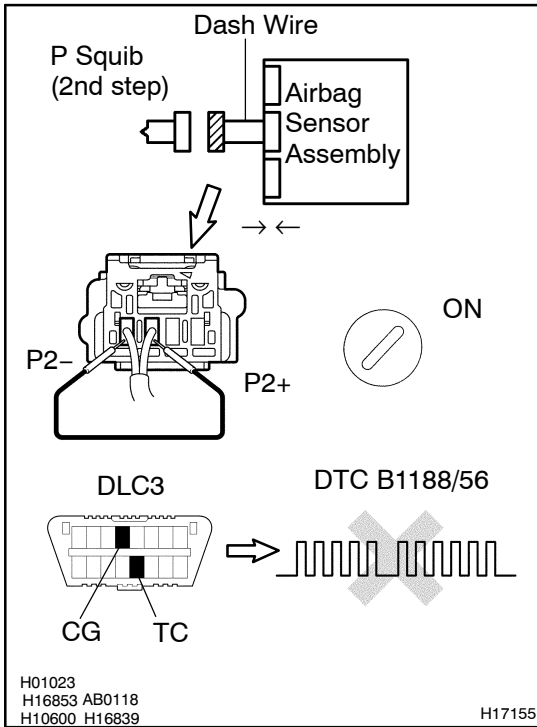
### 3 Check airbag sensor assembly.

#### PREPARATION:

- Connect the connector to the airbag sensor assembly.
- Using a service wire, connect P2+ and P2- of the dash wire connector on the front passenger airbag assembly (P squib (2nd step)) side.
- Connect the negative (-) terminal cable to the battery, and wait at least for 2 seconds.

#### CHECK:

- Turn the ignition switch to ON, and wait at least for 10 seconds.
- Clear the DTC stored in memory (See page [DI-699](#)).
- Turn the ignition switch to LOCK, and wait at least for 10 seconds.
- Turn the ignition switch to ON, and wait at least for 10 seconds.
- Check the DTC (See page [DI-699](#)).

#### OK:

**DTC B1188/56 is not output.**

**NG**

**Replace airbag sensor assembly.**

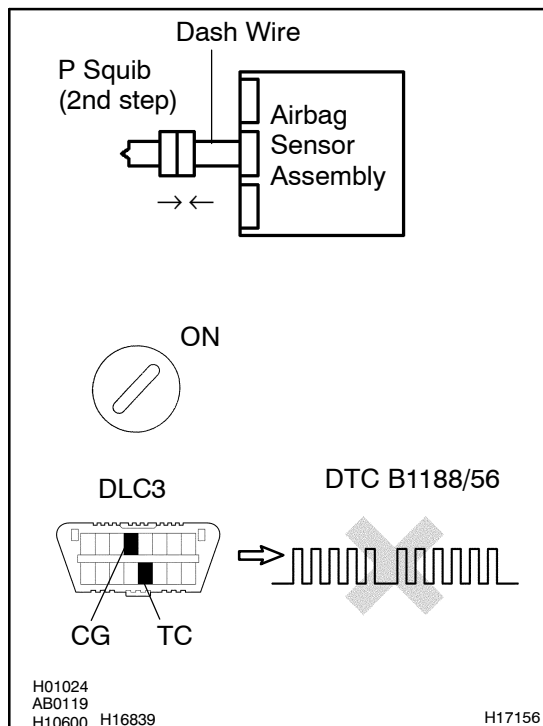
#### 4 Check P squib (2nd step).

#### PREPARATION:

- Turn the ignition switch to LOCK.
- Disconnect the negative (-) terminal cable from the battery, and wait at least for 90 seconds.
- Connect the front passenger airbag assembly (P squib (2nd step)) to the dash wire.
- Connect the negative (-) terminal cable to the battery, and wait at least for 2 seconds.

#### CHECK:

- Turn the ignition switch to ON, and wait at least for 10 seconds.
- Clear the DTC stored in memory (See page [DI-699](#)).
- Turn the ignition switch to LOCK, and wait at least for 10 seconds.
- Turn the ignition switch to ON, and wait at least for 10 seconds.
- Check the DTC (See page [DI-699](#)).

#### OK:

**DTC B1188/56 is not output.**

**NG**

**Replace front passenger airbag assembly (P squib (2nd step)).**
