## INSPECTION

### 1. VEHICLES NOT INVOLVED IN A COLLISION

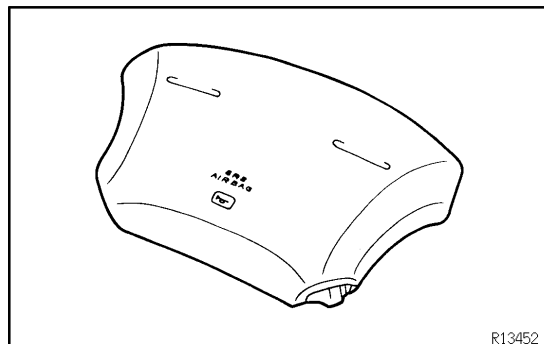
Check for cuts, minute cracks or marked discoloration of the steering wheel pad top surface and grooved portion.

- (a) Do a diagnostic system check (See page [DI-240](#)).
- (b) With the steering wheel pad (with airbag) installed in the vehicle, do a visual check with includes the following items.

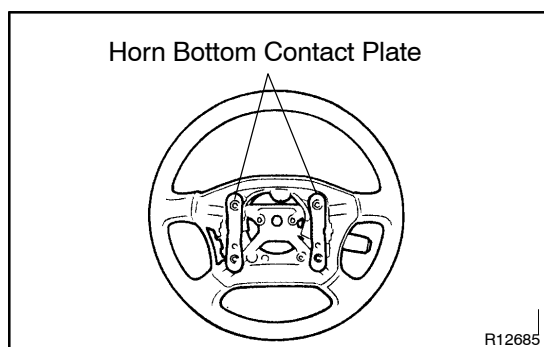
- Check for cuts and cracks in, or marked discoloration of, the steering wheel pad top surface and its grooved portion.
- Check for cuts and cracks in wire harnesses, and for chipping in connectors.
- Check for deformation of the horn button contact plate of the steering wheel.

With the steering wheel pad removed from the vehicle, do a visual check with includes the following items.

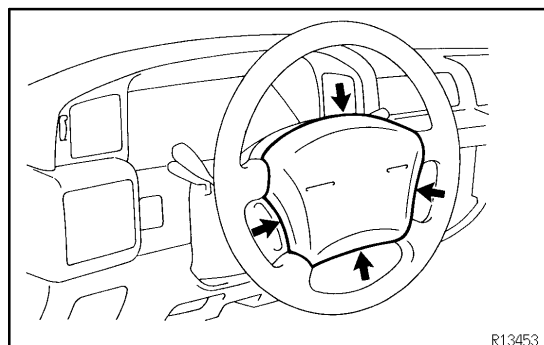
- If the horn button contact plate of the steering wheel is deformed, never repair it. Always replace the steering wheel assembly with a new one.

- There should be no interference between the steering wheel pad and the steering wheel, and the clearance should be uniform all the way around when the new steering wheel pad is installed on the steering wheel.
