| <b>Instrument Panel J/B Assembly<br/>(Before Aug. 2017 Production)</b> | <b>LHD : Cowl Side Panel LH</b> |

## F RELAY LOCATIONS

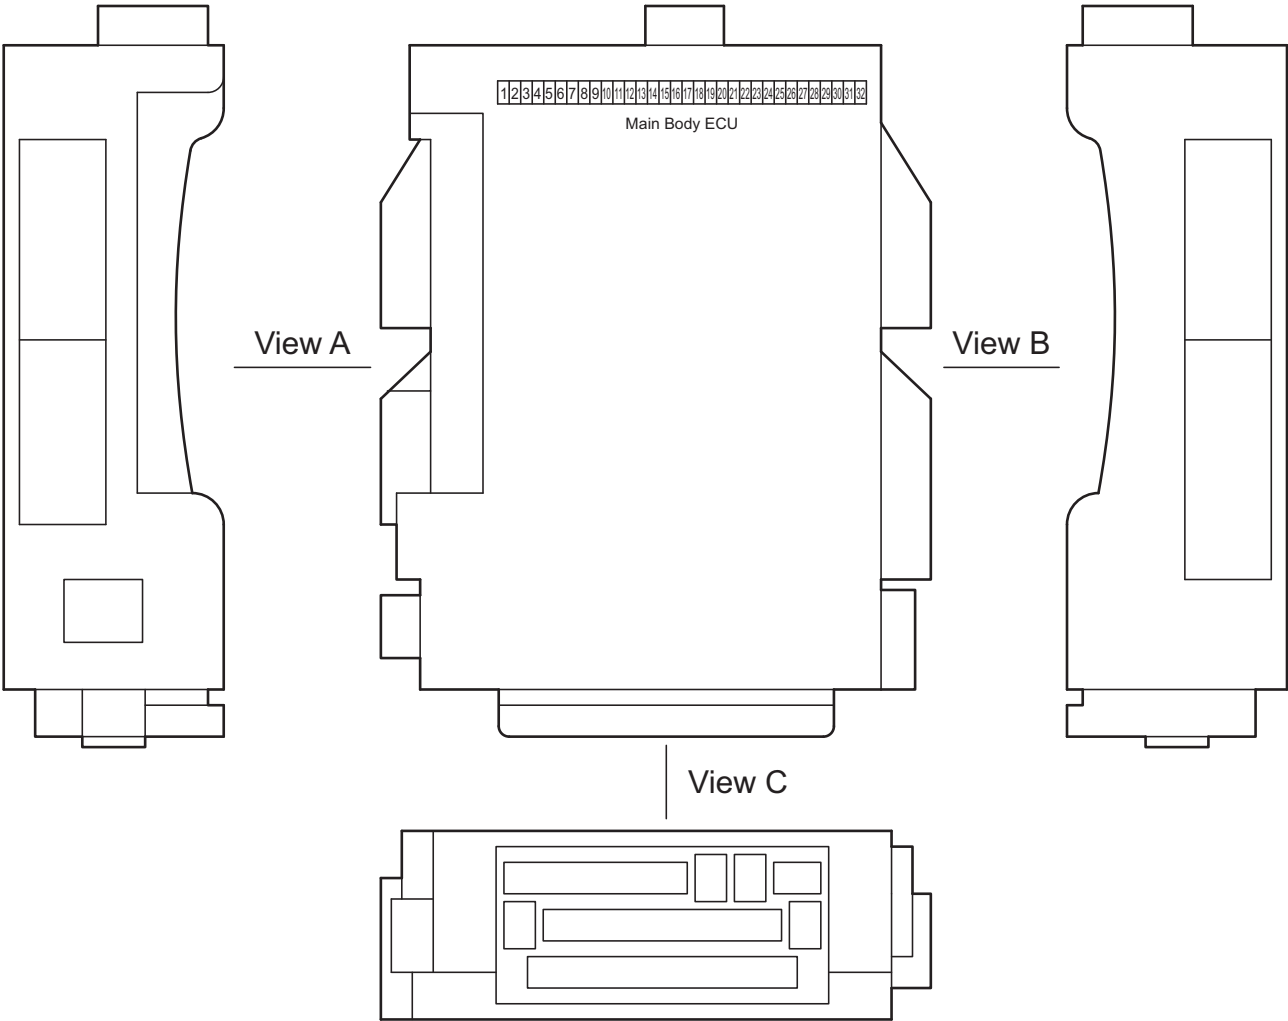
| | <b>RHD : Cowl Side Panel RH</b> |

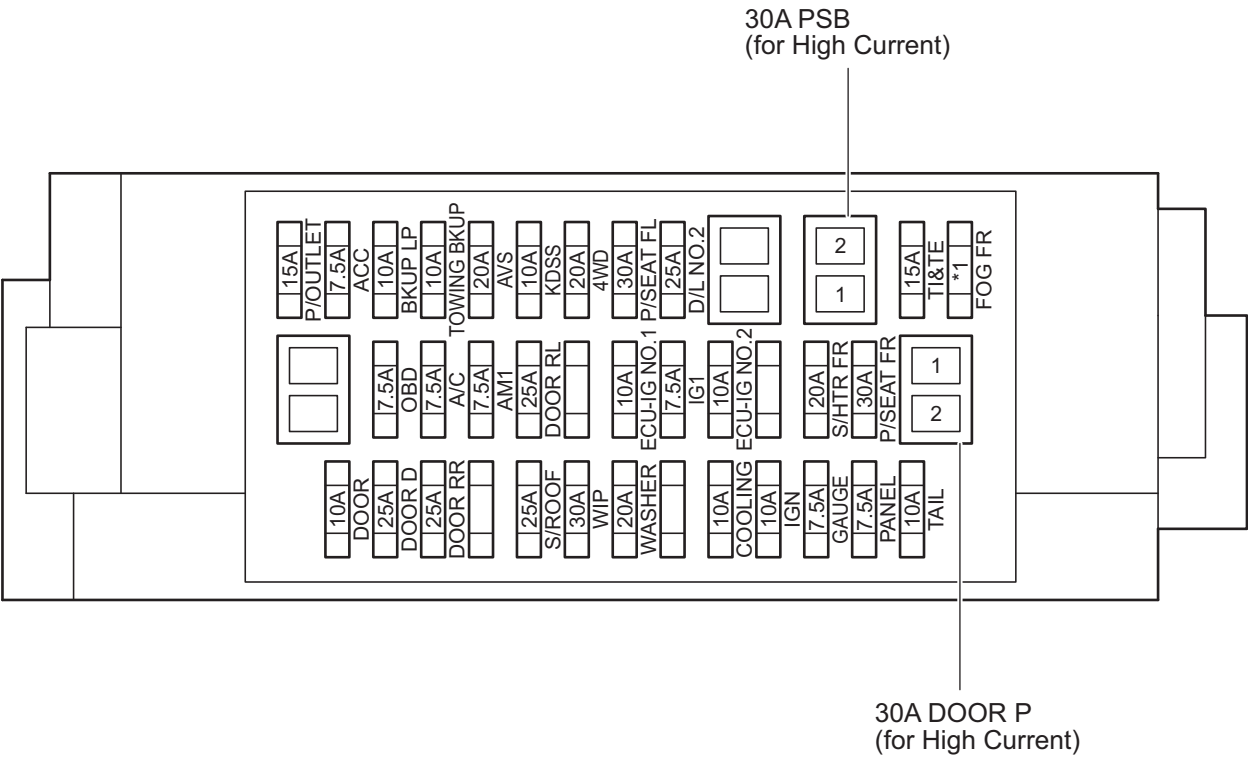
View C

\* 1:15A (Before Aug. 2013 Production)  
10A (From Aug. 2013 Production)

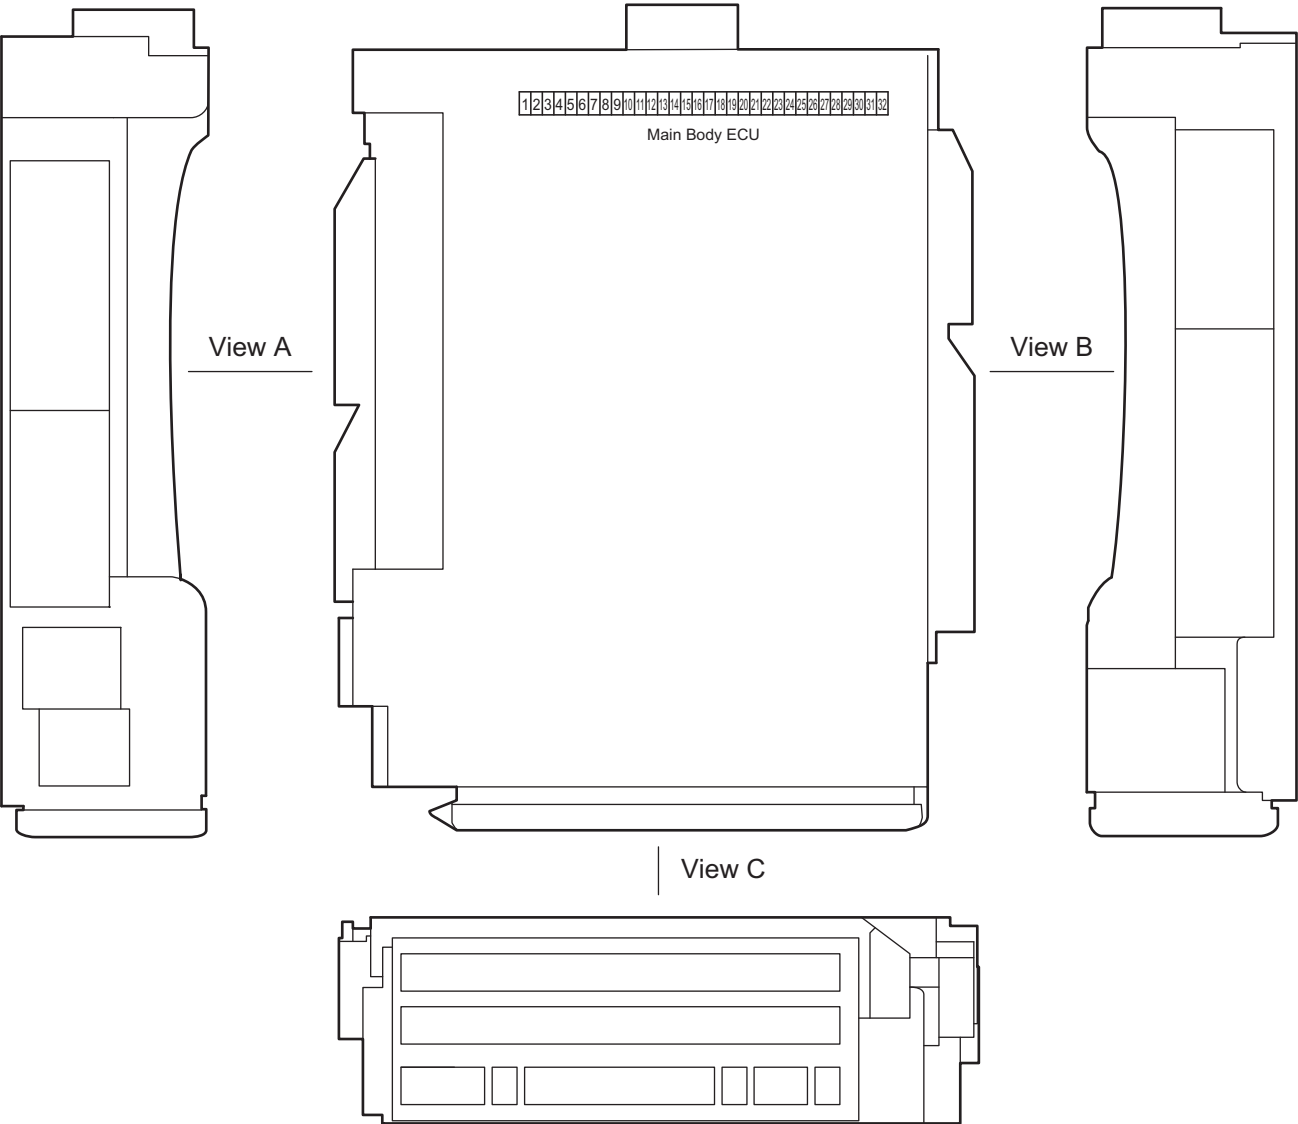
| Instrument Panel J/B Assembly<br>(From Aug. 2017 Production) | LHD : Cowl Side Panel LH |
| | RHD : Cowl Side Panel RH |

(Except 5L-E)

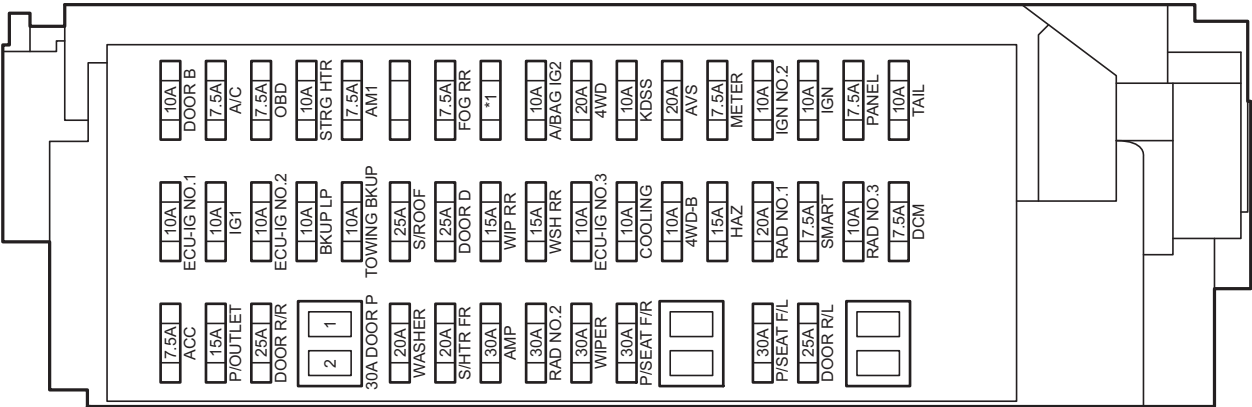
## View C

\*1: 10A S&S IG2(w/ Door Control Battery)

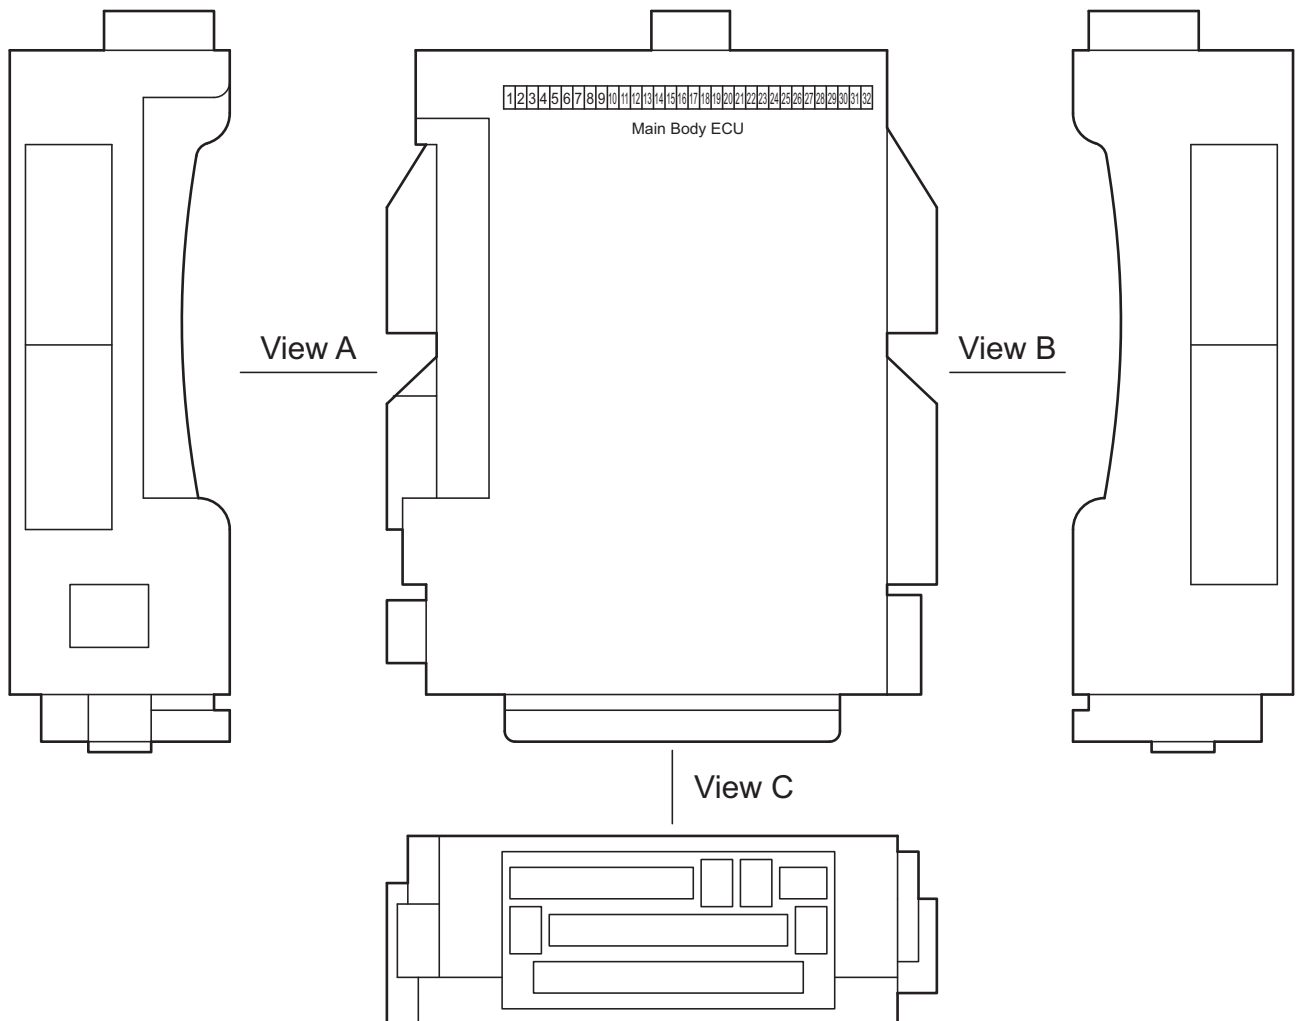
| <b>Instrument Panel J/B Assembly</b><br><b>(From Aug. 2017 Production)</b> | <b>LHD : Cowl Side Panel LH</b> |
| | <b>RHD : Cowl Side Panel RH</b> |

(5L-E)

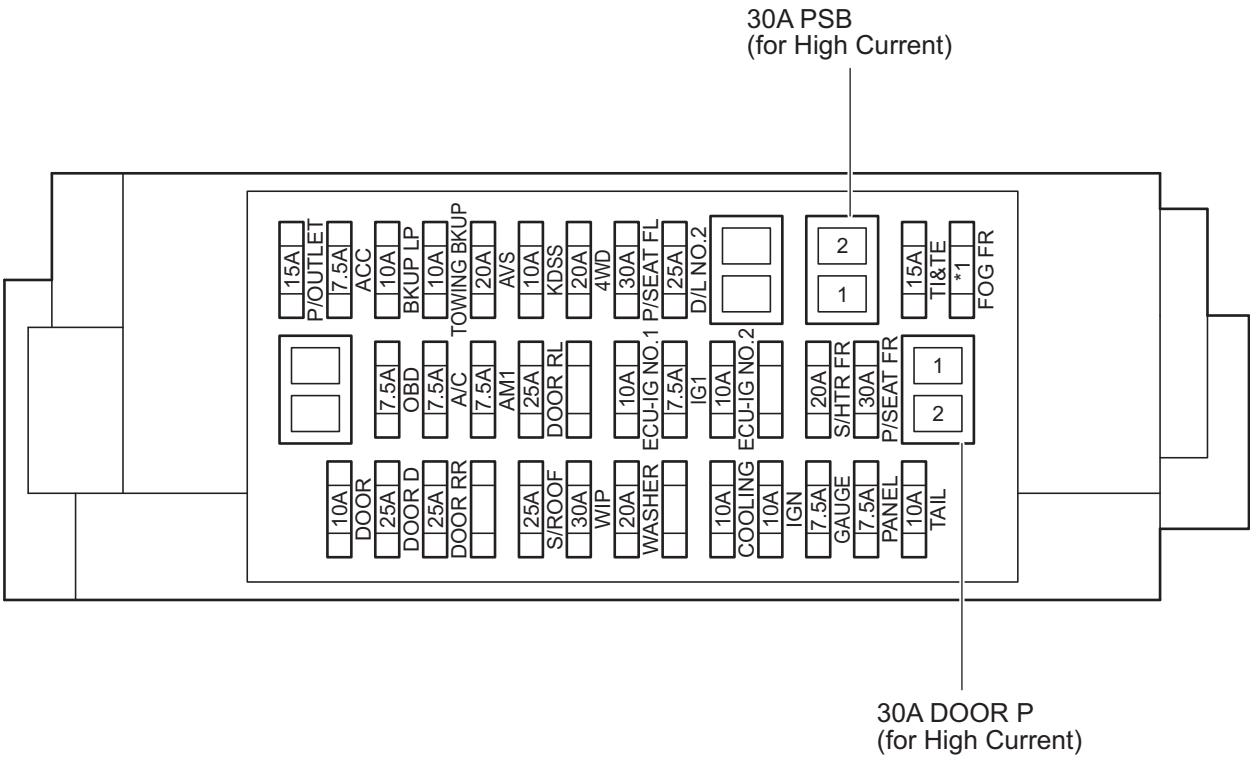
View C

\* 1:15A (Before Aug. 2013 Production)  
10A (From Aug. 2013 Production)
