Position of Parts in Instrument Panel (LHD Front Bench Seat) (Before Aug. 2017 Production)

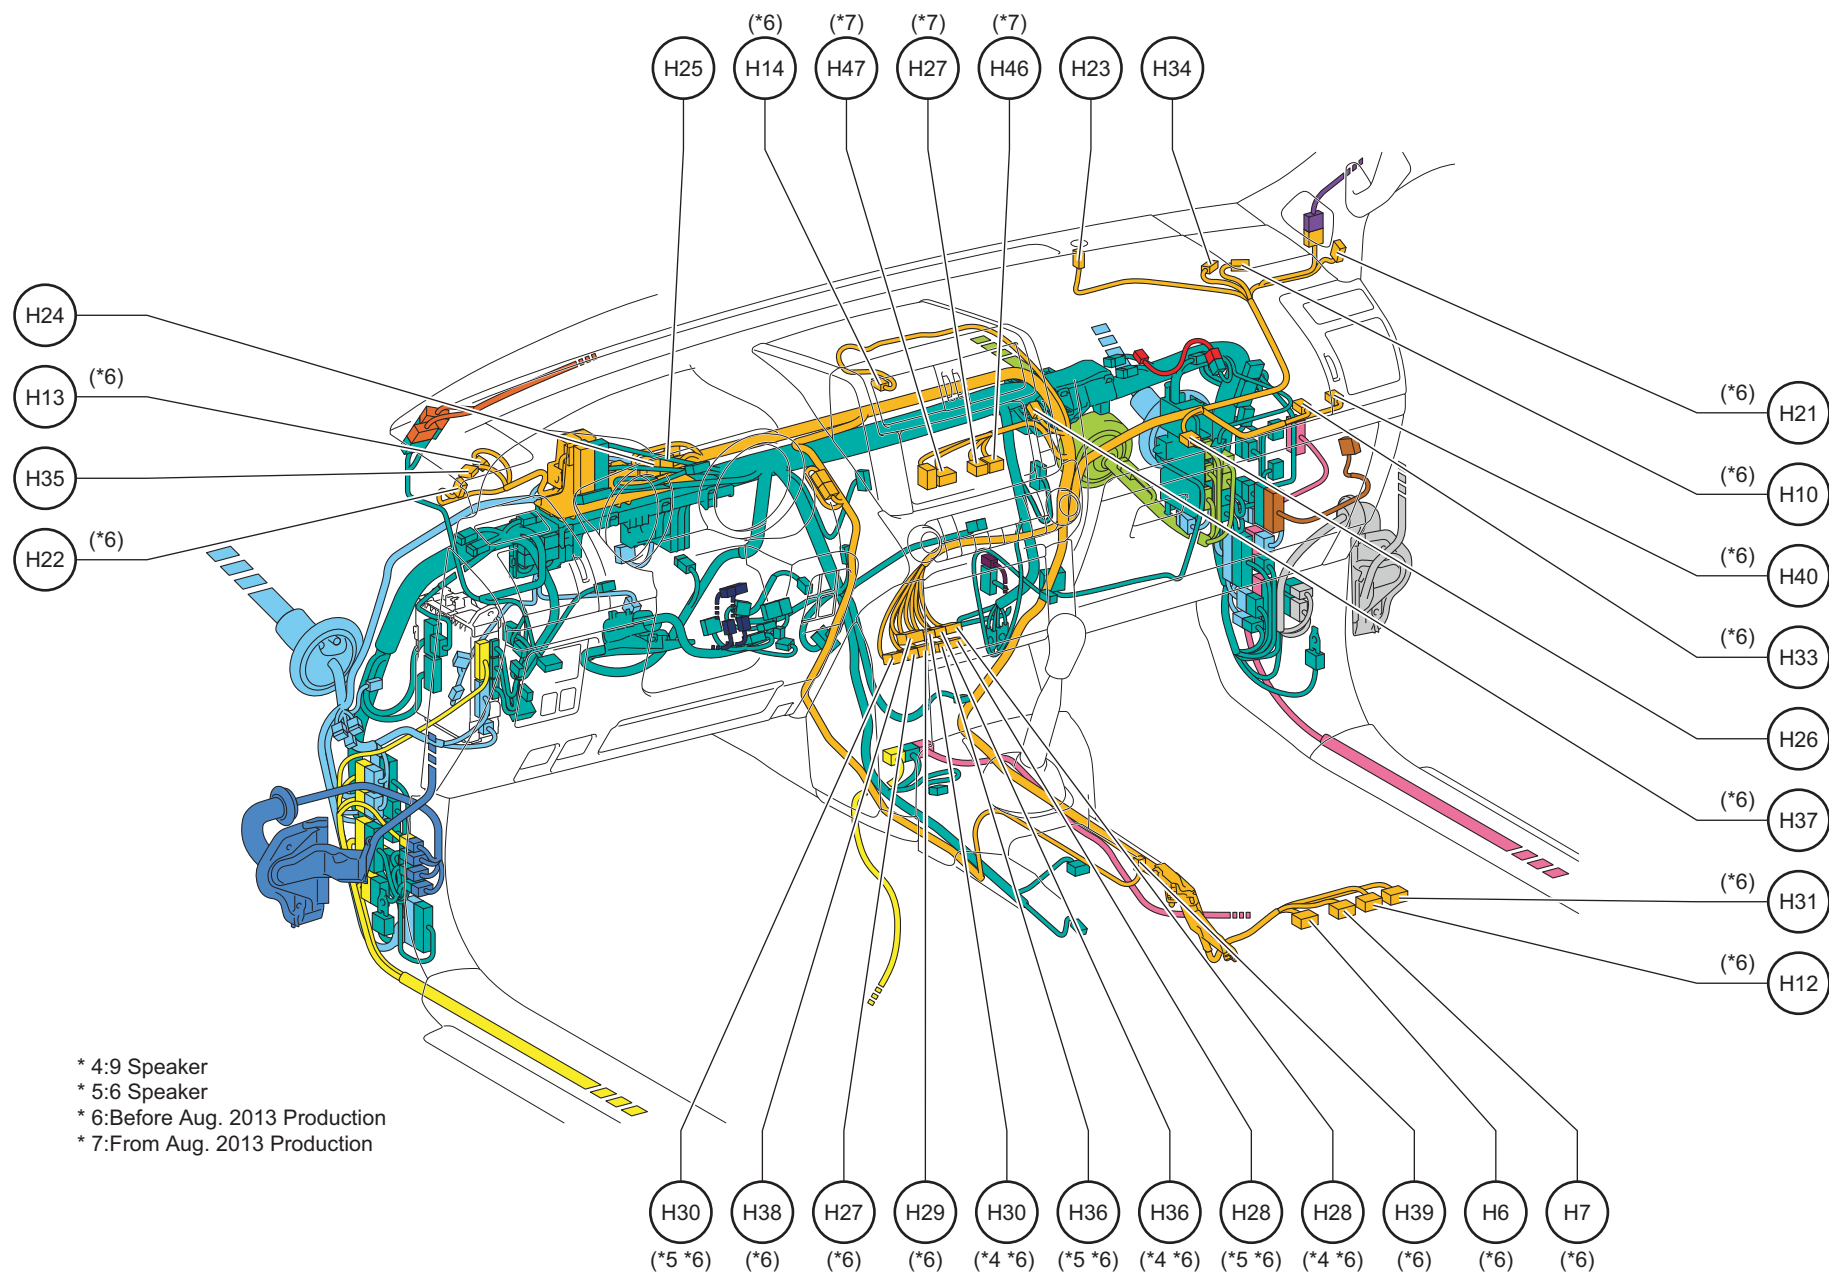
| H 6 | Stereo Component Amplifier Assembly |
| H 7 | Stereo Component Amplifier Assembly |
| H 10 | Front No. 1 Speaker Assembly RH |
| H 12 | Stereo Component Amplifier Assembly |
| H 13 | Front No. 1 Speaker Assembly LH |
| H 14 | Front No. 4 Speaker Assembly |
| H 21 | Front No. 3 Speaker Assembly RH |
| H 22 | Front No. 3 Speaker Assembly LH |
| H 23 | Theft Warning Indicator Light Assembly |
| H 24 | Junction Connector |
| H 25 | Junction Connector |
| H 26 | Junction Connector |
| H 27 | Radio Receiver Assembly |
| H 28 | Radio Receiver Assembly |
| H 29 | Radio Receiver Assembly |
| H 30 | Radio Receiver Assembly |
| H 31 | Stereo Component Amplifier Assembly |
| H 33 | Multi-Media Interface ECU |
| H 34 | Front No. 2 Speaker Assembly RH |
| H 35 | Front No. 2 Speaker Assembly LH |
| H 36 | Radio Receiver Assembly |
| H 37 | Amplifier Antenna Assembly |
| H 38 | Radio Receiver Assembly |
| H 39 | No. 1 Stereo Jack Adapter Assembly |
| H 40 | Multi-Media Interface ECU |
| H 46 | Radio Receiver Assembly |
| H 47 | Radio Receiver Assembly |

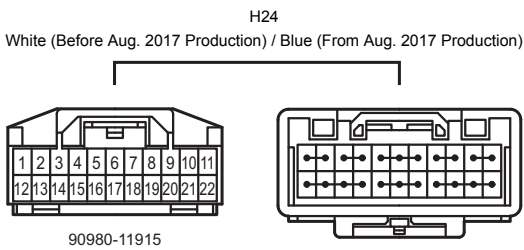
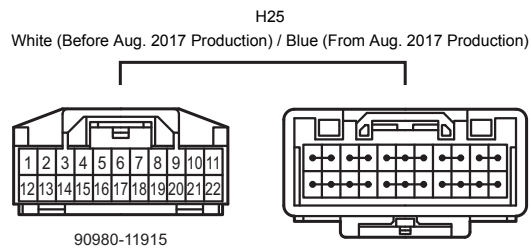
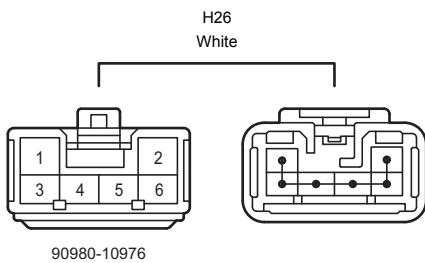
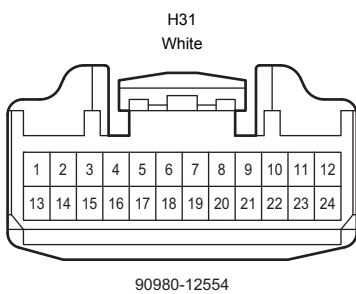
**Position of Parts in Instrument Panel (LHD Front Bench Seat) (Before Aug. 2017 Production)**

H35  
White

90980-12304

H36  
White

90980-12552

H37  
White

90980-10871

H38  
White

90980-12038

H39  
Black

90980-12849

H40  
Brown

90980-12850

H46  
White

90980-10997

H47  
White

90980-12555
