E117(A), E118(B), E137(C)  
Main Body ECU

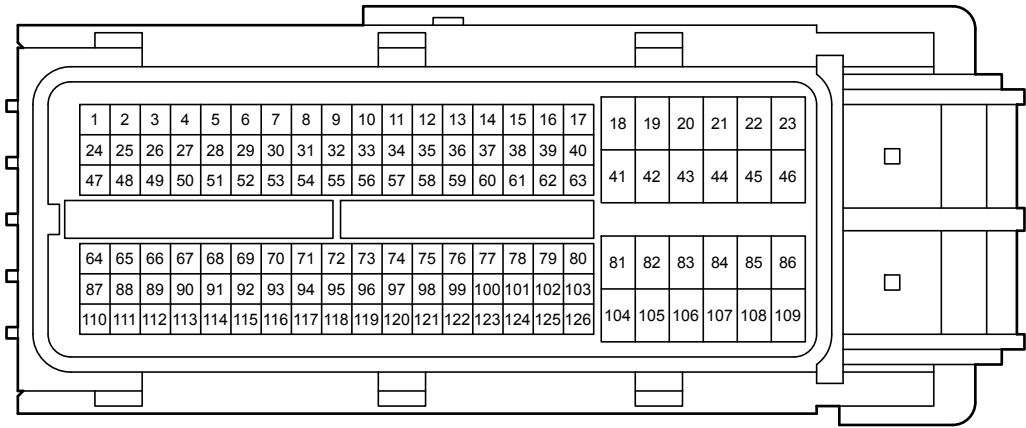
C 46  
Black

Remote Control Mirror <w/ Retractor , From Aug. 2015 Production>
