## F RELAY LOCATIONS

: Cowl Side J/B RH Assembly

LAND CRUISER (EM2664E)

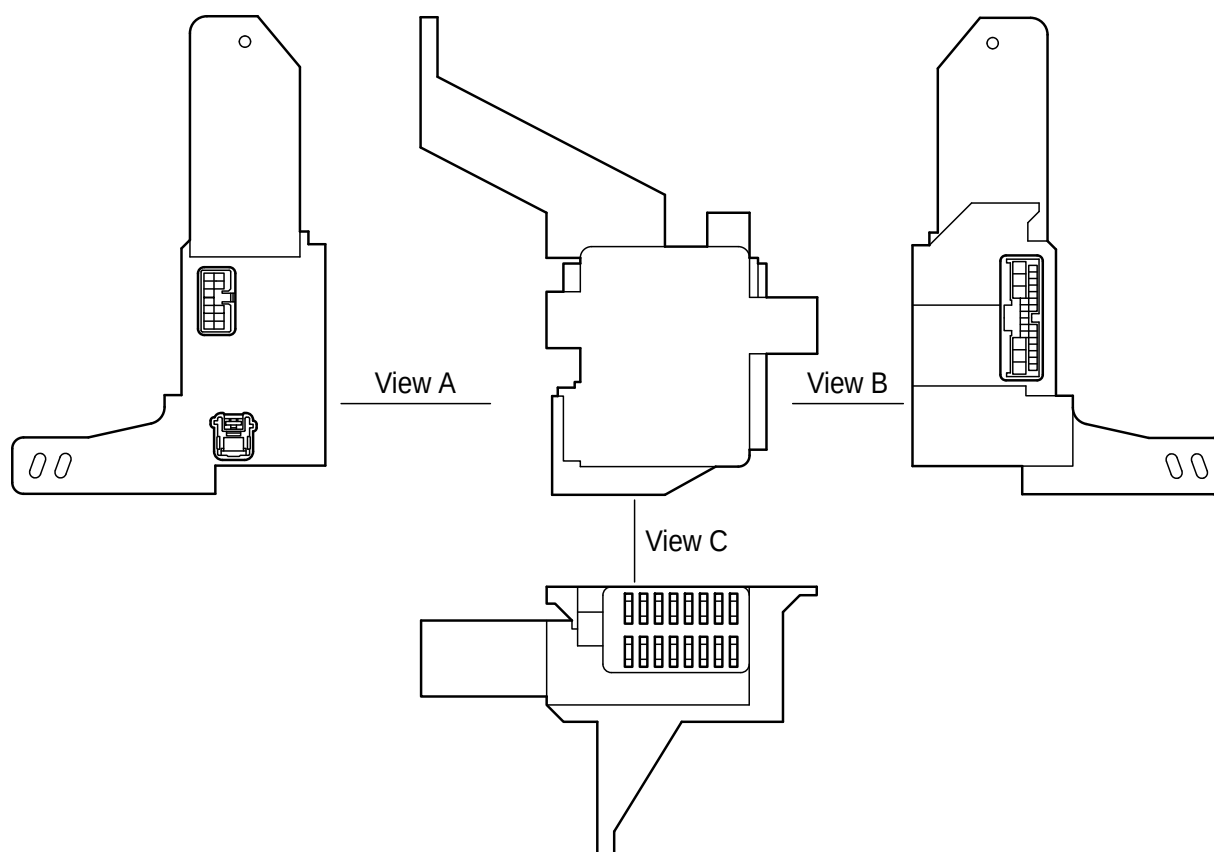
Cowl Side Right

(LHD Before Aug. 2015 Production)

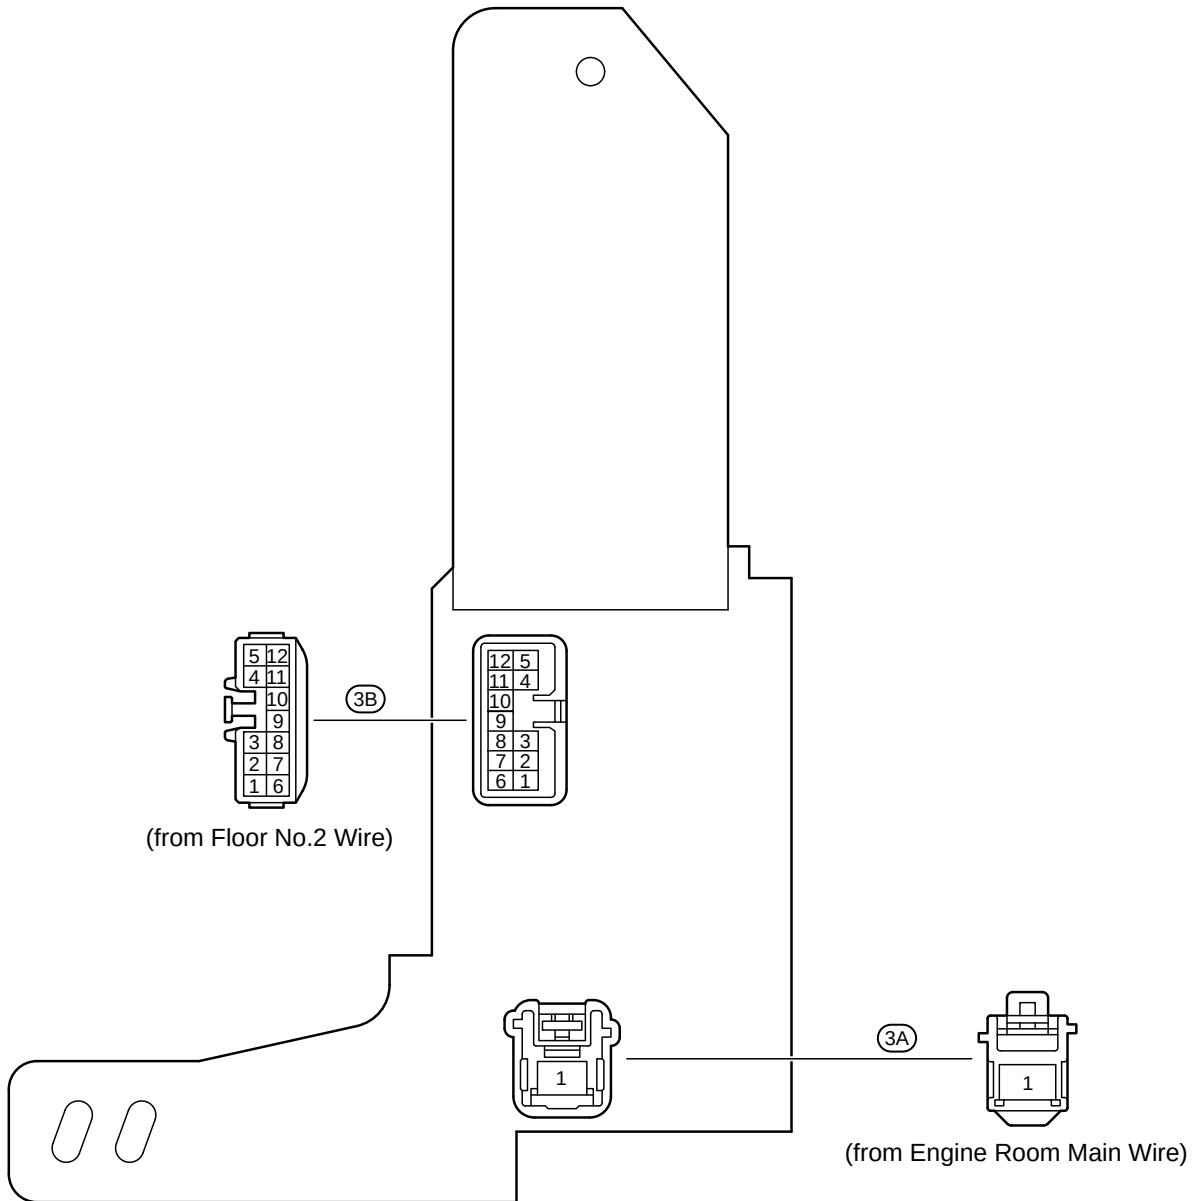
View A

: Cowl Side J/B RH Assembly

**Cowl Side Right**

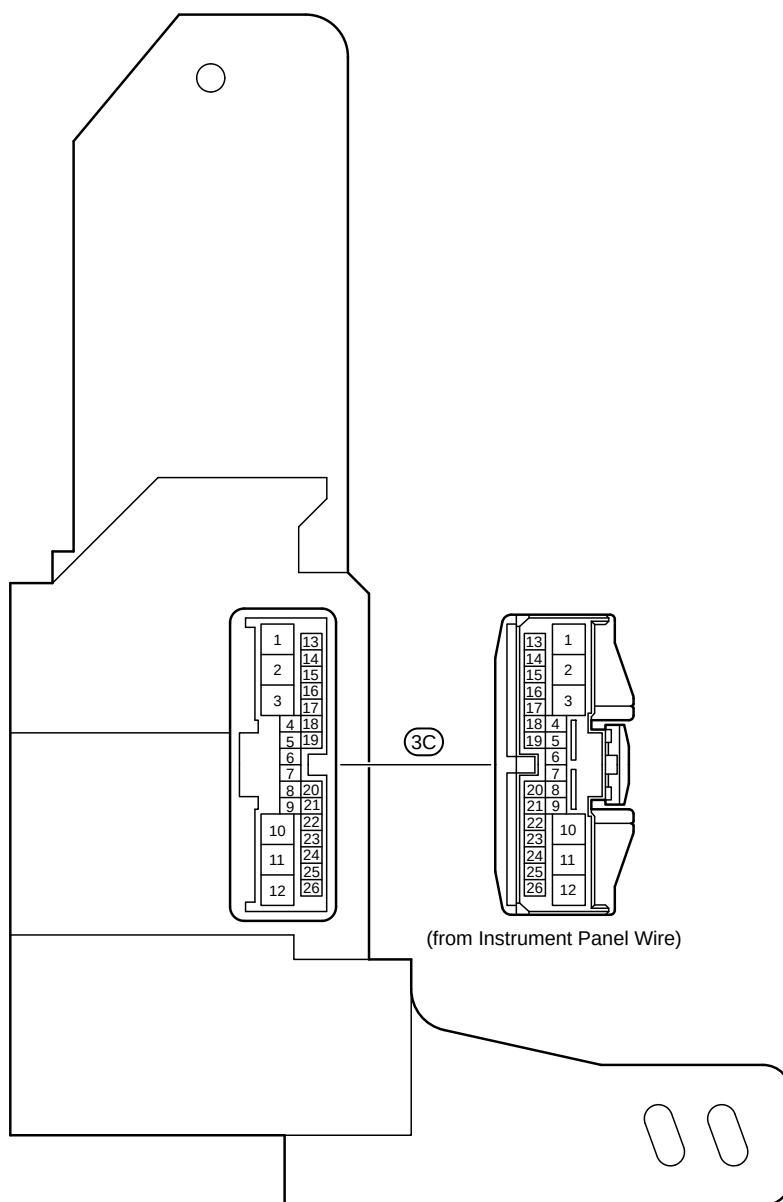
View B

: Cowl Side J/B RH Assembly **Cowl Side Right**  
(LHD Before Aug. 2015 Production)

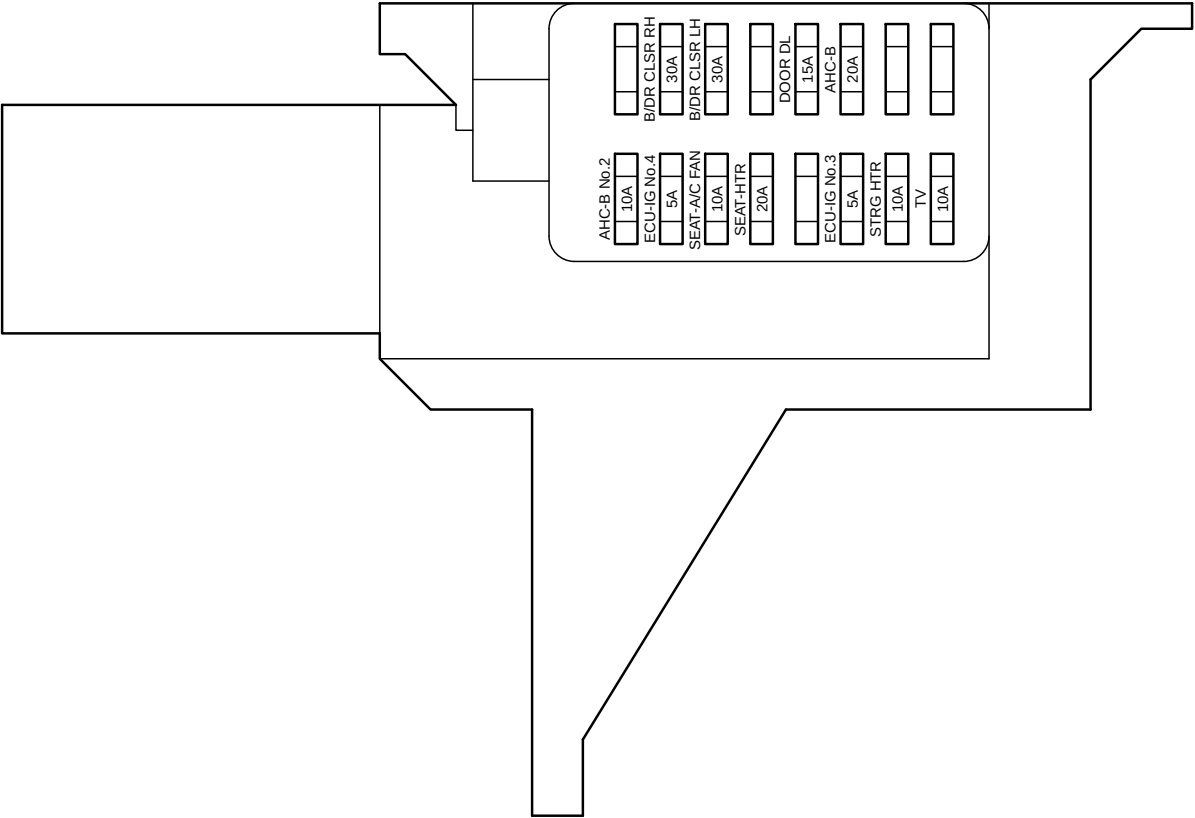
View C

: Cowl Side J/B RH Assembly

Cowl Side Right

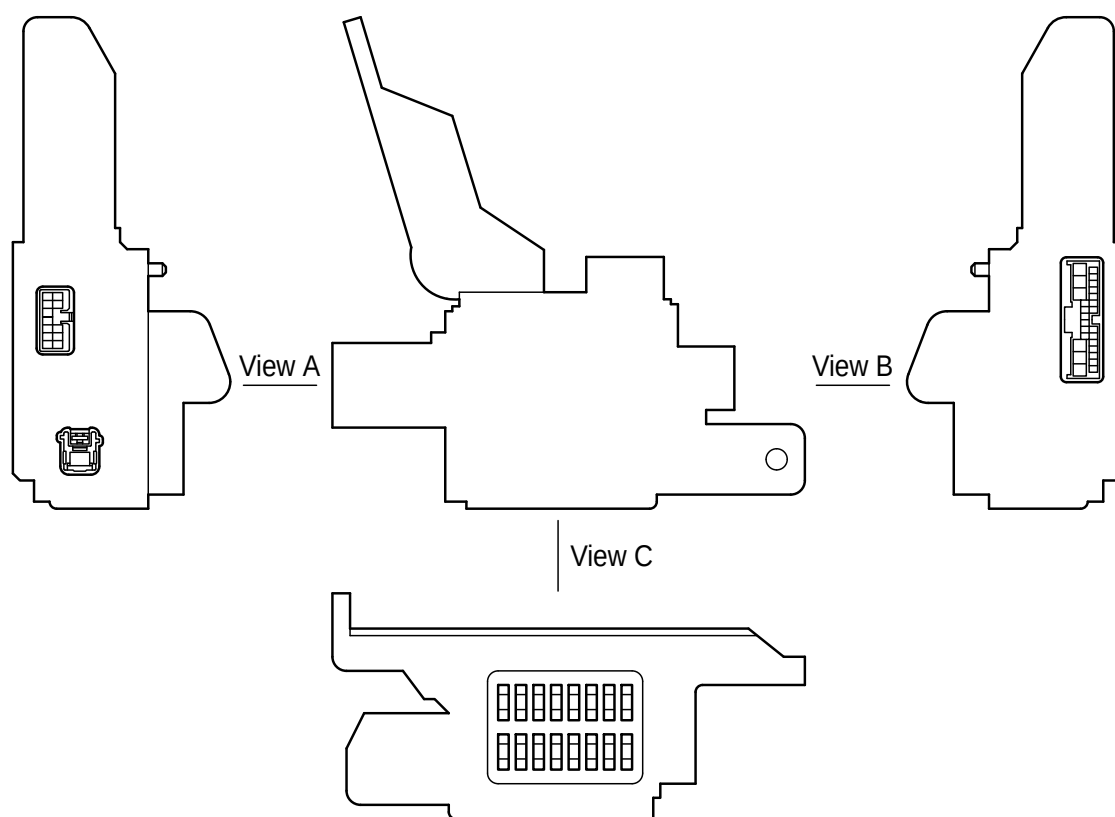
| : Cowl Side J/B RH Assembly | Cowl Side Right |

(RHD Before Aug. 2015 Production)

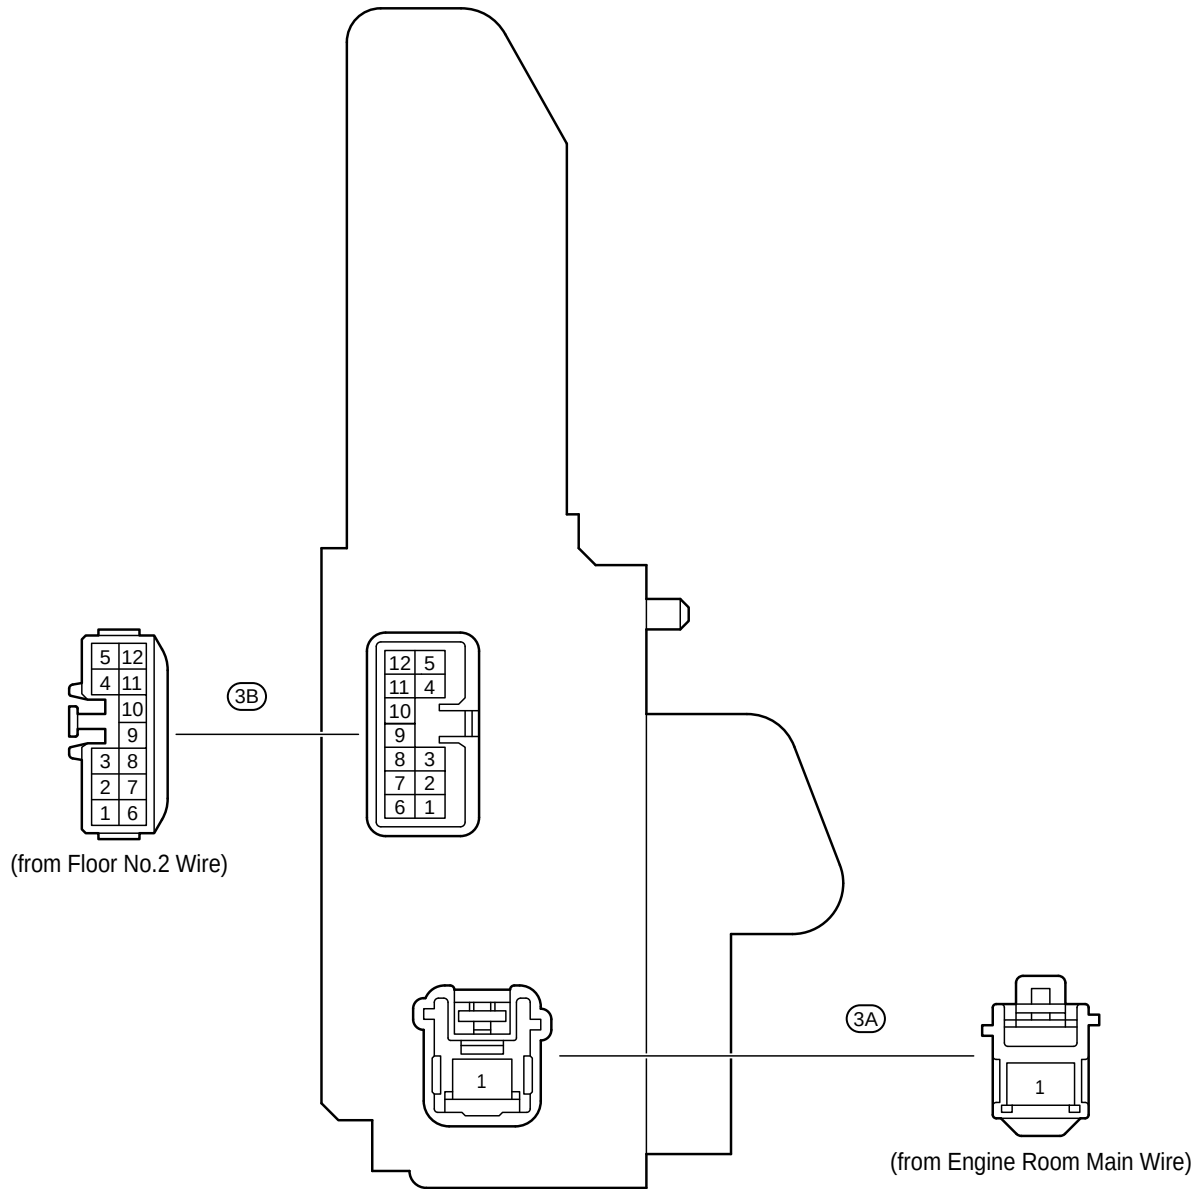
View A

: Cowl Side J/B RH Assembly **Cowl Side Right**

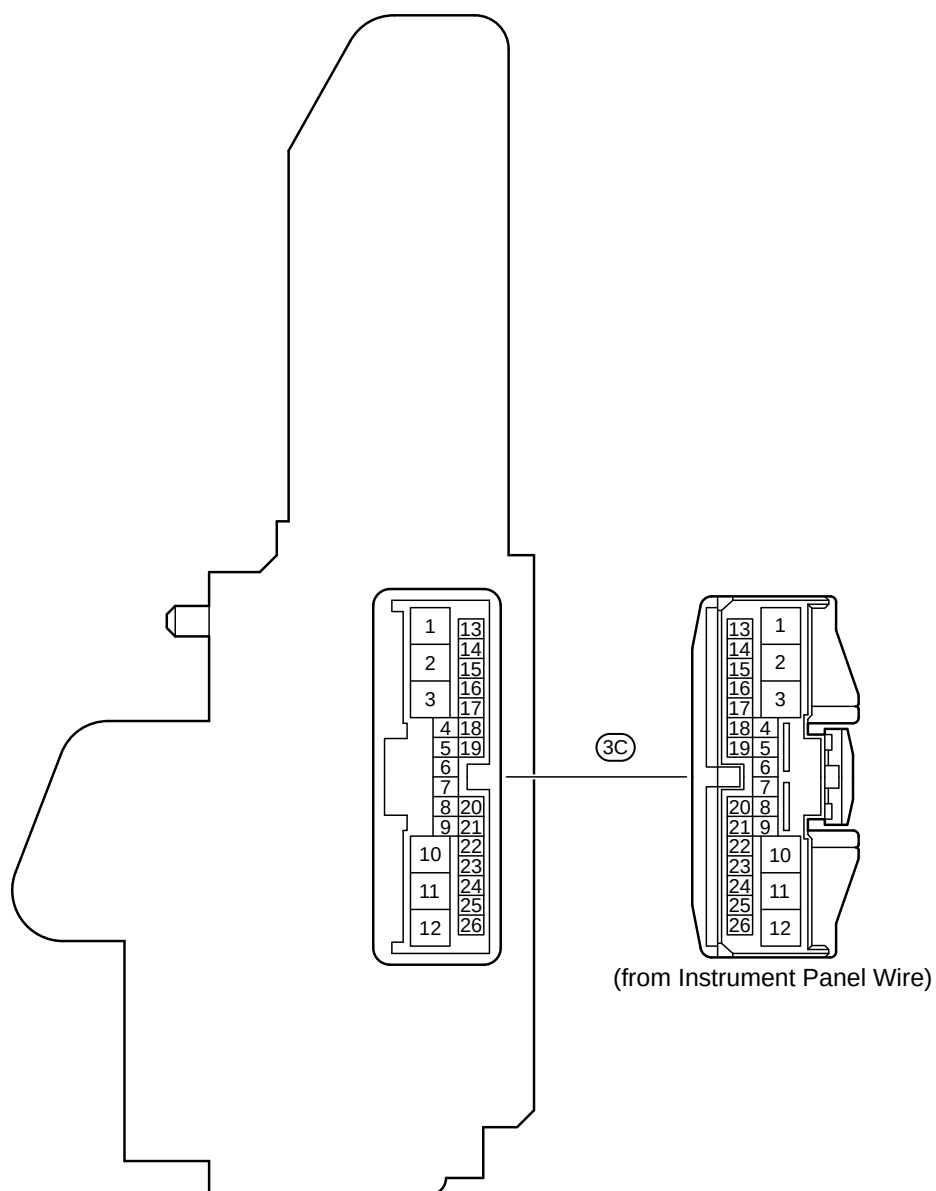
View B

: Cowl Side J/B RH Assembly

Cowl Side Right

(RHD Before Aug. 2015 Production)

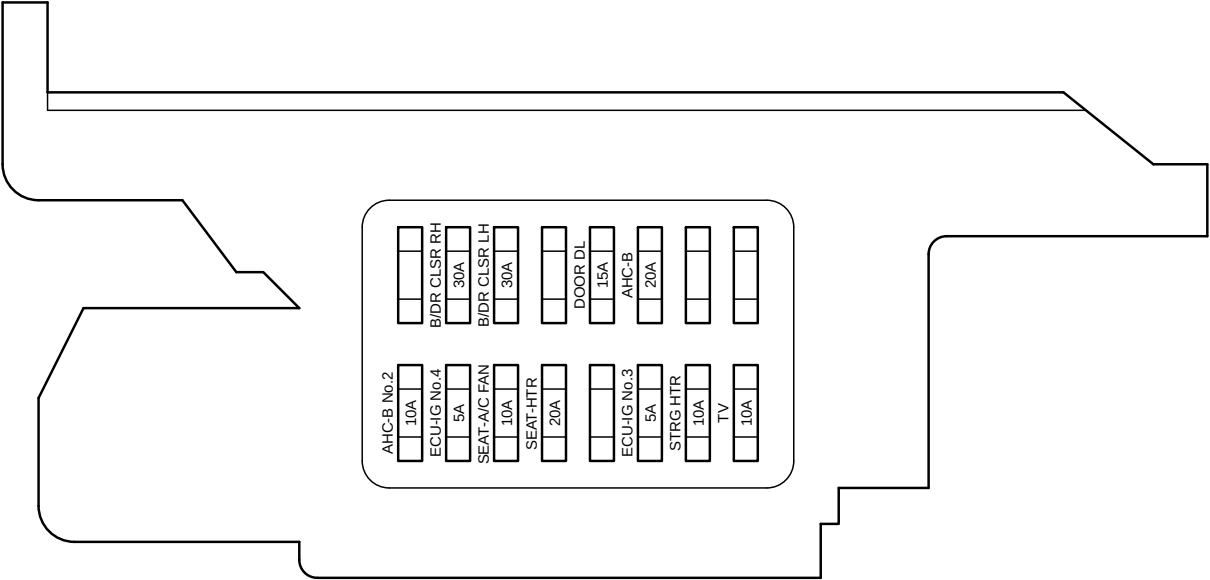
View C

| : Cowl Side J/B RH Assembly | Cowl Side Right |

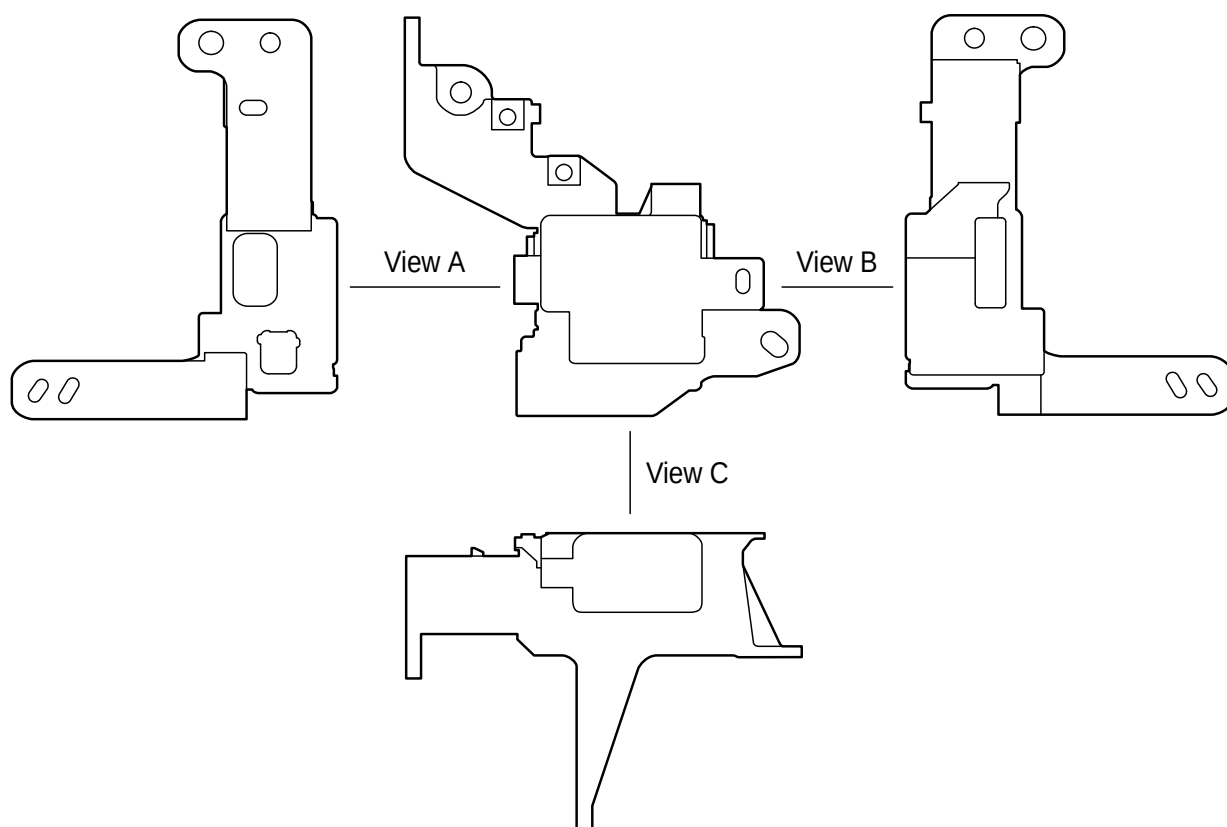
: Cowl Side J/B RH Assembly

Cowl Side Right

(LHD From Aug. 2015 Production)

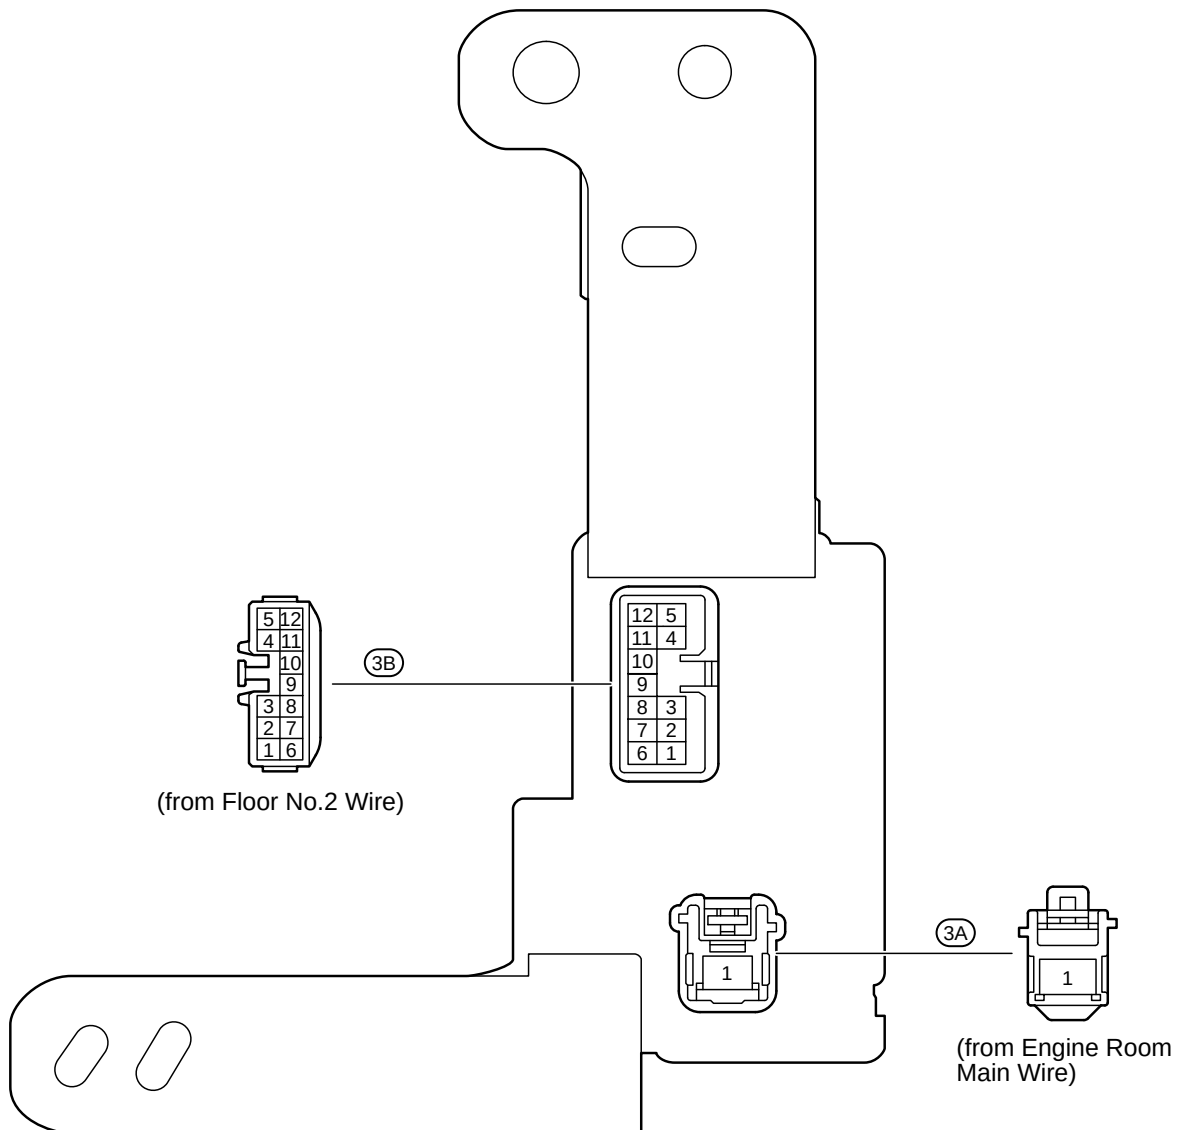
## View A

: Cowl Side J/B RH Assembly **Cowl Side Right**

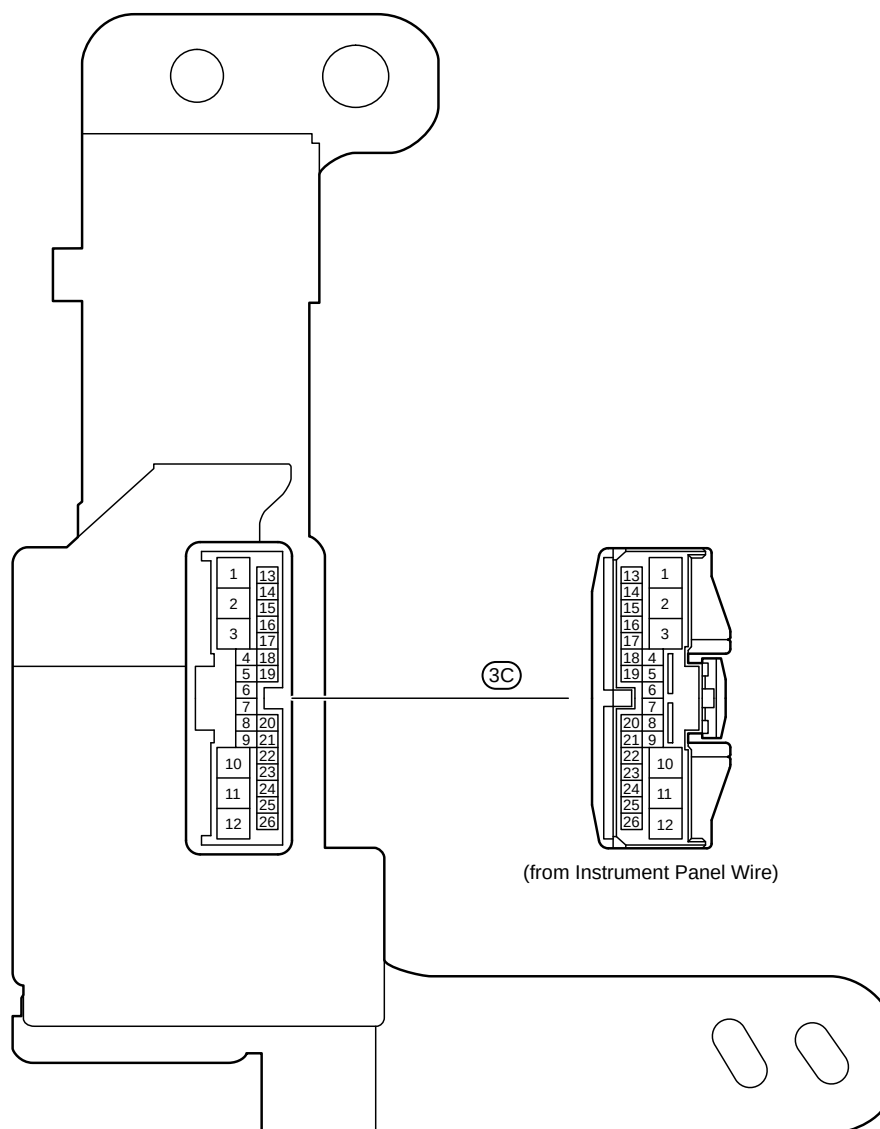
View B

: Cowl Side J/B RH Assembly

Cowl Side Right

(LHD From Aug. 2015 Production)

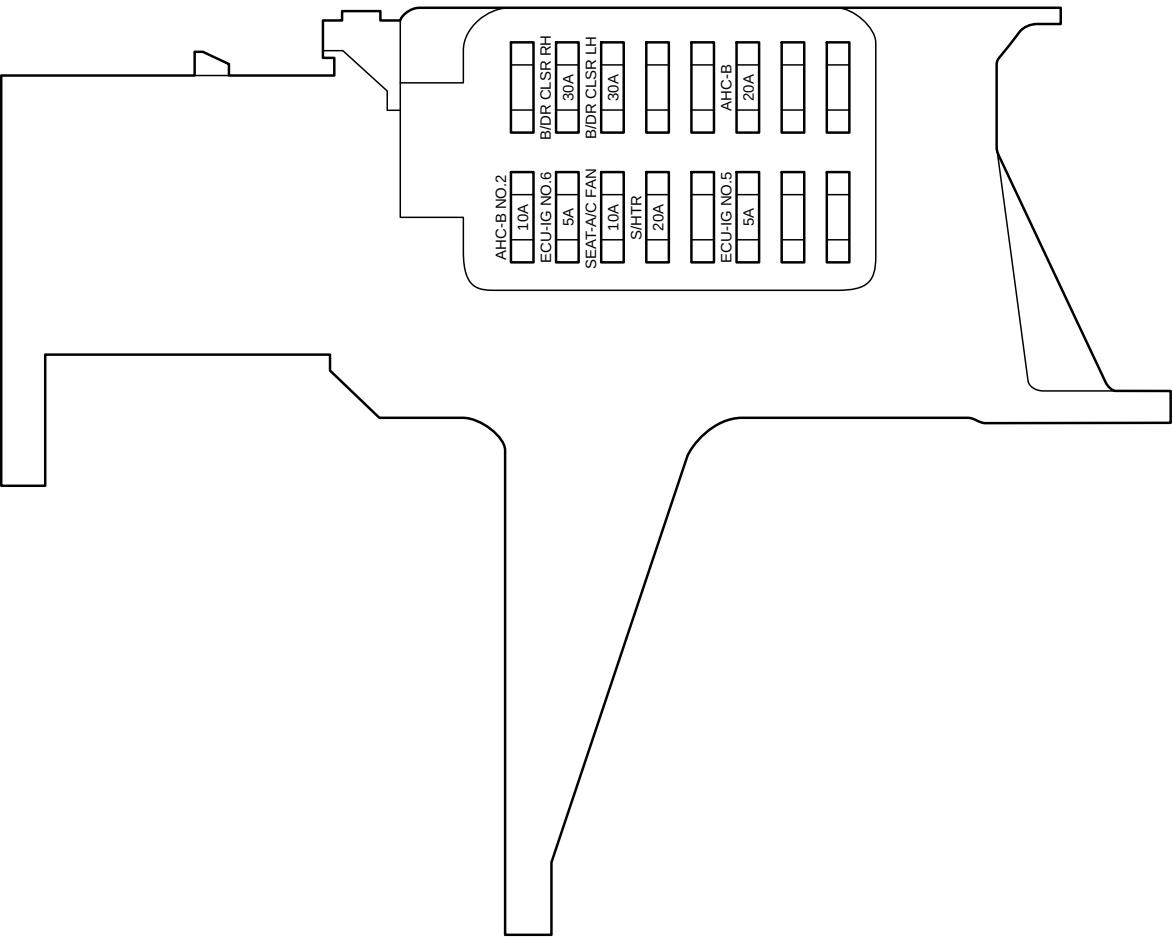
View C

: Cowl Side J/B RH Assembly

Cowl Side Right

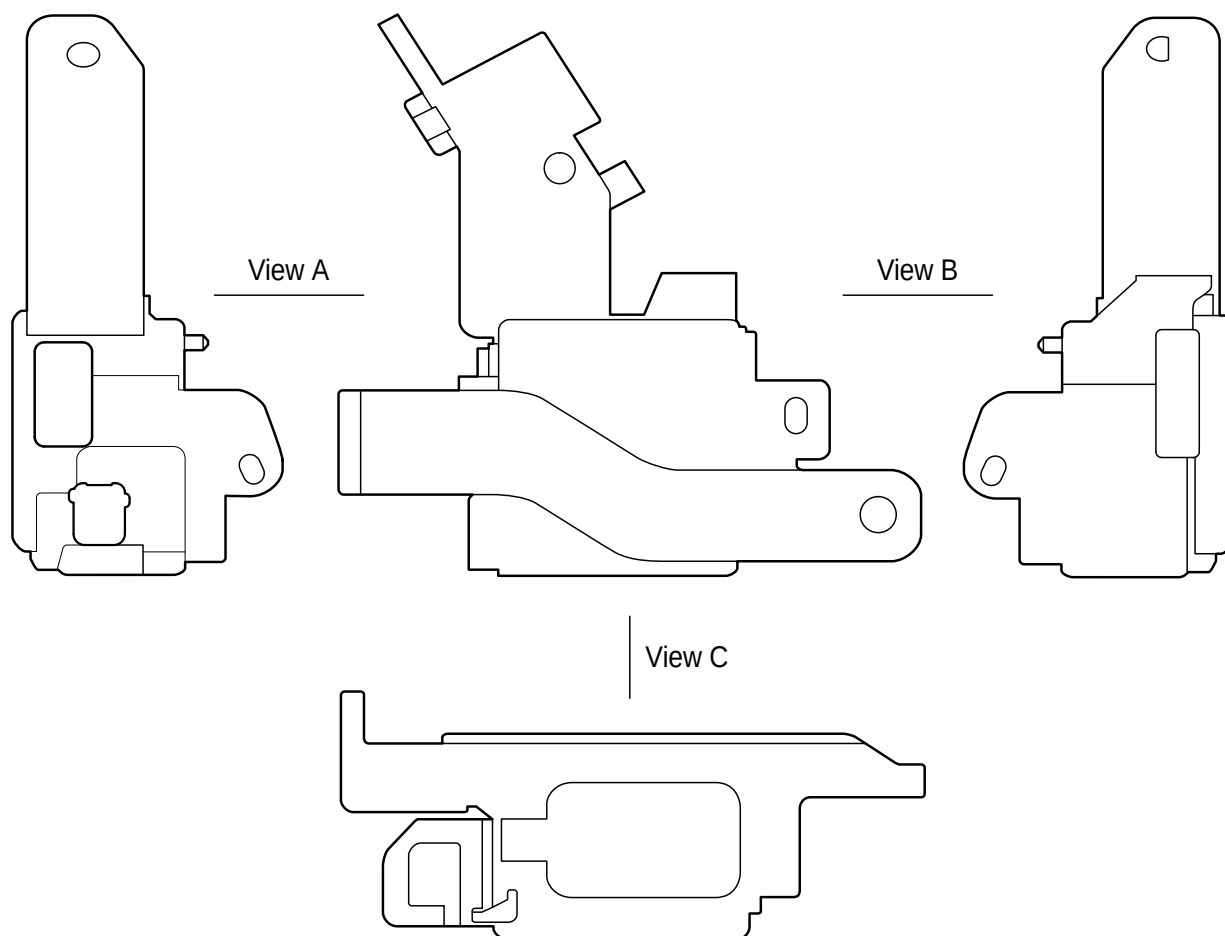
: Cowl Side J/B RH Assembly

Cowl Side Right

(RHD From Aug. 2015 Production)

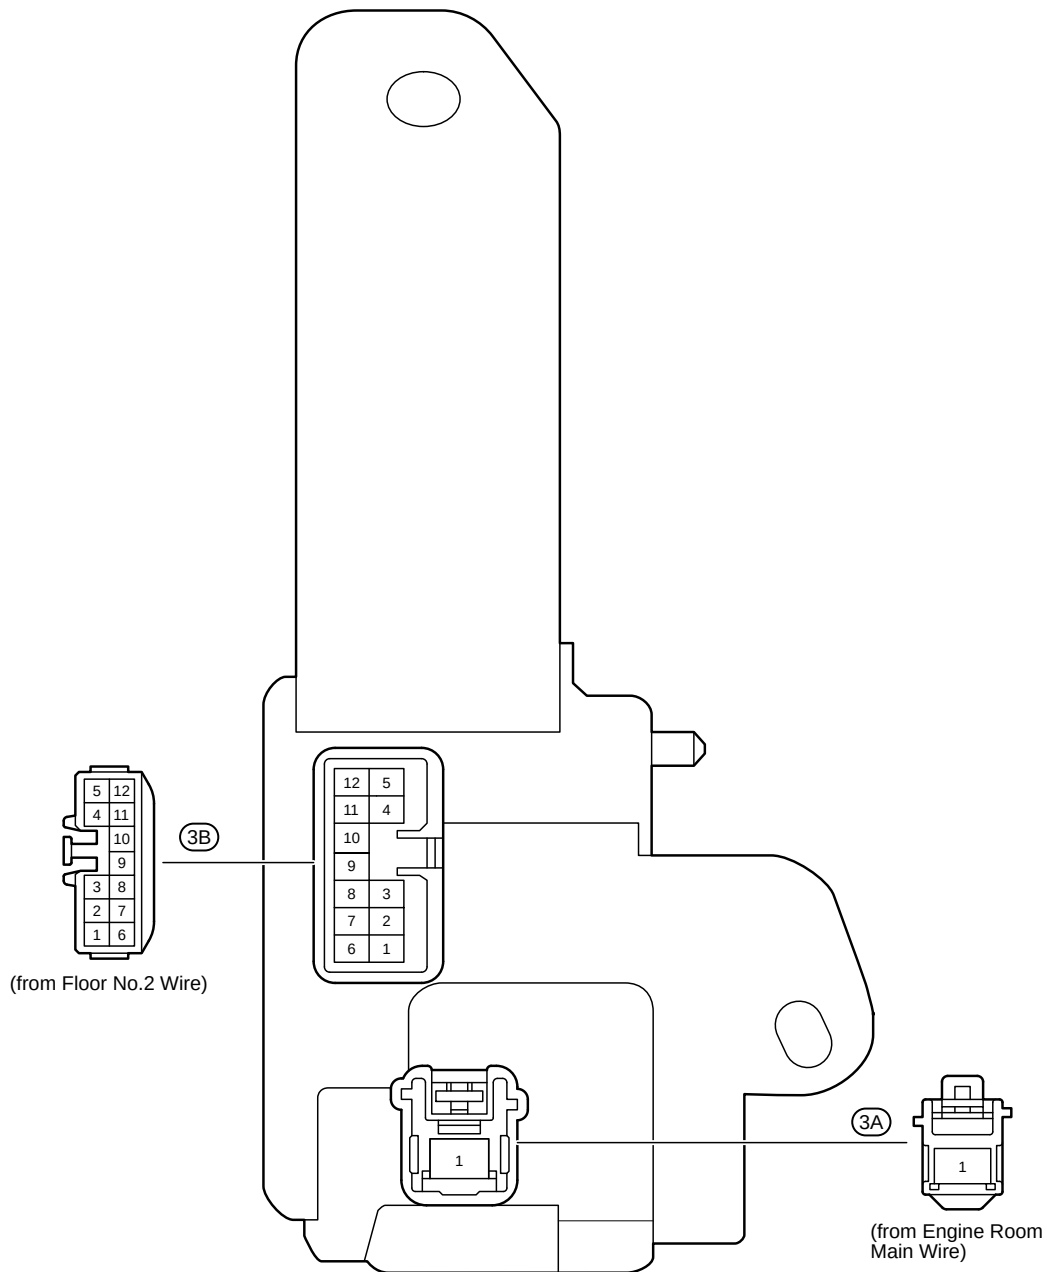
## View A

: Cowl Side J/B RH Assembly **Cowl Side Right**

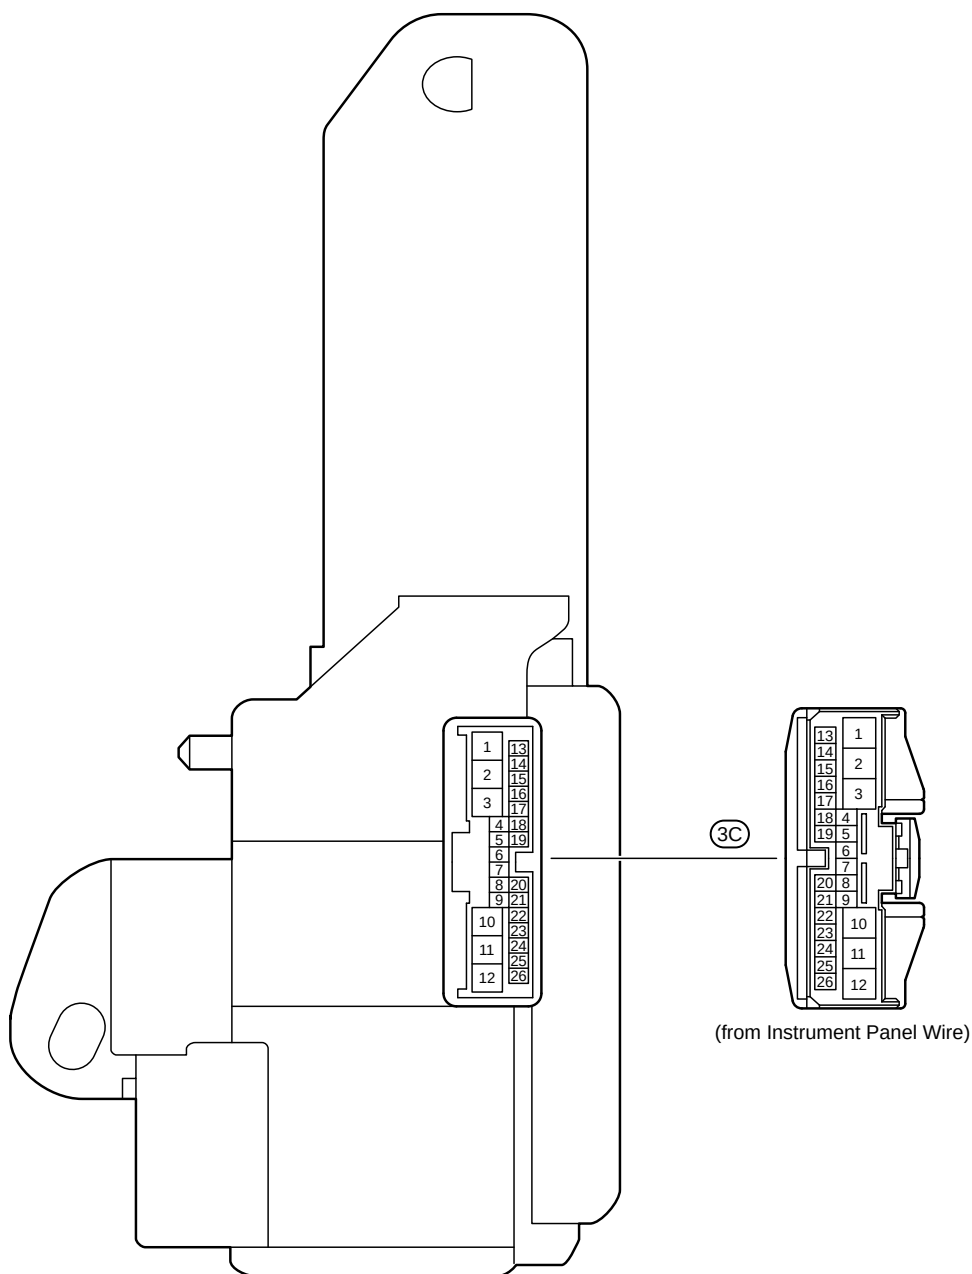
View B

: Cowl Side J/B RH Assembly

Cowl Side Right

(RHD From Aug. 2015 Production)

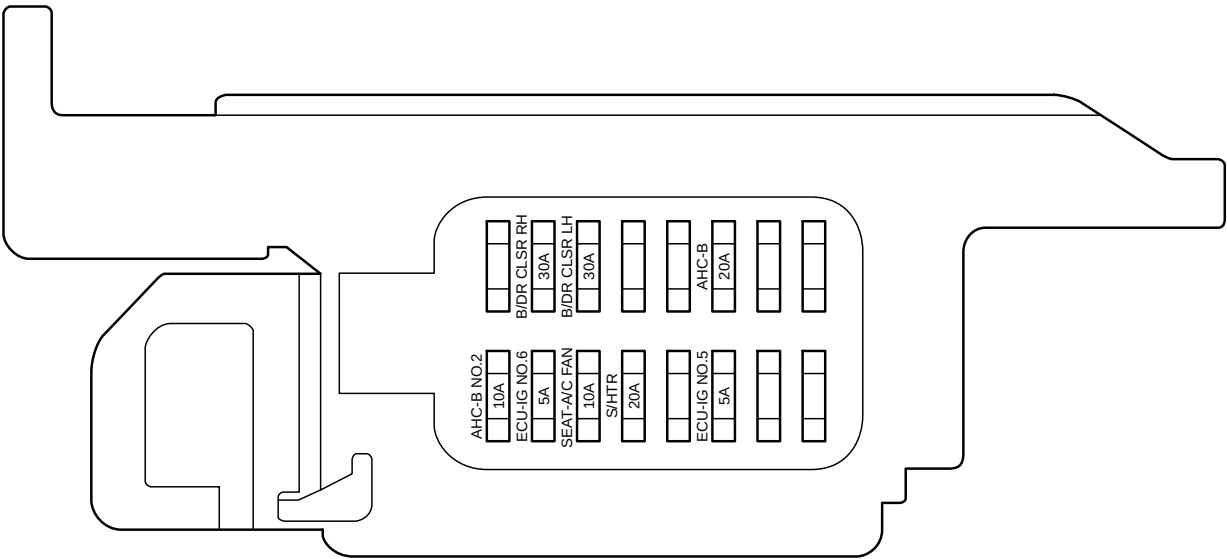
View C

: Cowl Side J/B RH Assembly

Cowl Side Right
