## F RELAY LOCATIONS

### [Cowl Side J/B LH Assembly Inner Circuit] (Before Aug. 2015 Production)

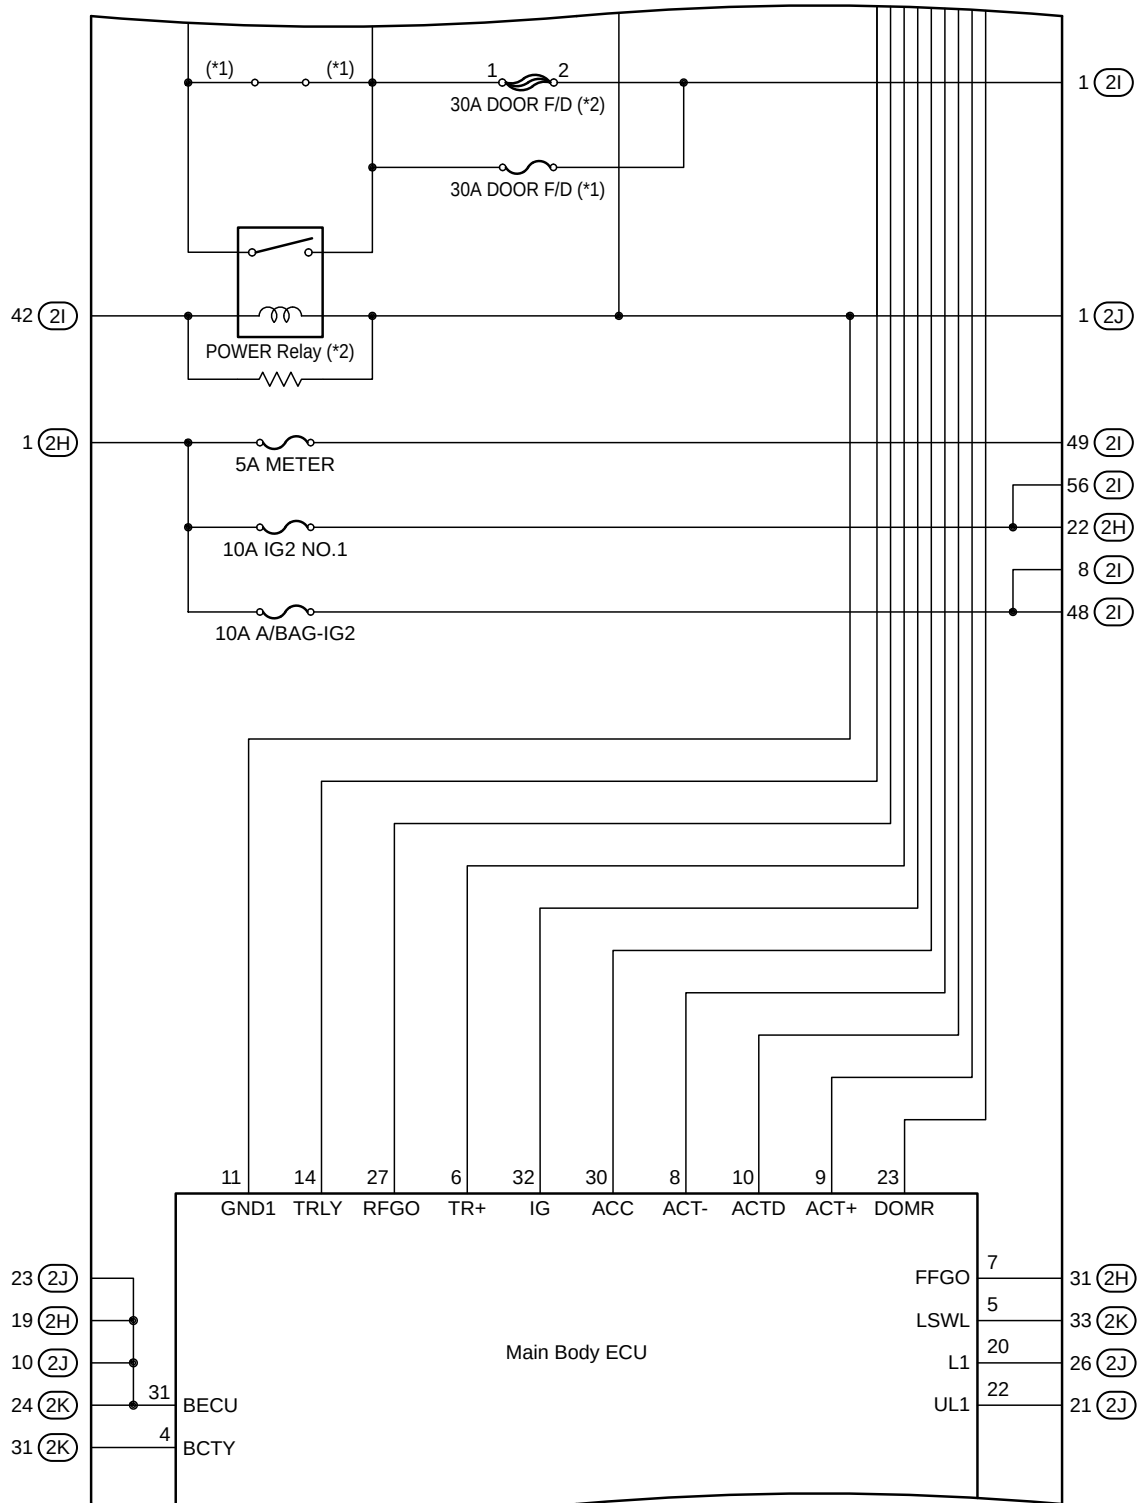
# [Cowl Side J/B LH Assembly Inner Circuit] (From Aug. 2015 Production)

\* 1: All Door Jam Protection  
\* 2: Driver's Door Only Jam Protection
