# Seat Belt Warning <RHD>

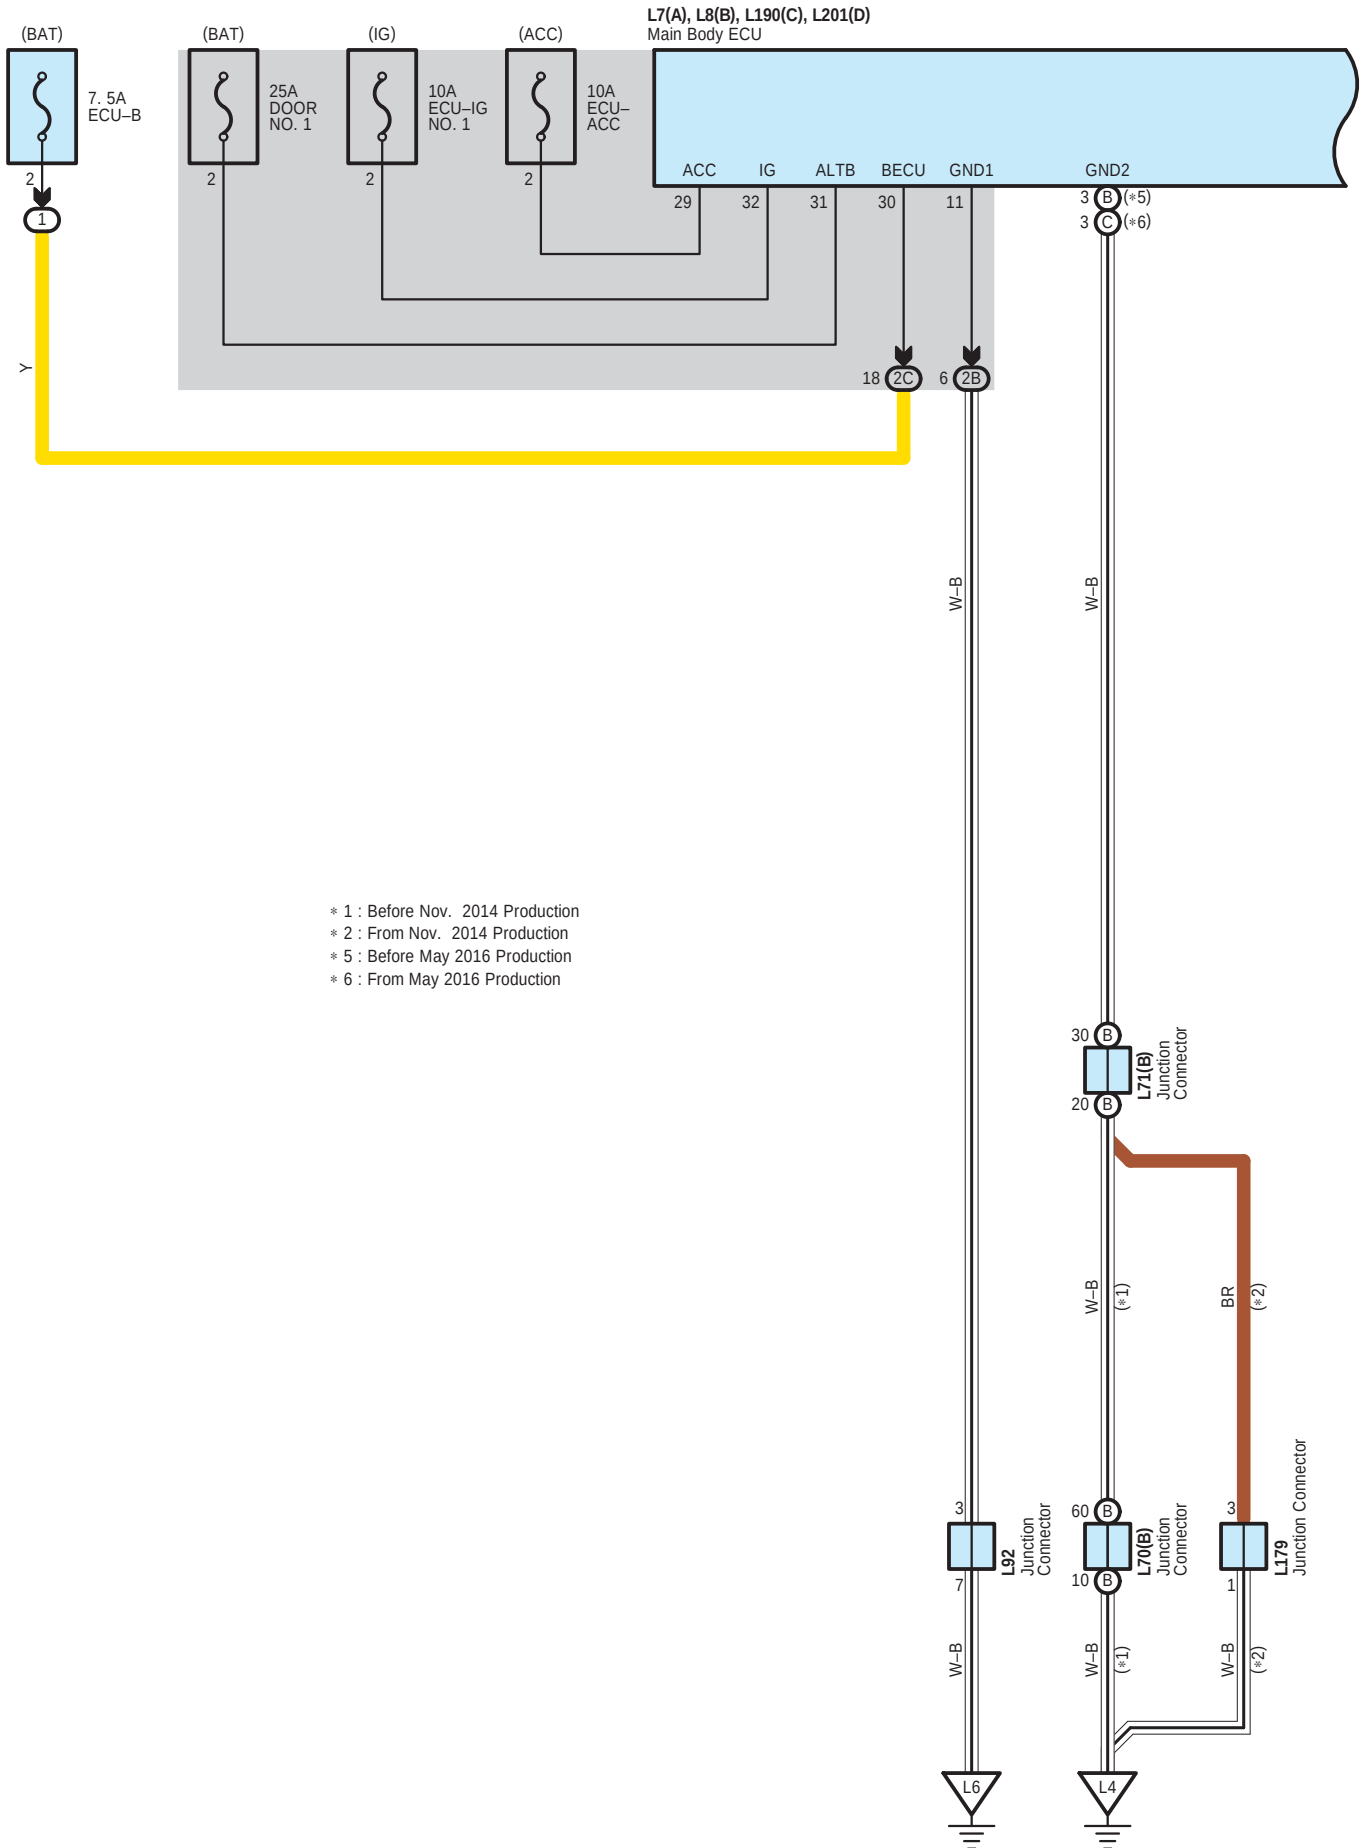
L7(A), L8(B), L190(C), L201(D)  
Main Body ECU

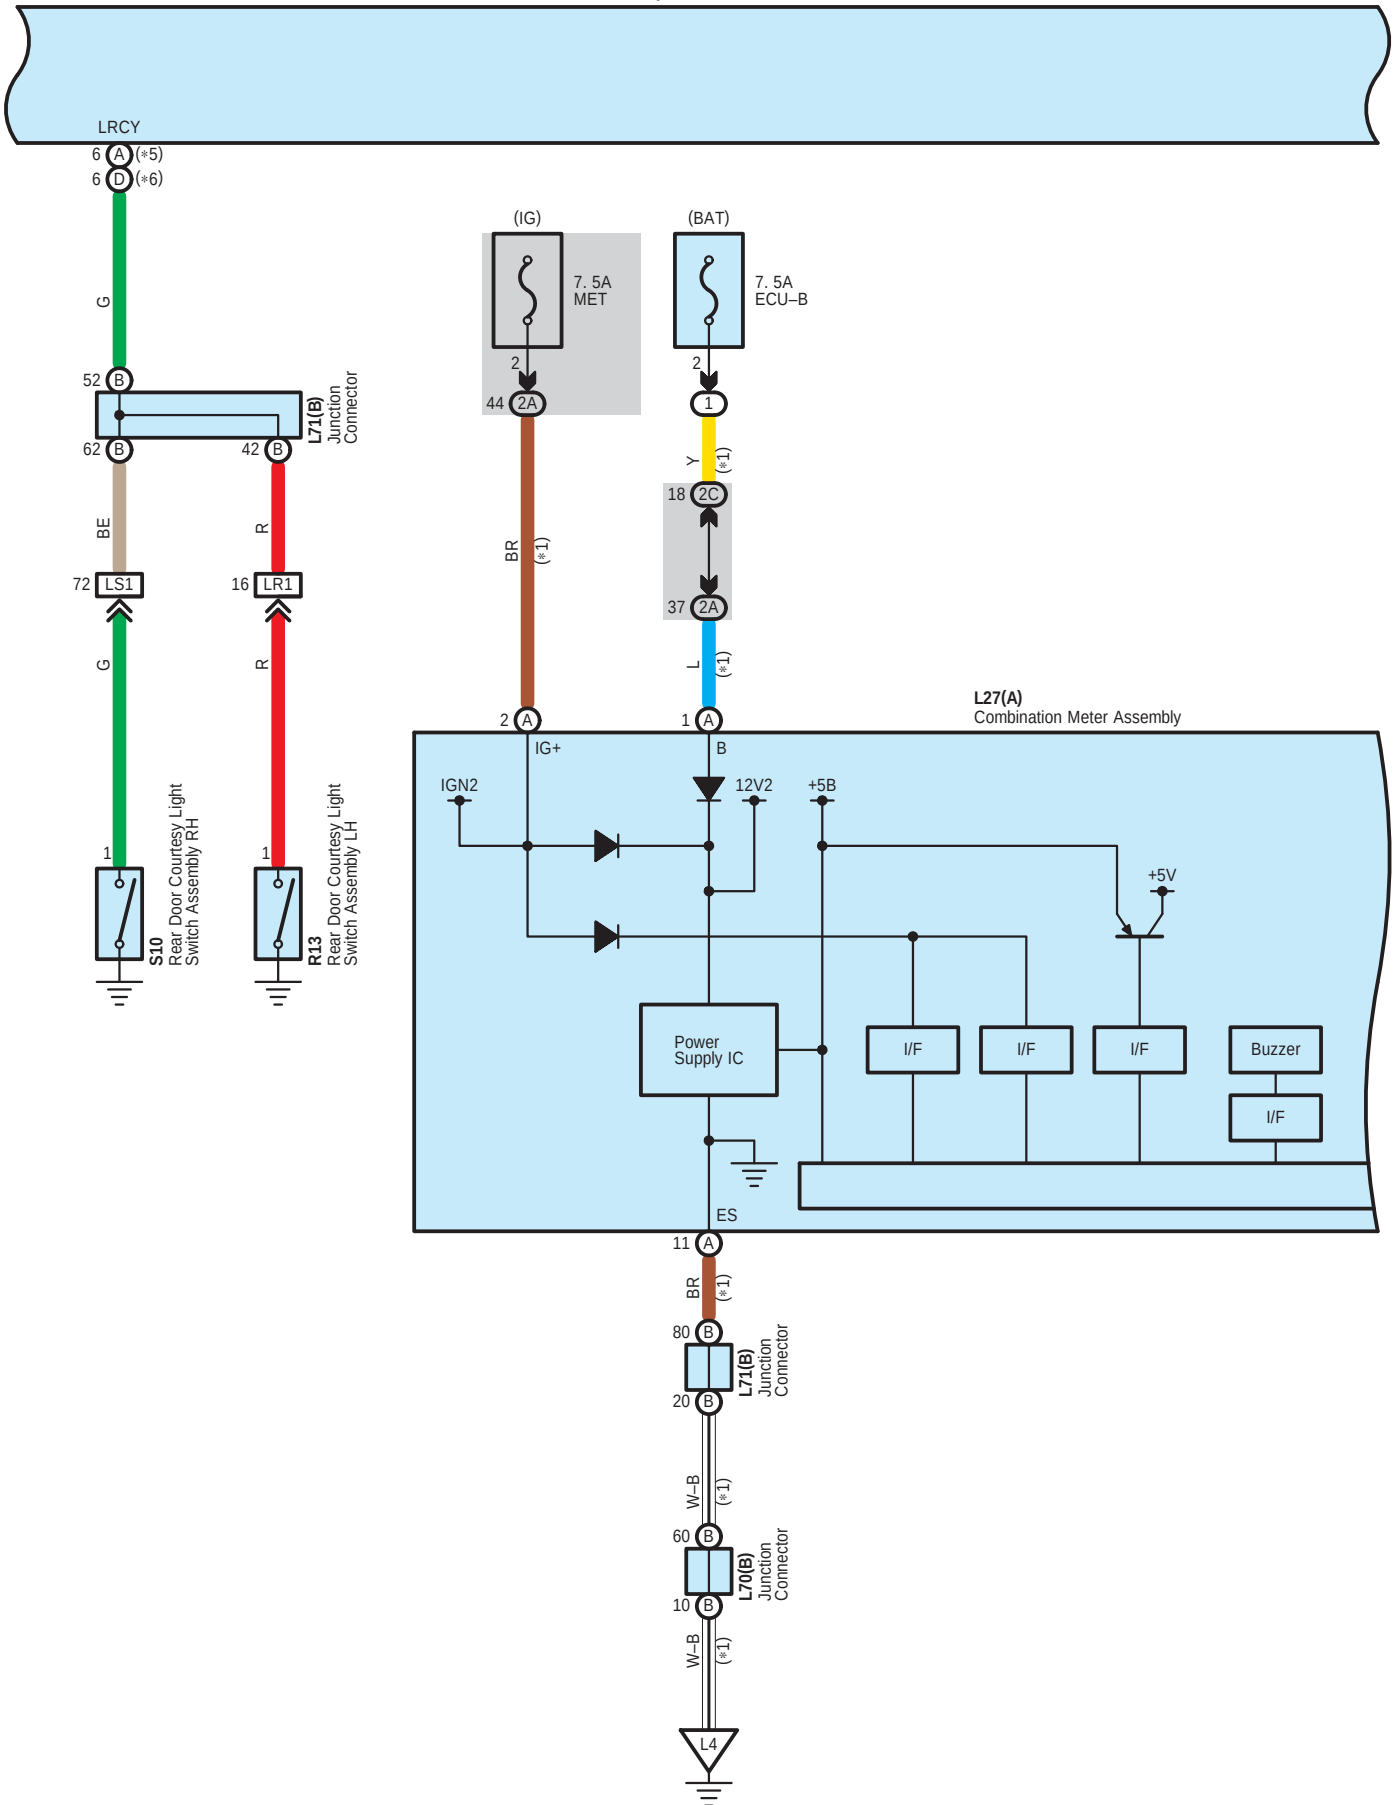
L7(A), L8(B), L190(C), L201(D)  
Main Body ECU

L27(A)  
Combination Meter Assembly

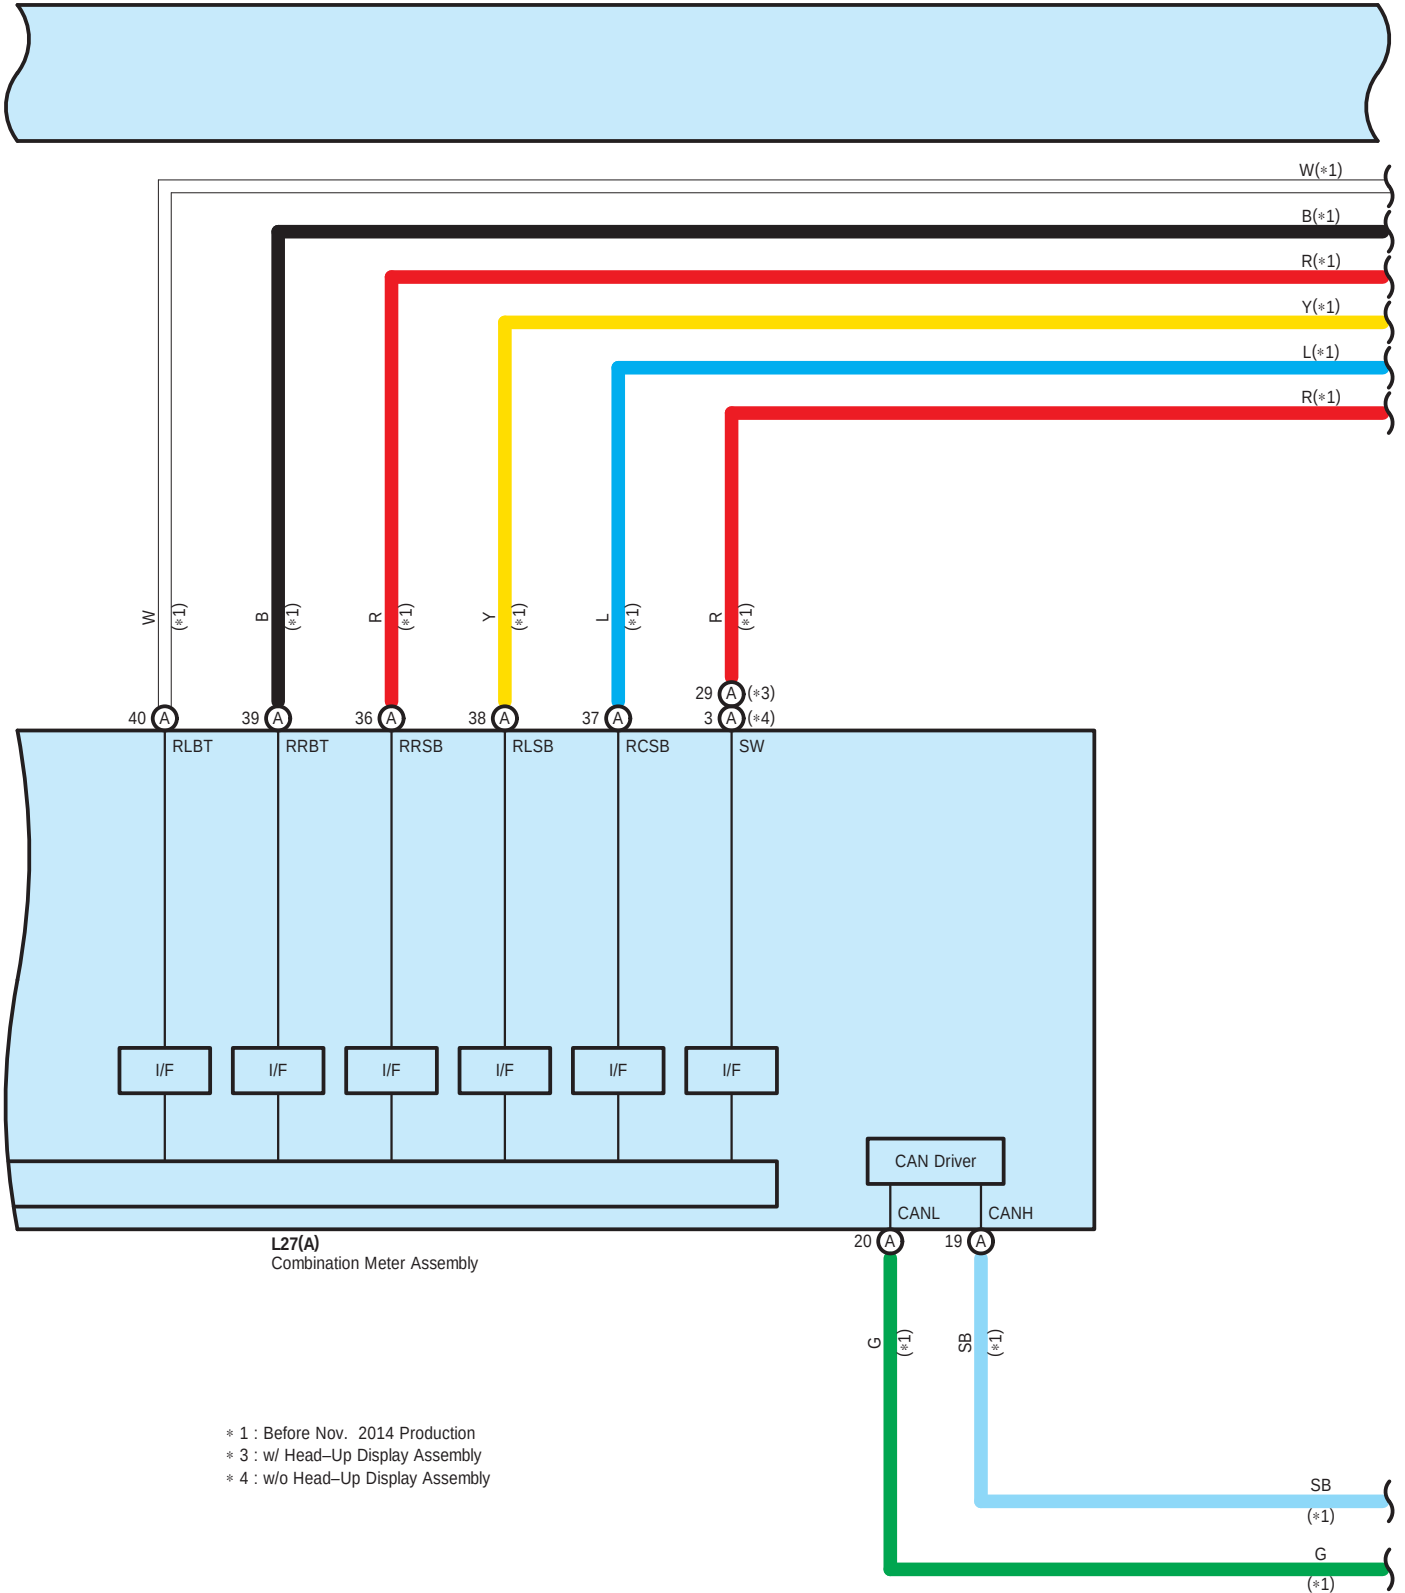
# Seat Belt Warning <RHD>

L7(A), L8(B), L190(C), L201(D)  
Main Body ECU

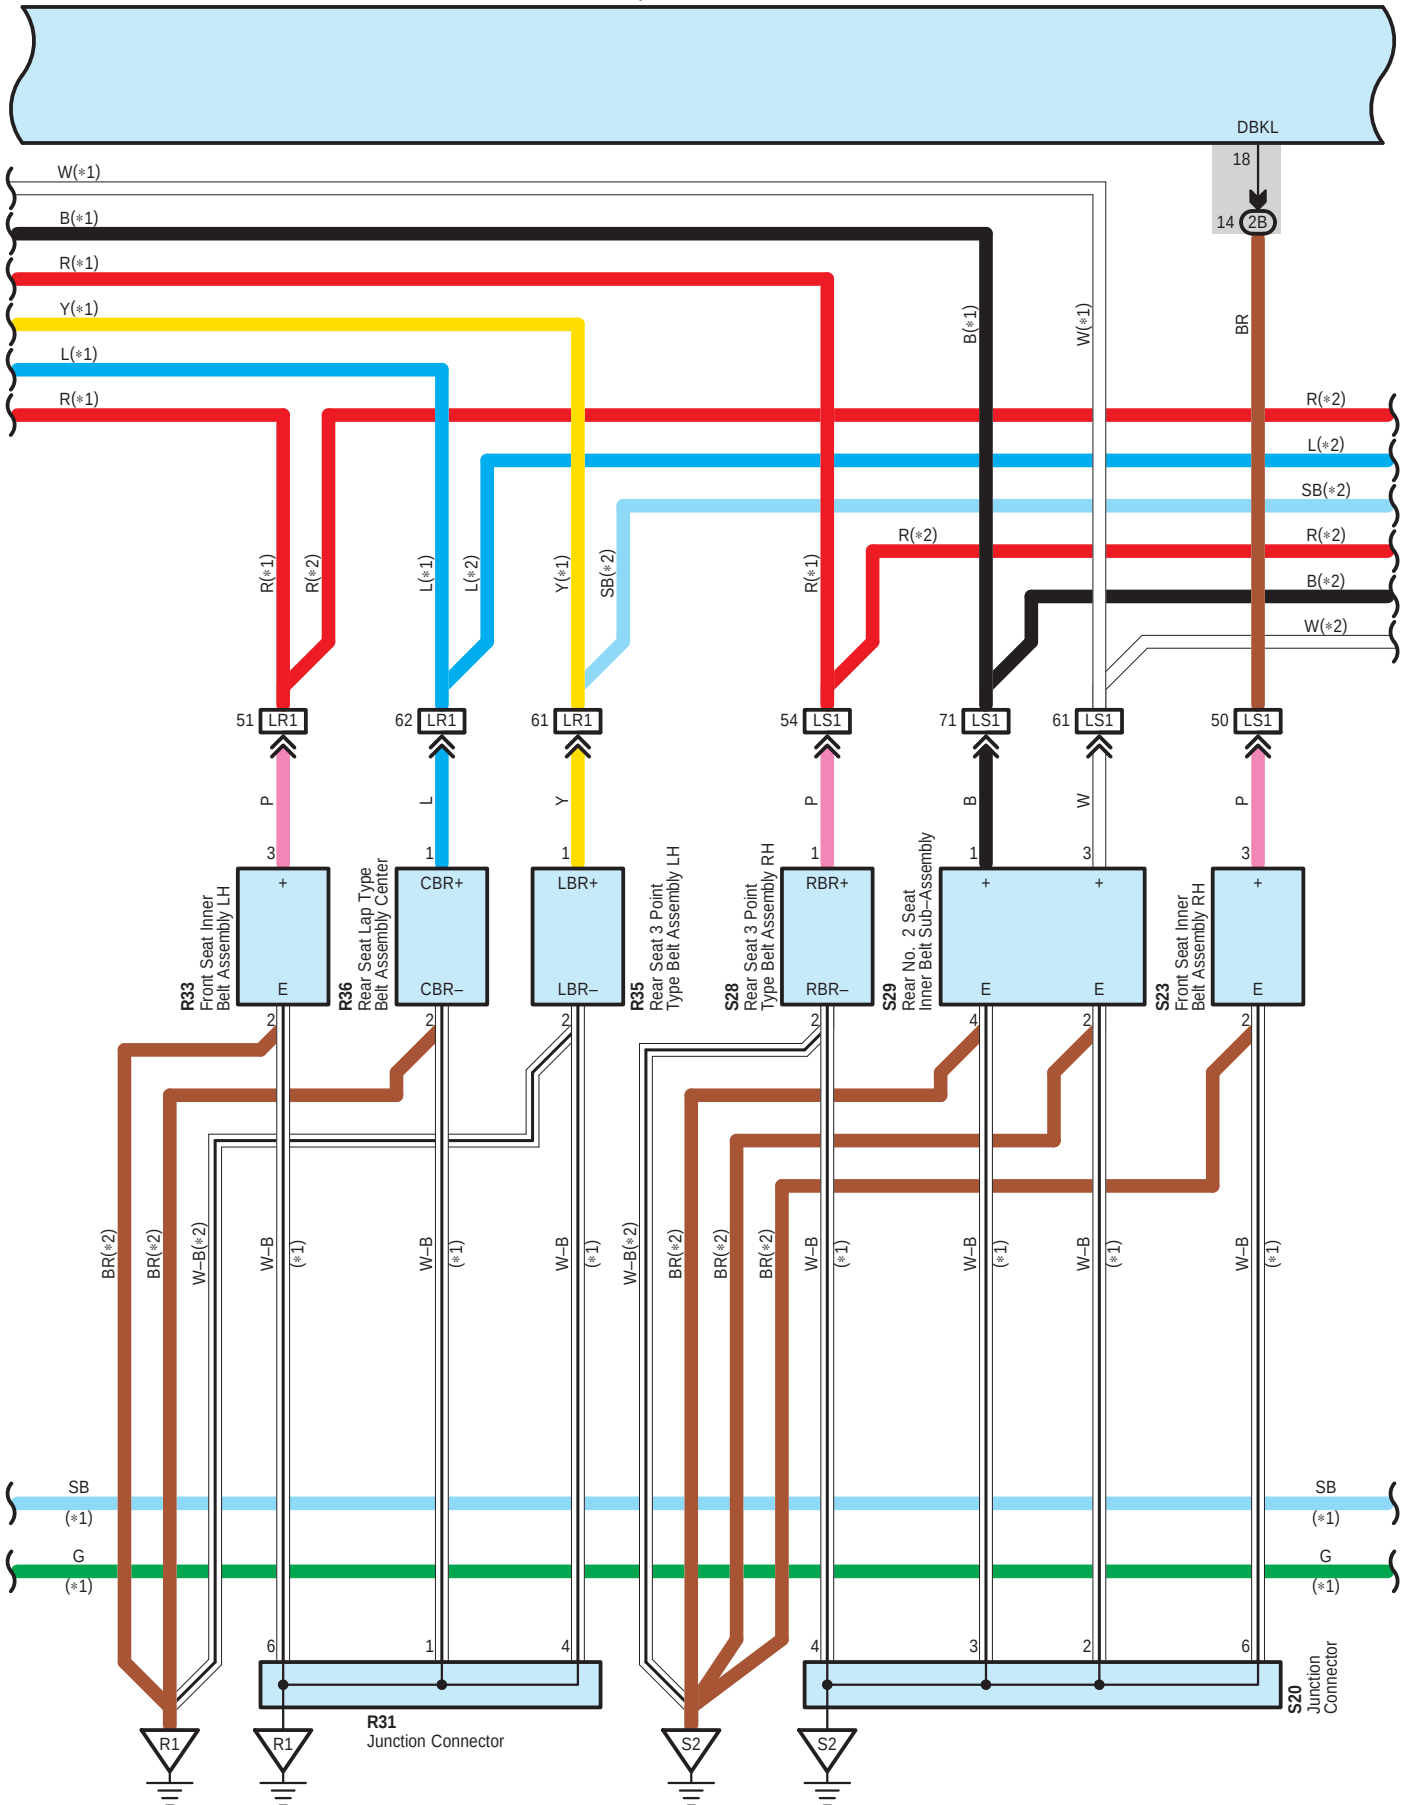
# Seat Belt Warning <RHD>

L7(A), L8(B), L190(C), L201(D)  
Main Body ECU

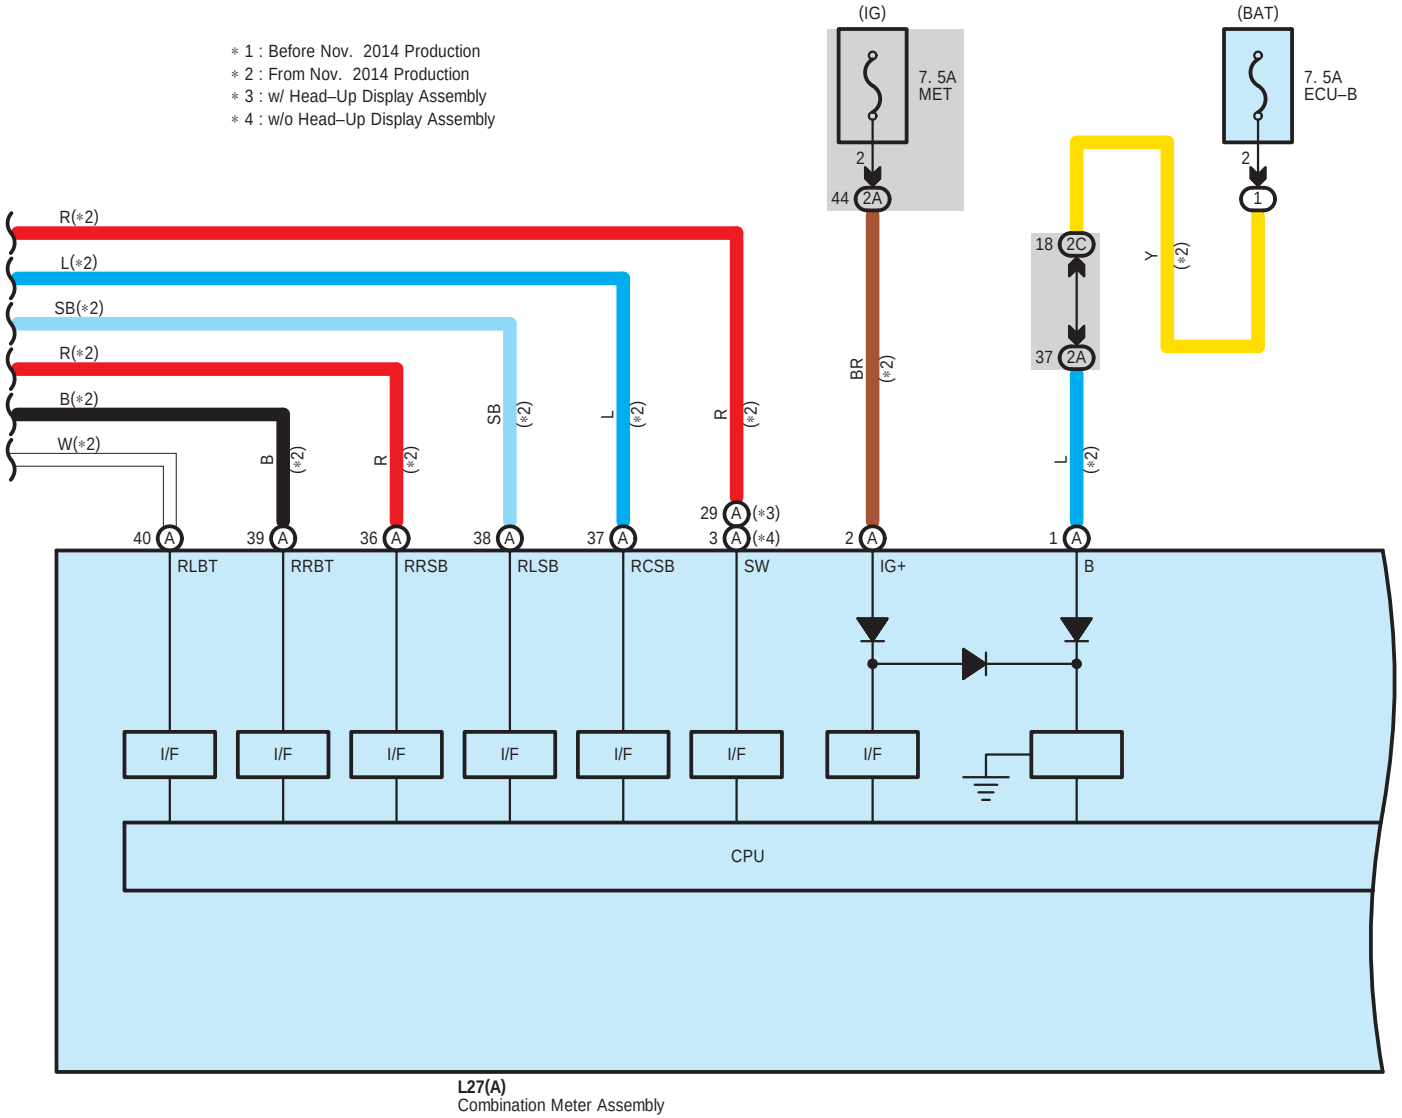
L7(A), L8(B), L190(C), L201(D)  
Main Body ECU

- \* 1 : Before Nov. 2014 Production
- \* 2 : From Nov. 2014 Production
- \* 5 : Before May 2016 Production
- \* 6 : From May 2016 Production
