# Position of Parts in Instrument Panel (LHD)

## Position of Parts in Instrument Panel (LHD)

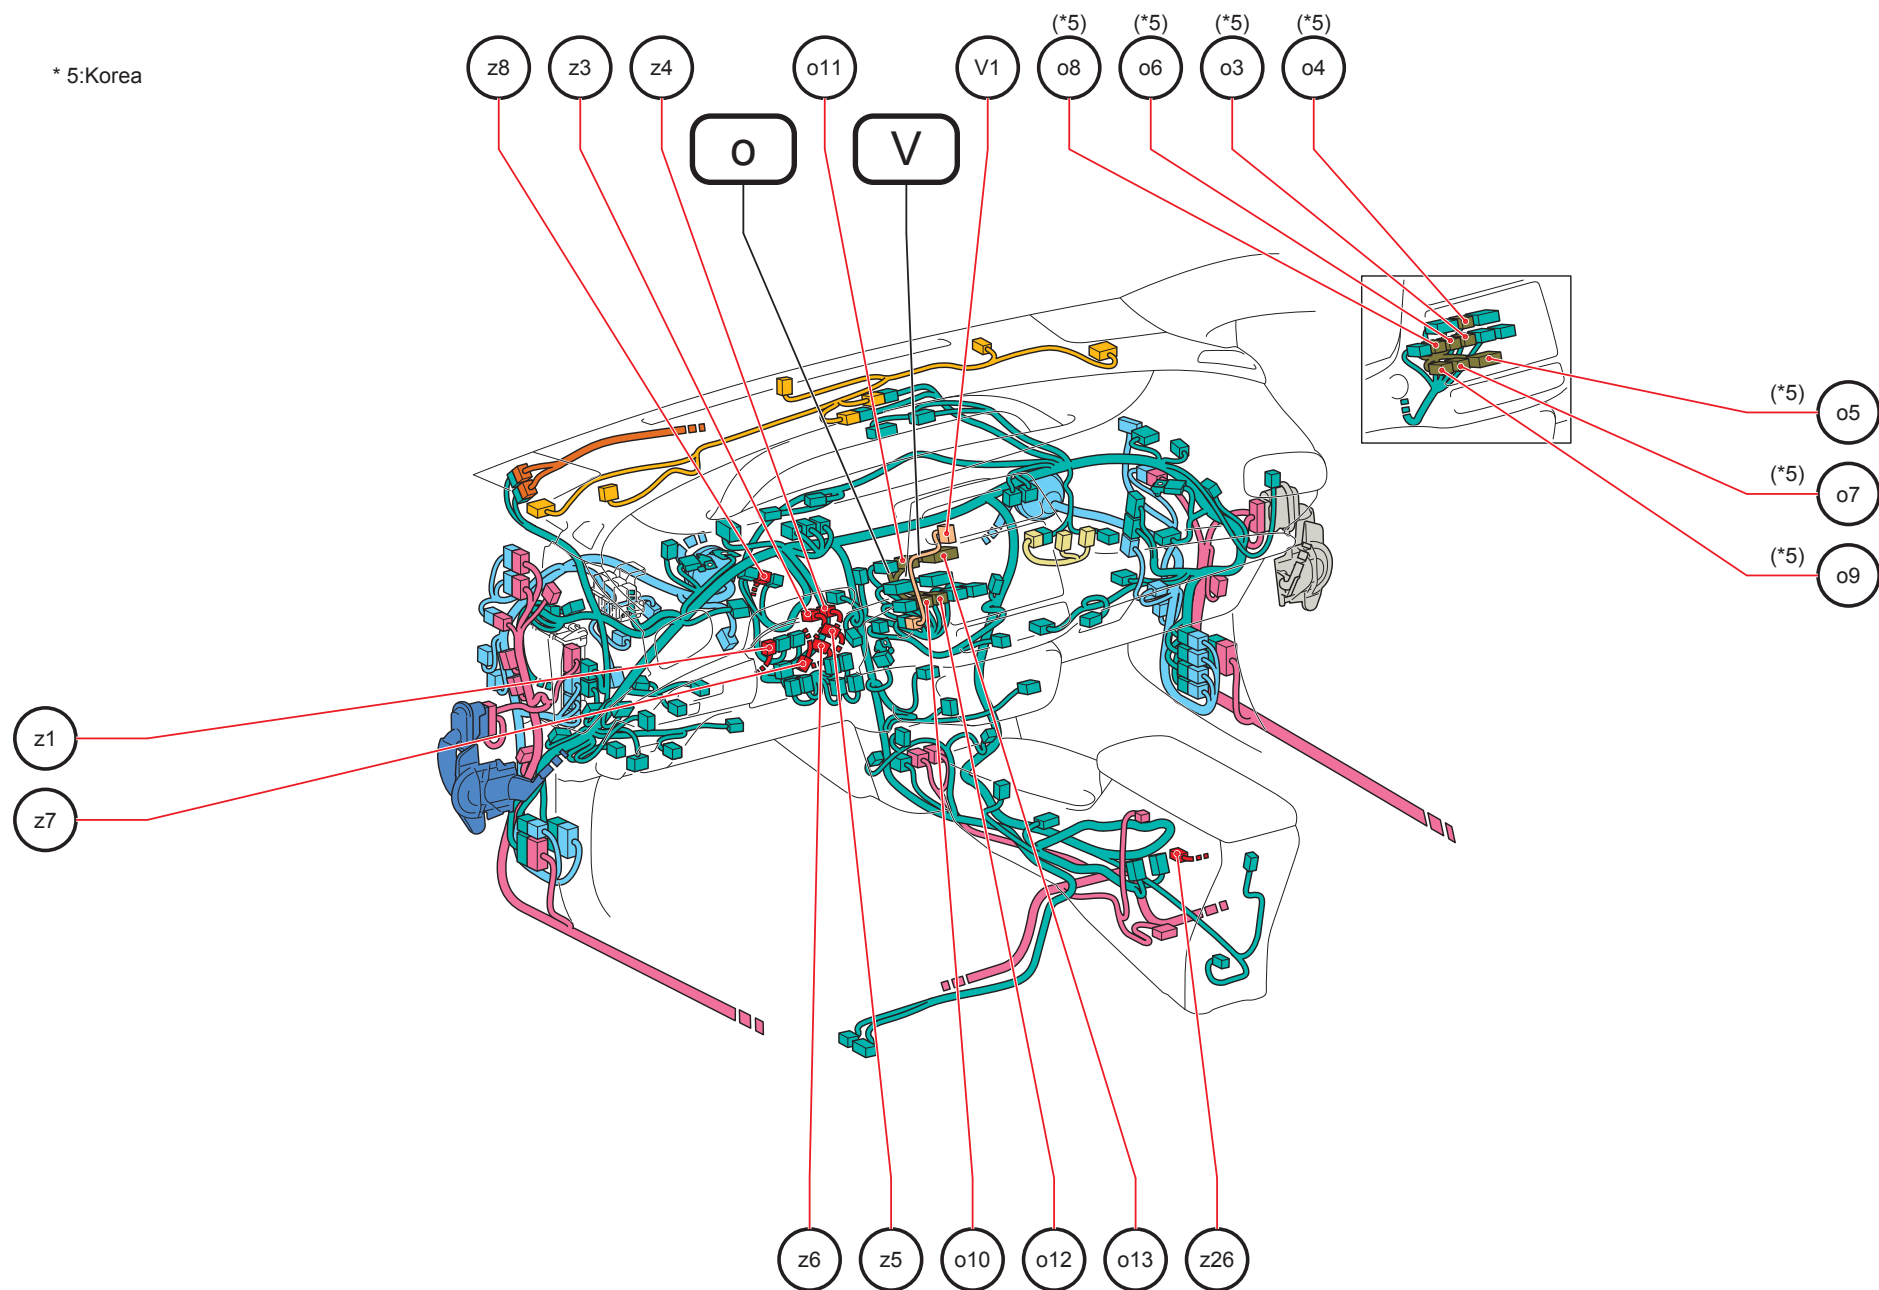
| V1 | Hazard Warning Signal Switch Assembly |
| o3 | Radio & Display Receiver Assembly |
| o4 | Radio & Display Receiver Assembly |
| z1 | A/C Harness Assembly , A/C Amplifier Assembly |
| z3 | Steering Pad Switch Assembly , Spiral Cable with Sensor Sub-Assembly |
| z4 | Cruise Control Switch Wire , Spiral Cable with Sensor Sub-Assembly |
| z5 | Driver Side Squib Circuit (Horn Button Assembly) , Spiral Cable with Sensor Sub-Assembly |
| z6 | Driver Side Squib Circuit (Horn Button Assembly) , Spiral Cable with Sensor Sub-Assembly |
| z7 | Heater Control Assembly, Spiral Cable with Sensor Sub-Assembly |
| z8 | Electric Power Steering Column Sub-Assembly , Power Steering ECU Assembly |
| z26 | Rechargeable Battery Assembly , Thermistor (Rechargeable Battery Assembly) |
