# Mirror Heater , Rear Window Defogger

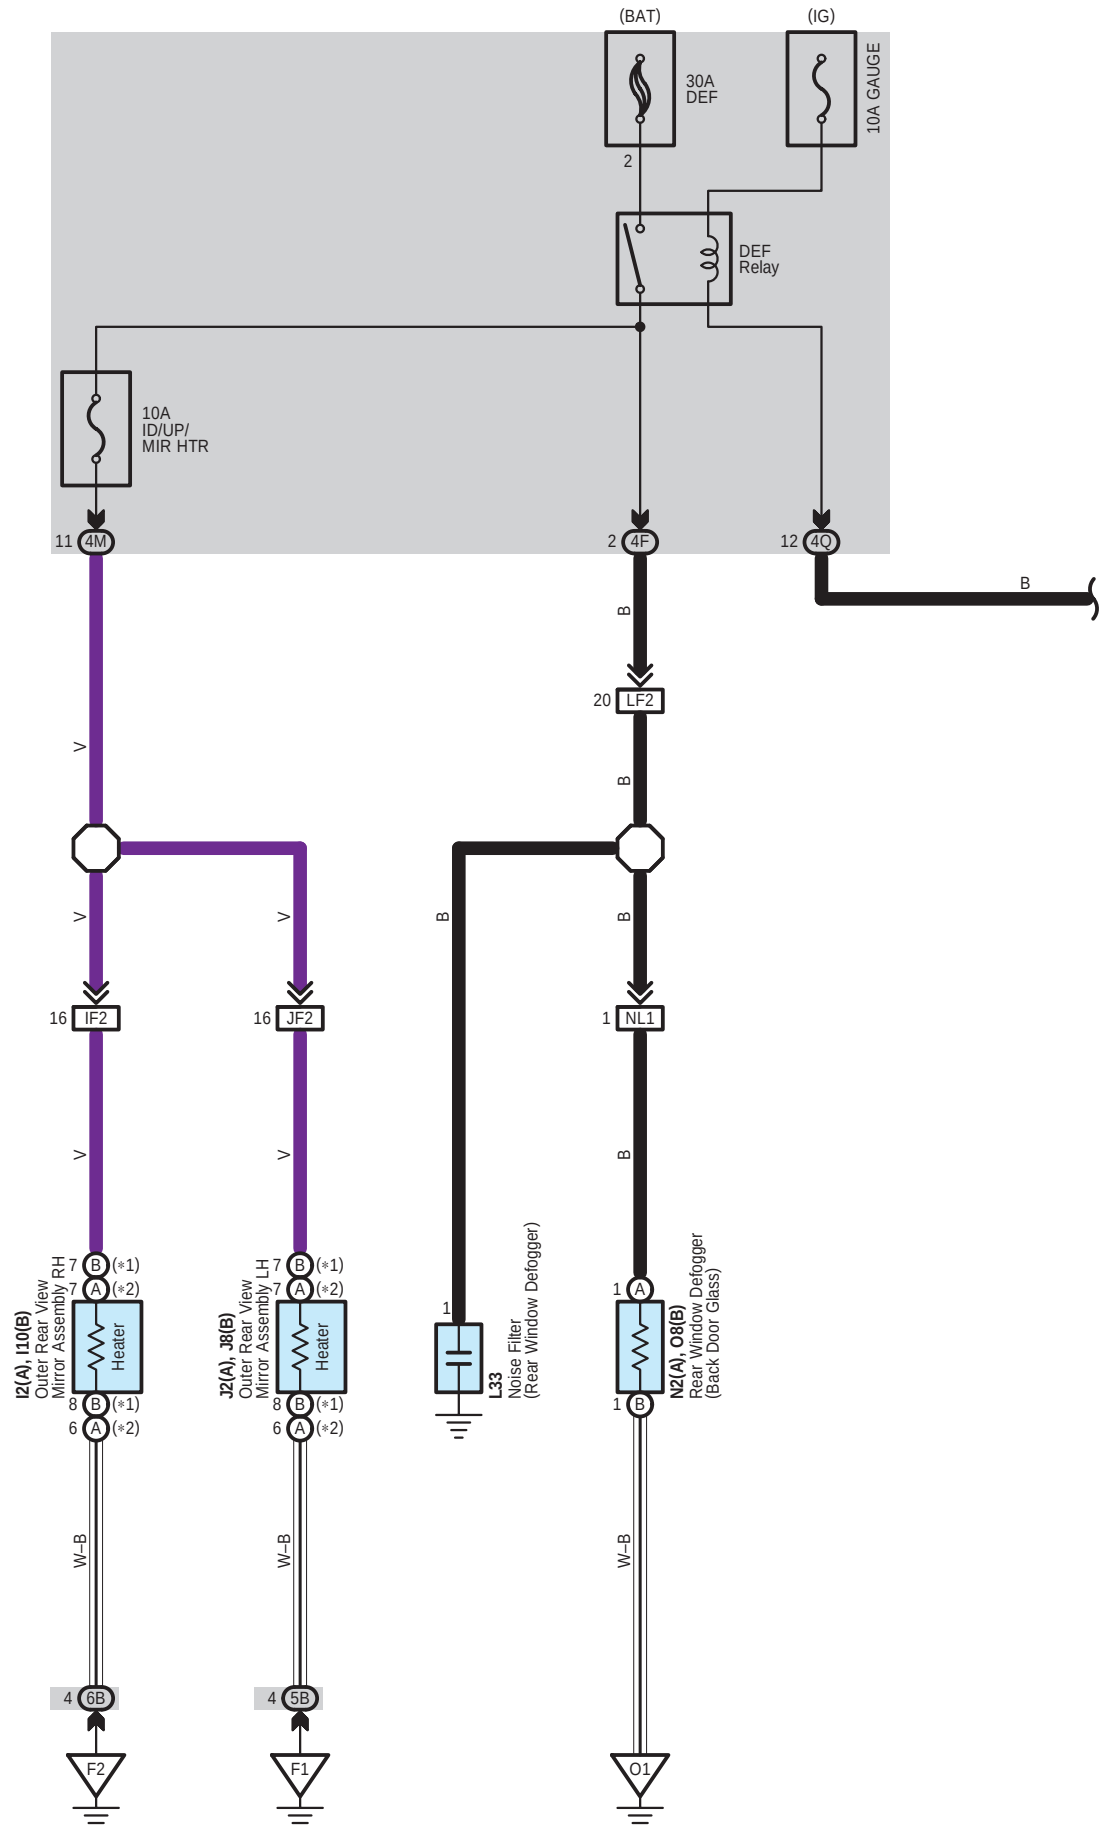
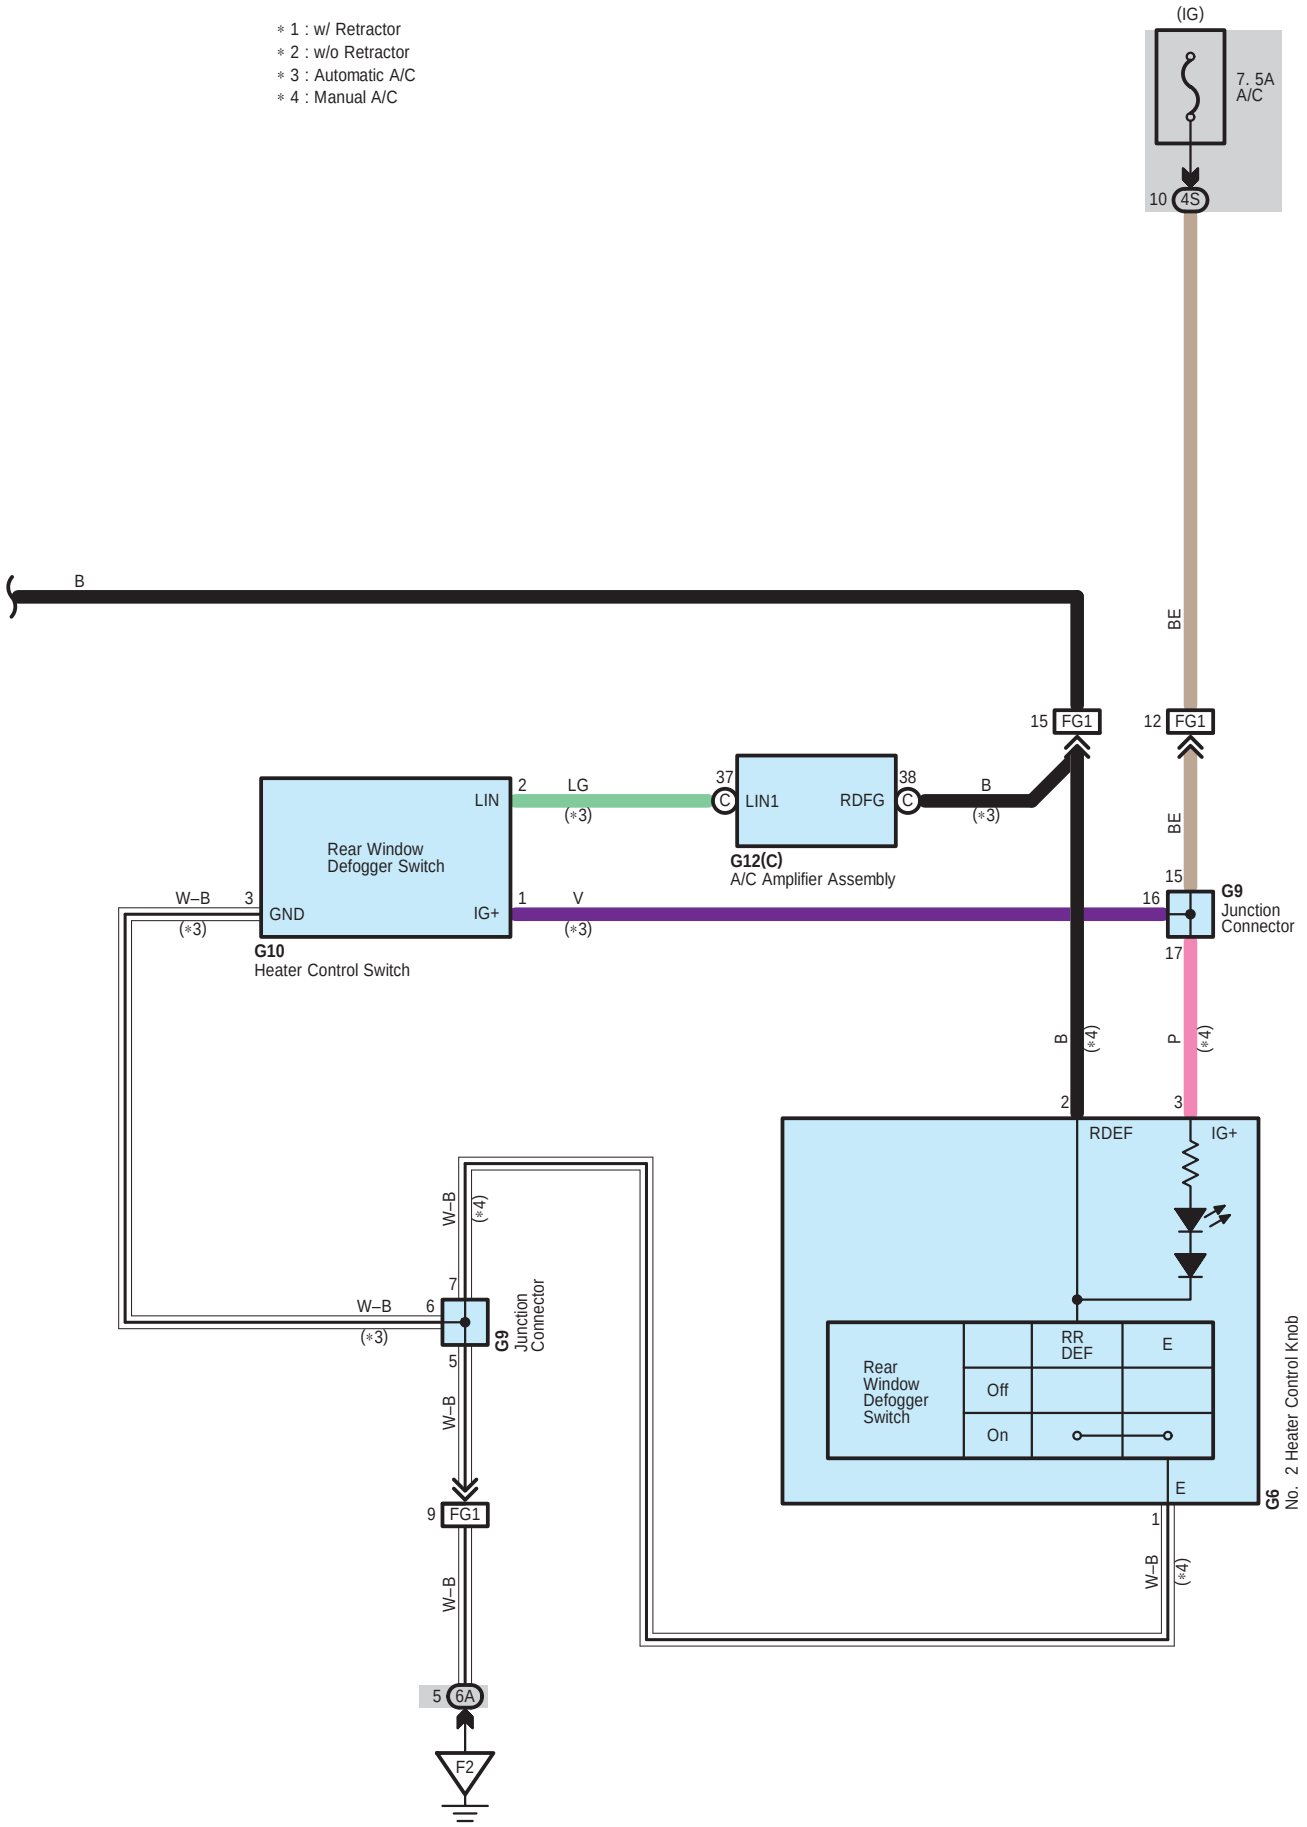
- \* 1 : w/ Retractor
- \* 2 : w/o Retractor
- \* 3 : Automatic A/C
- \* 4 : Manual A/C
