Position of Parts in Instrument Panel <RHD S/D>

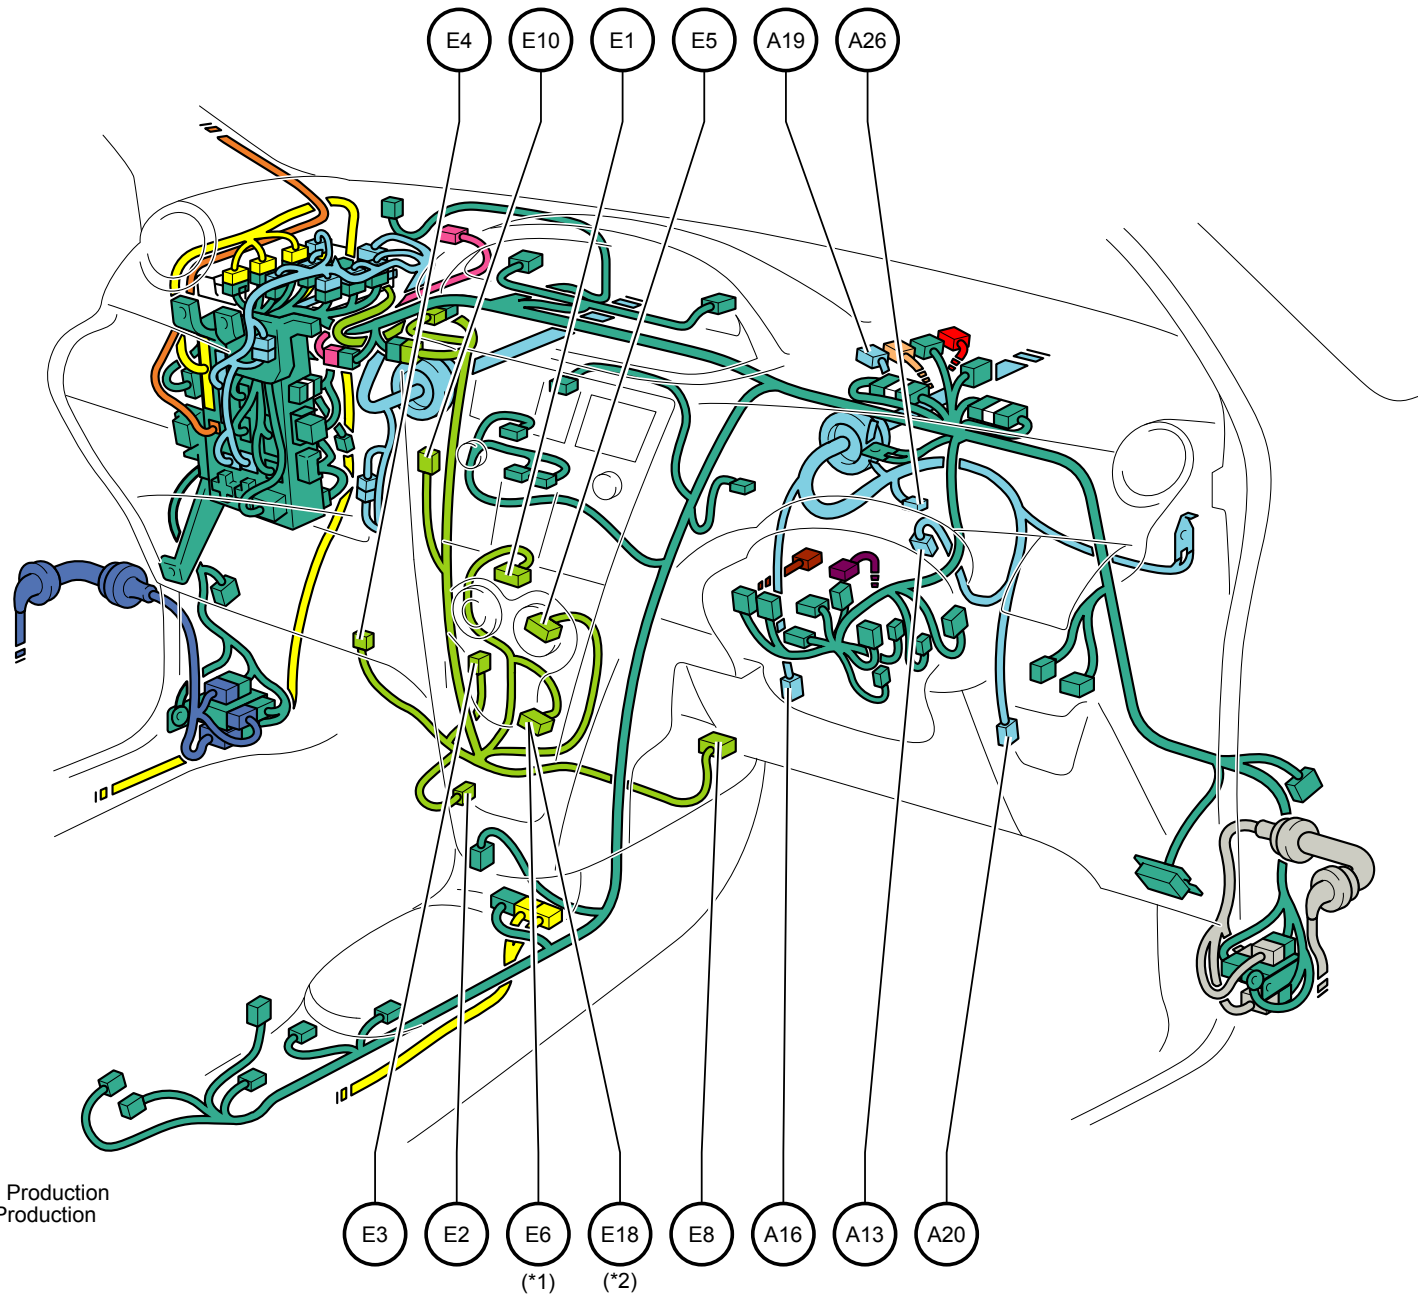
A 13 Stop Lamp SW  
A 13 Stop Lamp SW  
A 16 Clutch Start SW  
A 19 Power Steering ECU  
A 19 Power Steering ECU  
A 20 Accelerator Position Sensor  
A 26 Junction Connector

E 1 Blower SW  
E 2 A/C Thermistor No.1  
E 3 Blower Resistor  
E 4 Blower Motor  
E 5 A/C SW  
E 6 Rear Window Defogger SW  
E 8 A/C Amplifier  
E 8 A/C Amplifier  
E 10 Junction Connector  
E 18 Rear Window Defogger SW  
E 18 Rear Window Defogger SW
